| ENGINE MODEL: | PW4056-3 |
| ENGINE S/N: | 723873 |

LOW PRESSURE COMPRESSOR INSPECTION. In reference with B747 A.M.M. Chapter 72-00-00.

HIGH PRESSURE COMPRESSOR INSPECTION. In reference with B747 A.M.M. Chapter 72-00-00.

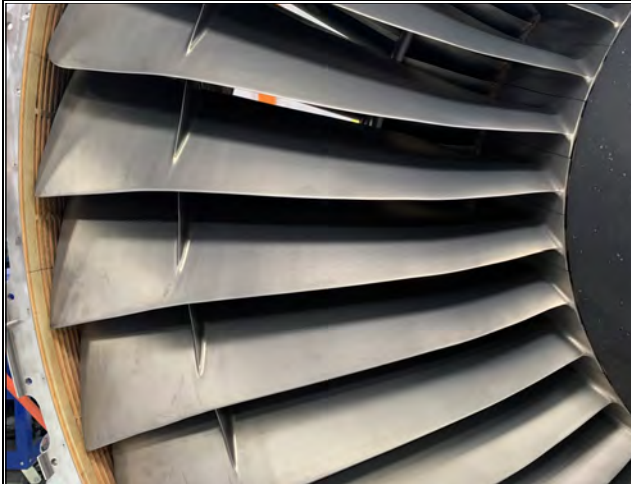
STAGE-1 FAN BLADES

CONDITION: SERVICEABLE

- Blade leading edges feel rough to the touch.
- No unserviceable damage found at the time of inspection.

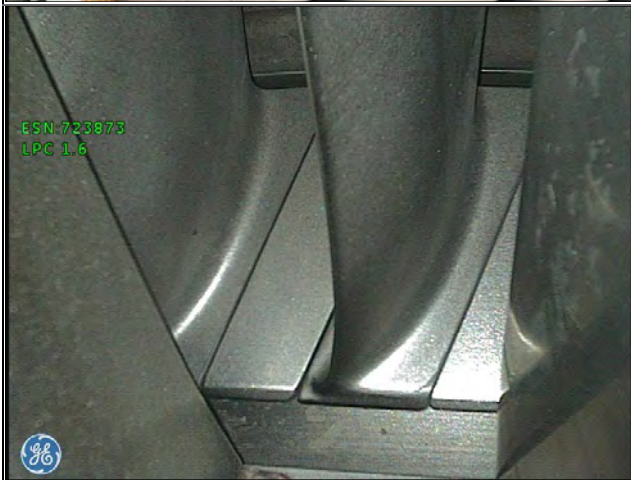
STAGE-1.6 BLADES

CONDITION: SERVICEABLE

- No unserviceable damage found at the time of inspection.

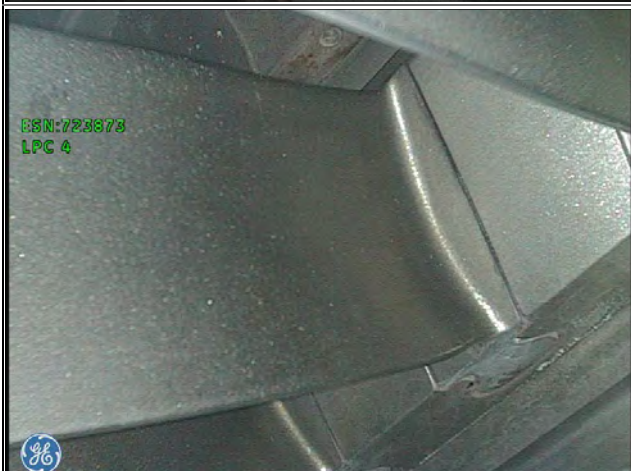
STAGE-4 BLADES

CONDITION: SERVICEABLE

- No unserviceable damage found at the time of inspection.

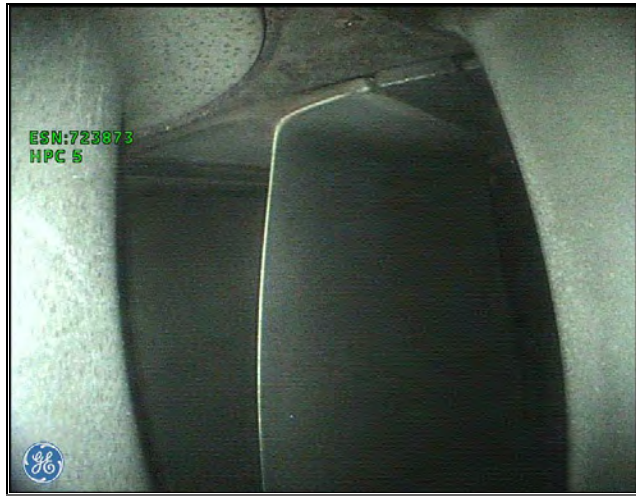
| | <p>CONDITION: SERVICEABLE</p> <p>STAGE-5 BLADES</p> <ul style="list-style-type: none"> No unserviceable damage found at the time of inspection. |

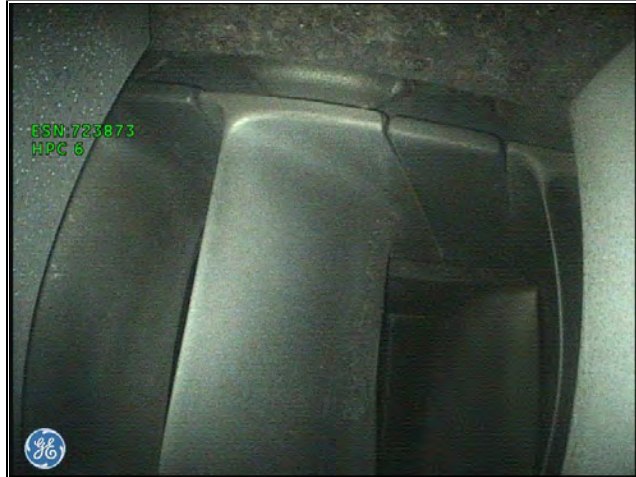
| | <p>CONDITION: SERVICEABLE</p> <p>STAGE-6 BLADES</p> <ul style="list-style-type: none"> No unserviceable damage found at the time of inspection. |

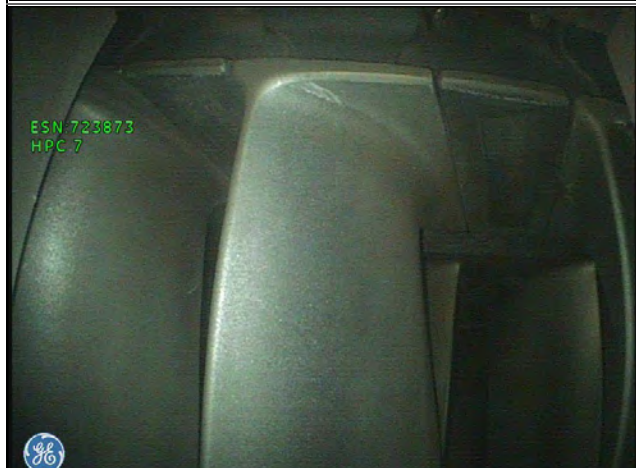
| | <p>CONDITION: SERVICEABLE</p> <p>STAGE-7 BLADES</p> <ul style="list-style-type: none"> No unserviceable damage found at the time of inspection. |

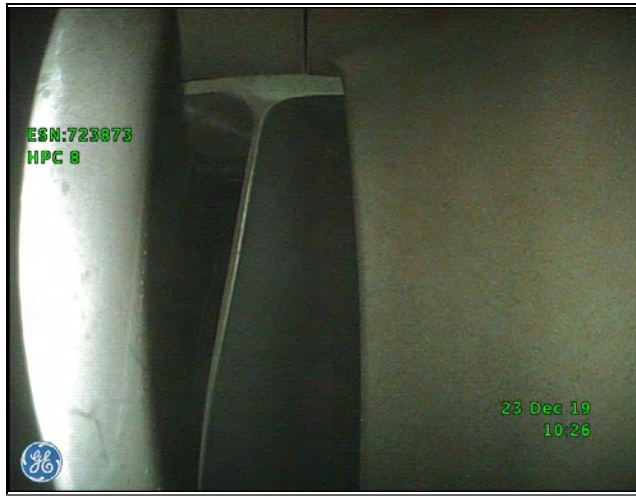
| | <p><u>CONDITION:</u> SERVICEABLE</p> <p>STAGE-8 BLADES</p> <ul style="list-style-type: none"> No unserviceable damage found at the time of inspection. |

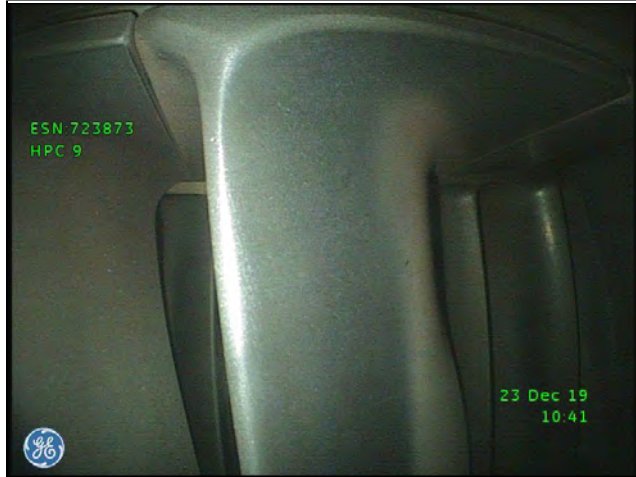
| | <p><u>CONDITION:</u> SERVICEABLE</p> <p>STAGE-9 BLADES</p> <ul style="list-style-type: none"> No unserviceable damage found at the time of inspection. |

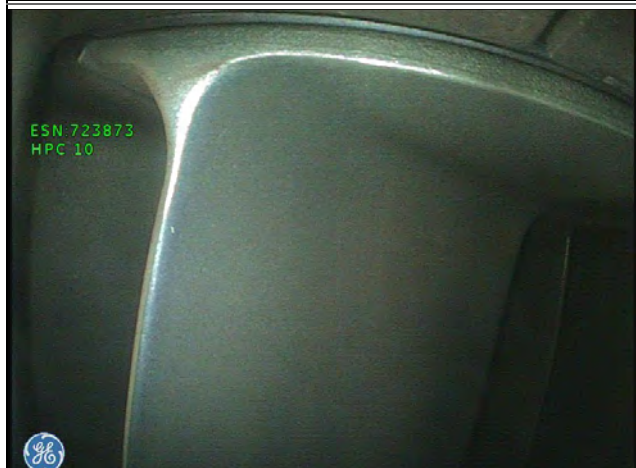
| | <p><u>CONDITION:</u> SERVICEABLE</p> <p>STAGE-10 BLADES</p> <ul style="list-style-type: none"> No unserviceable damage found at the time of inspection. |

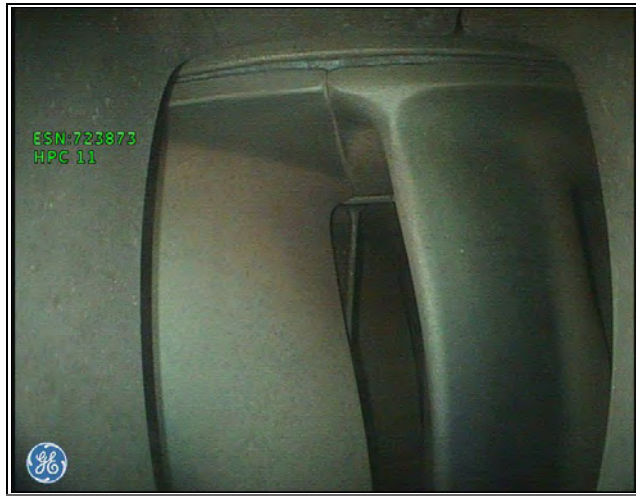
| | <p>CONDITION: SERVICEABLE</p> <p>STAGE-11 BLADES</p> <ul style="list-style-type: none"> No unserviceable damage found at the time of inspection. |

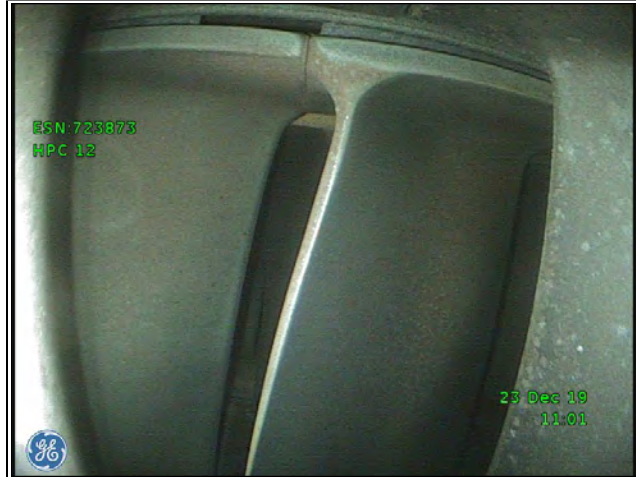
| | <p>CONDITION: SERVICEABLE</p> <p>STAGE-12 BLADES</p> <ul style="list-style-type: none"> No unserviceable damage found at the time of inspection. |

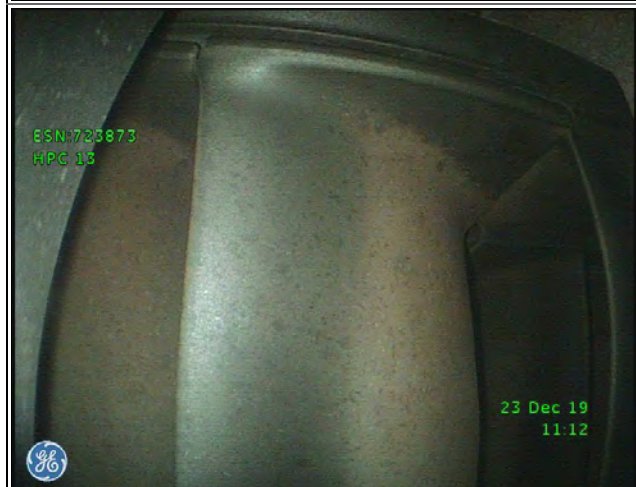
| | <p>CONDITION: SERVICEABLE</p> <p>STAGE-13 BLADES</p> <ul style="list-style-type: none"> No unserviceable damage found at the time of inspection. |

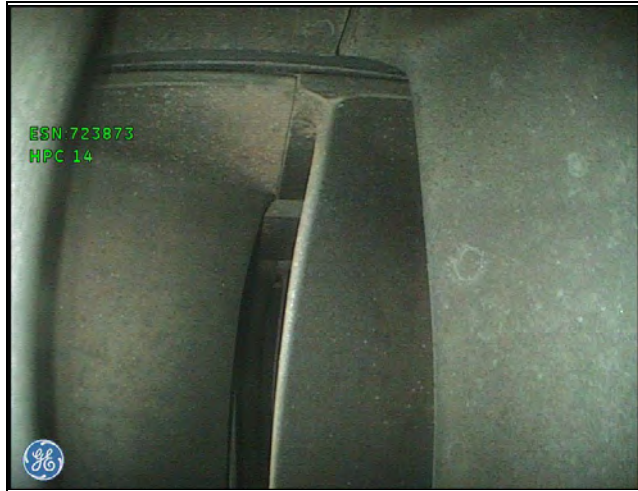
| | <p>CONDITION: SERVICEABLE</p> <p>STAGE-14 BLADES</p> <ul style="list-style-type: none"> No unserviceable damage found at the time of inspection. |

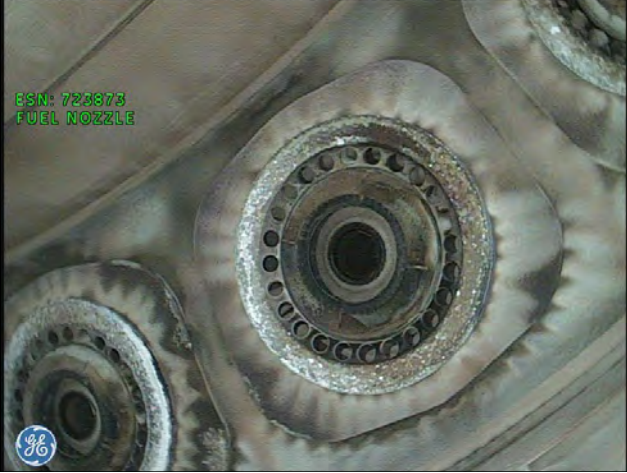
| <p>ESN: 723873 FUEL NOZZLE</p> | <p>CONDITION: SERVICEABLE</p> <p>FUEL NOZZLES</p> <ul style="list-style-type: none"> • Discoloration, erosion and carbon accumulation noted on the Fuel Nozzles bulk head injectors and face of the bulkhead heat shields . • No unserviceable damage found at the time of inspection. |

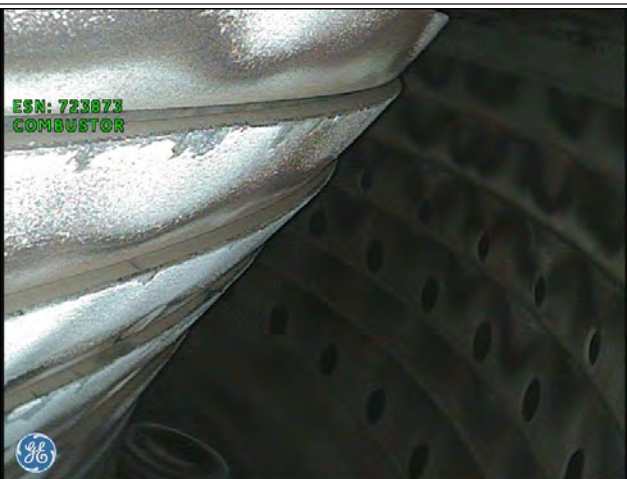
| <p>ESN: 723873 COMBUSTOR</p> | <p>CONDITION: SERVICEABLE</p> <p>INNER LINERS</p> <ul style="list-style-type: none"> • Several minor cracks noted on the inner liners of the combustor. • No unserviceable damage found at the time of inspection. |

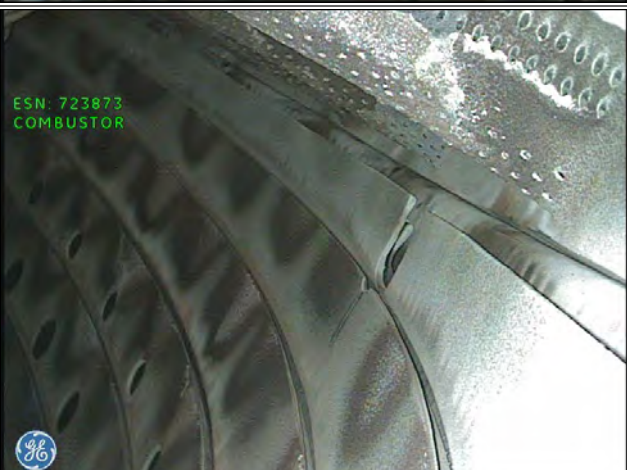
| <p>ESN: 723873 COMBUSTOR</p> | <p>CONDITION: SERVICEABLE</p> <p>OUTER LINERS</p> <ul style="list-style-type: none"> • Several cracks noted on the outer liners of the combustion chamber which do not extend more than one louver. One axial crack noted which extends through two louvers. • No unserviceable damage found at the time of inspection. |

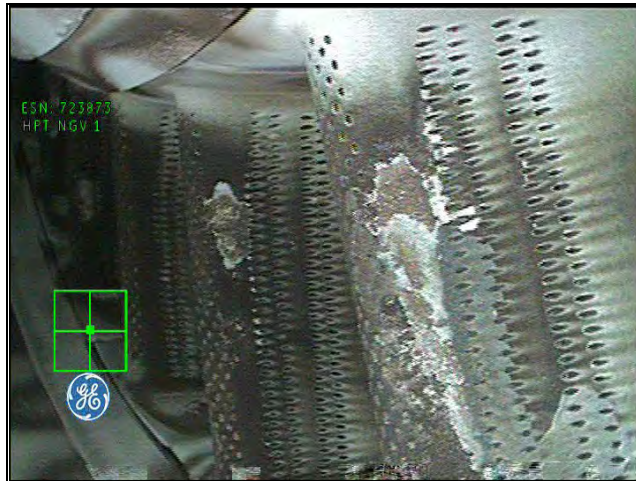
| | <p>CONDITION: SERVICEABLE</p> <p>STAGE-1 NOZZLE GUIDE VANES</p> <ul style="list-style-type: none"> No unserviceable damage found at the time of inspection. |

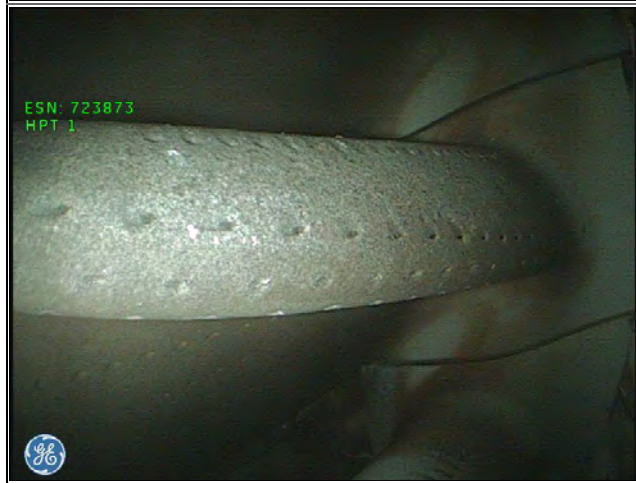
| | <p>CONDITION: SERVICEABLE</p> <p>STAGE-1 BLADES</p> <ul style="list-style-type: none"> No V-Notches noted at the time of inspection. No unserviceable damage found at the time of inspection. |

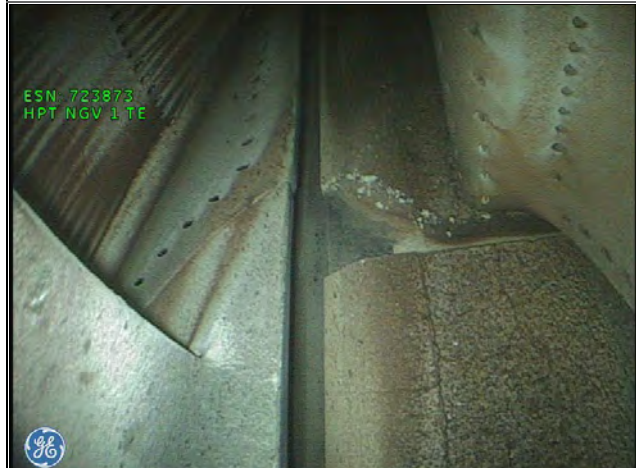
| | <p>CONDITION: SERVICEABLE</p> <p>STAGE-1 DUCT SEGMENTS</p> <ul style="list-style-type: none"> Several duct segments noted with missing thermal barrier coating B747 AMM 72-00-00-993-818 indicates that there is no limit on the quantity of chipped coating, coating loss. No unserviceable damage found at the time of inspection. |
