CUSTOMER:			LOCATION:	<u>Jet Pro- PHX</u>	
WORK ORDER:	<u>1085-132</u>	DATE:	<u>12-SEP-19</u>	PERFORMED BY:	<u>D. MADDOCK</u>
ENGINE MODEL:	<u>CFM56-3B1</u>	ENGINE S/N:			
A/C TYPE:	<u>B737</u>	A/C REG:	<u>N/A</u>	POSITION:	<u>Off</u>
REASON:	<u>Acceptance Inspection</u>

BORESCOPE INSPECTION REPORT

Summary: **SERVICEABLE**

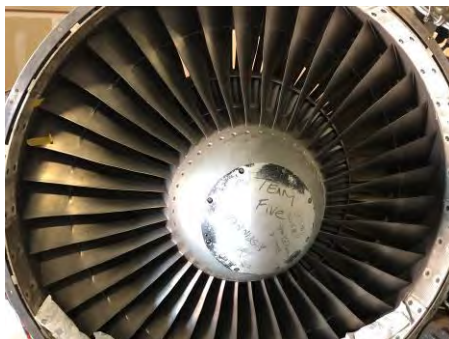
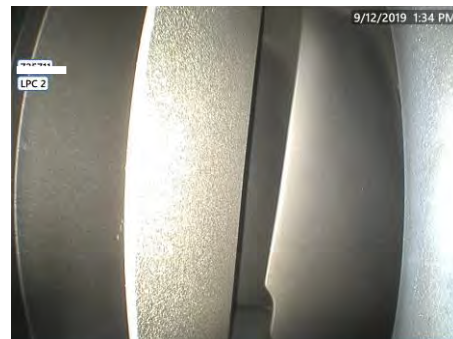
38 LPC 1 Fan

LE of the fan blades are smooth to the touch with blends observed, no recent FOD. No excessive missing material or heavy rubs around the running seal.

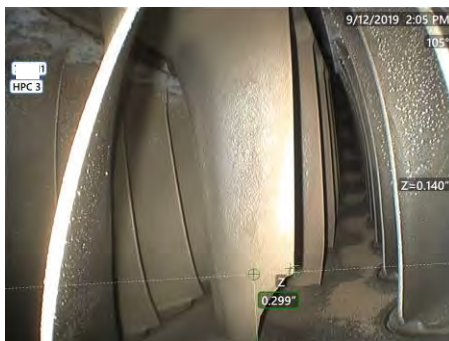
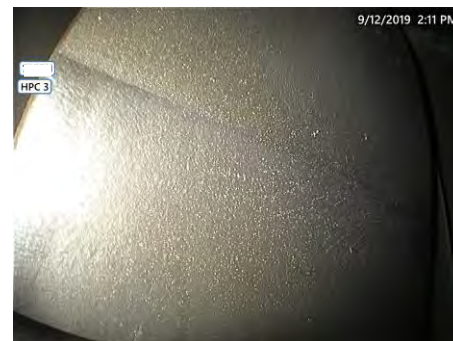
60 HPC 3 Blades

One blade has a tip corner missing on the TE .299" high and .140" deep. One other has a radial tip crack less than .300" from the TE and .060" high. Both are acceptable.

Ref. AMM 72-00-00 pgs. 617 & 620 attached.

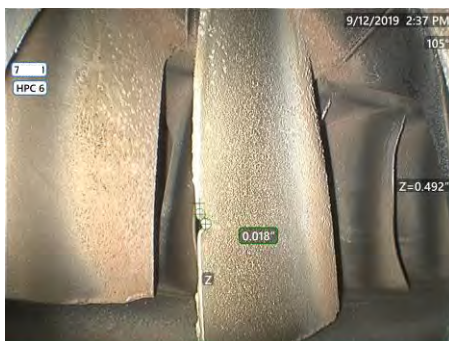
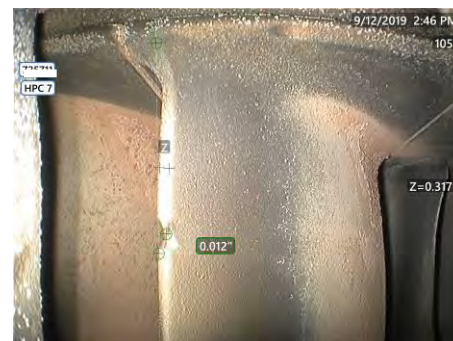
82 HPC 6 Blades

LE nicks in several blades the largest is .018" in Dim B. Max allowed is .040"
Ref. AMM 72-00-00 pg. 620 attached.

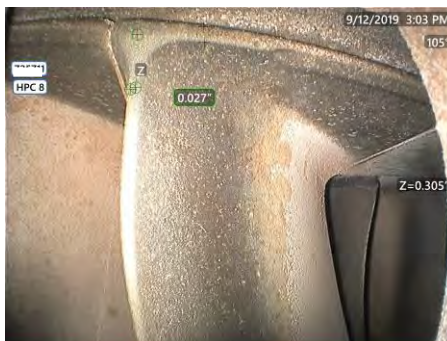
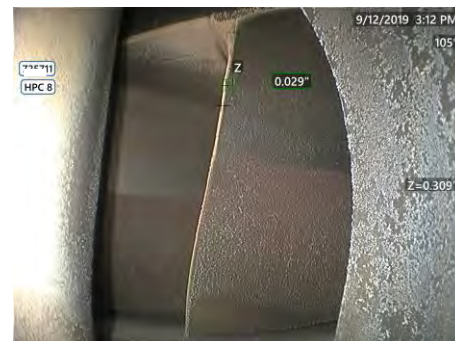
80 HPC 8 Blades

Round bottom dent in the root of one blade .027" in diameter and less than .003" deep. TE dent in the lower 25% .029" deep Max allowed is .030". Both are acceptable.

[Ref. AMM 72-00-00 pg. 618 attached.](#)

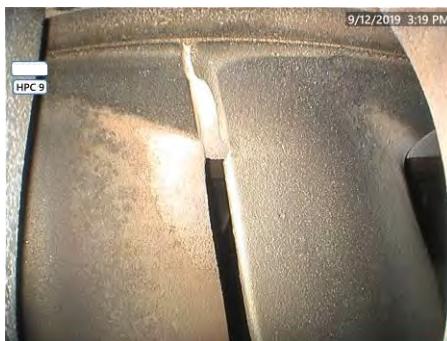
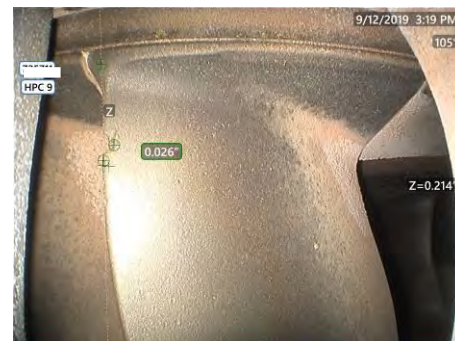
76 HPC 9 Blades

Nick in the LE of one blade .026" deep is acceptable. Max allowed is .030".

[Ref. AMM 72-00-00 pg. 618 attached.](#)

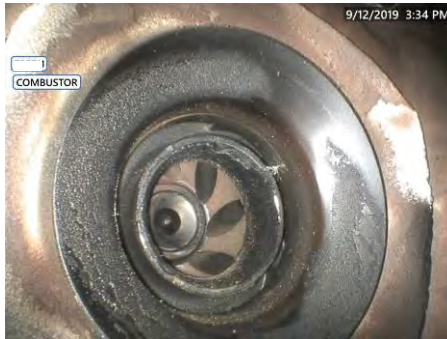
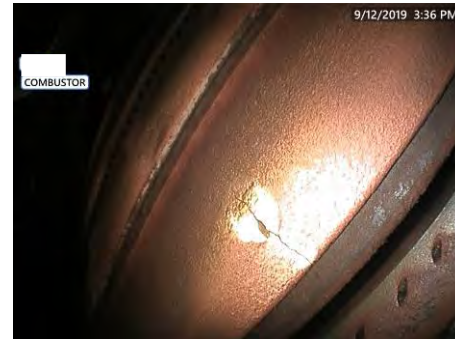
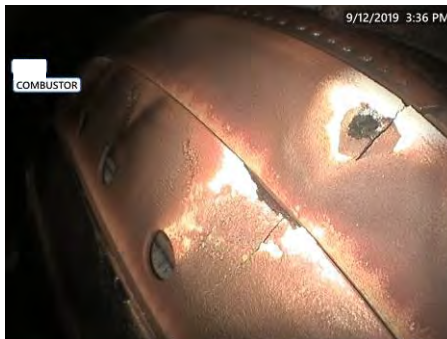
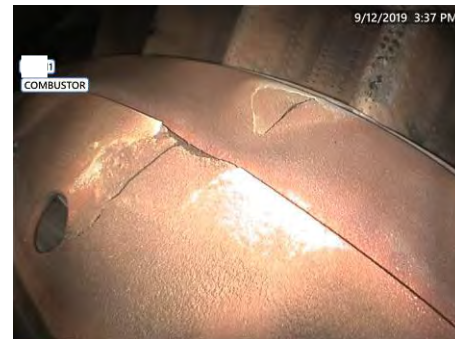
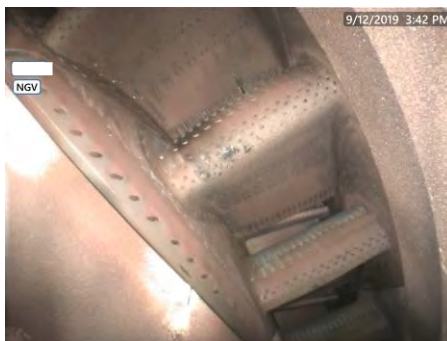
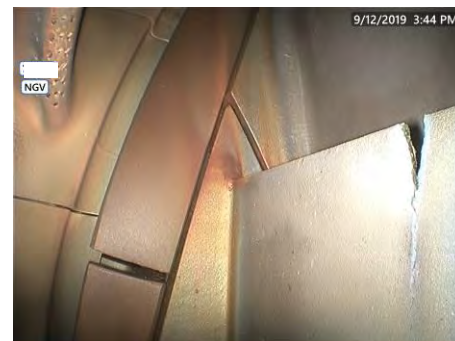
Minor deflector edge wear is acceptable.

Axial cracks less than one panel observed at several locations on the inner liner panels #3 & #4 are permitted. TBC loss is permitted.

Axial crack in the TE of one vane with missing material less than .250" in diameter is permitted.

[Ref. AMM 72-00-00 pg. 637 attached.](#)
