## Inspection Report Rolls Royce Avon

Subject	Inspection report
Gasturbine	Rolls Royce Avon
Customer	Capital Equipment Supply
Location	M.A.R.S Frederikshavn
Purchase order customer	N/A
Customer representative	Jonathan Simms

Unit No. customer	: N/A
Gas turbine model	: Rolls Royce Avon 1535-122G
Gas turbine s/n	: 38 495
Rating	: N/A
Type of Fuel	: Gas
Type of NOx	: N/A
Total starts	: N/A
Fired hours	: N/A
Starts	: N/A

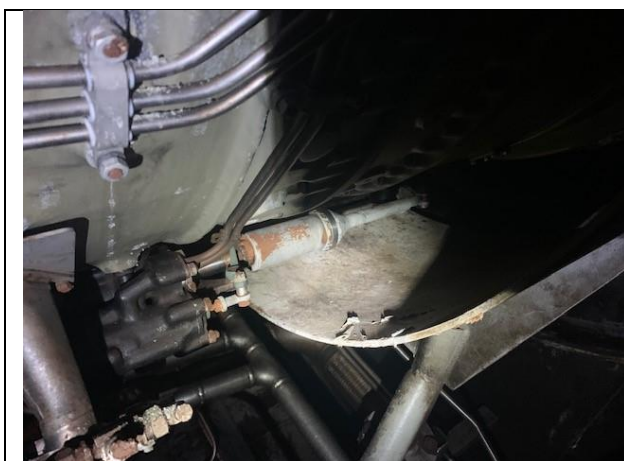
- General condition of the hardware on-engine is in typical condition. Found corrosion on IGV actuator, also minor wear on the actuator. IGV hardware arms and bushings found minor wear.

Picture 01: IGV compressor 6 o'clock corrosion

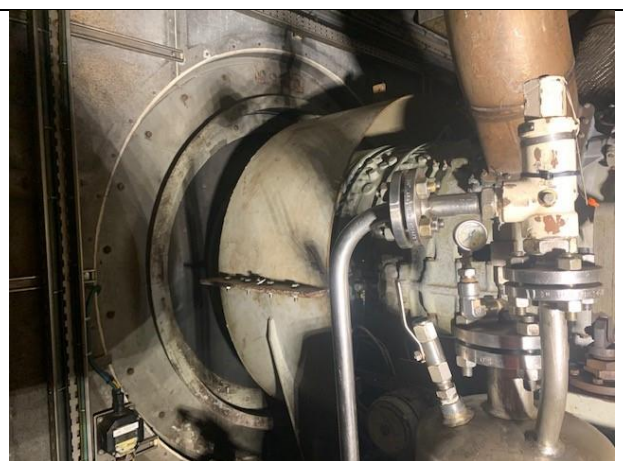
Picture 02: IGV rods and arms (RHS)

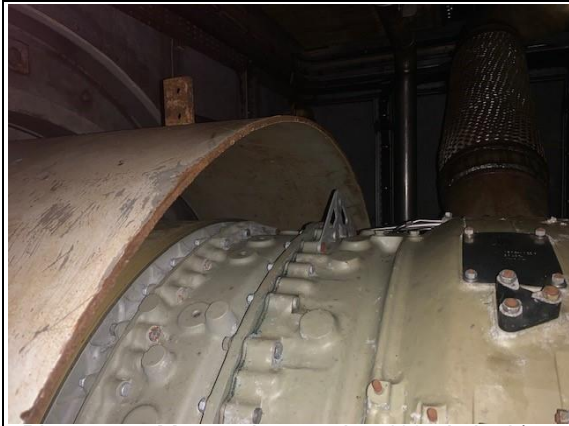
Picture 01: Magnesium casing (12 o'clock)

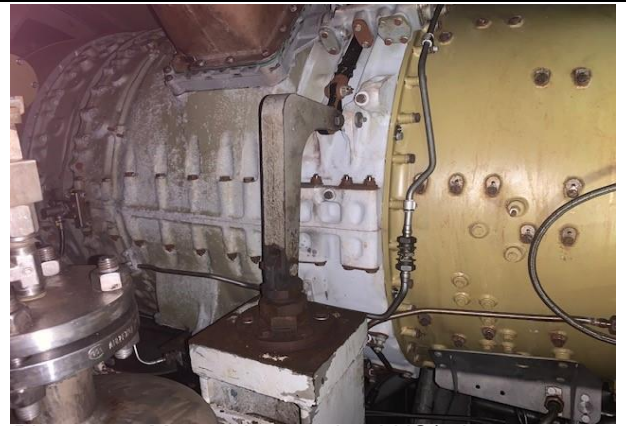
Picture 02: Magnesium casing LHS (minor corrosion)

Due long standstill and no standstill heating in the package, minor corrosion has developed in the machine as also outside of the machine. Found dirt on first stages of the compressor. Advice is to clean the compressor of the GT.

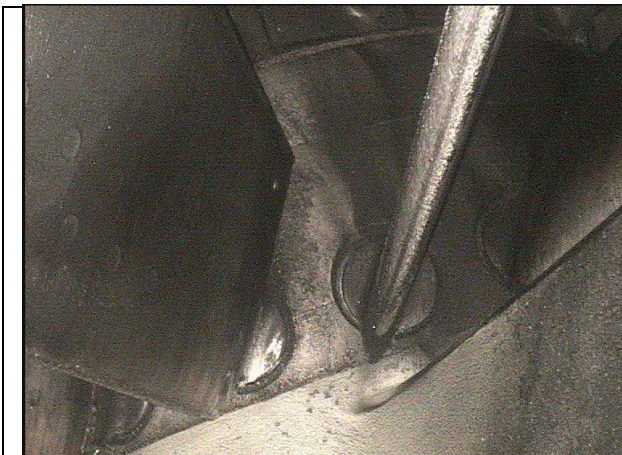
The rotor of the engine could be turned by hand, static inspection only. During inspection dirt and grease pollution on blades and vanes has been noticed. The inlet door couldn't be opened due missing scaffolding. Only under and RHS/LHS of the IGV and first stage blade of the compressor were inspected by means of the compressor front frame inspection plates 2x. Advice to clean or ice blast the compressor before operational use.

Picture 01: stg 1 IGV pollution

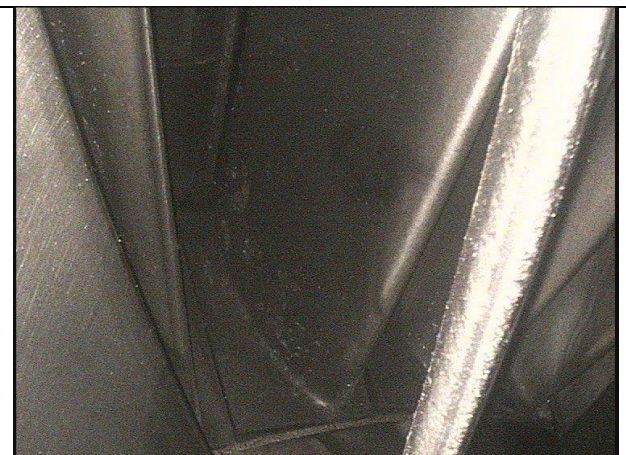
Picture 02: stg 2 pollution on blades (root) L.E

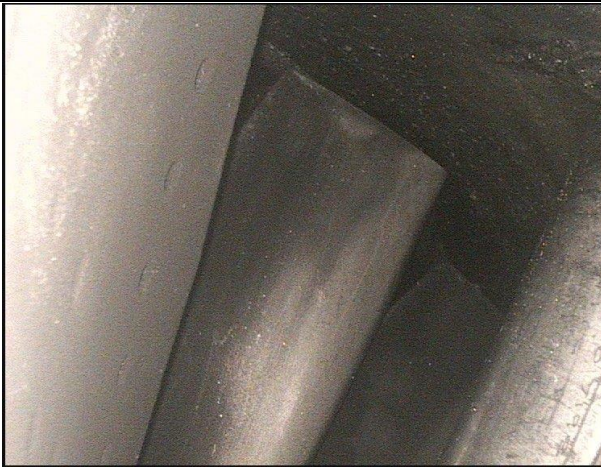
Picture 03: IGV stg 1 and stg 1 blades (tip)

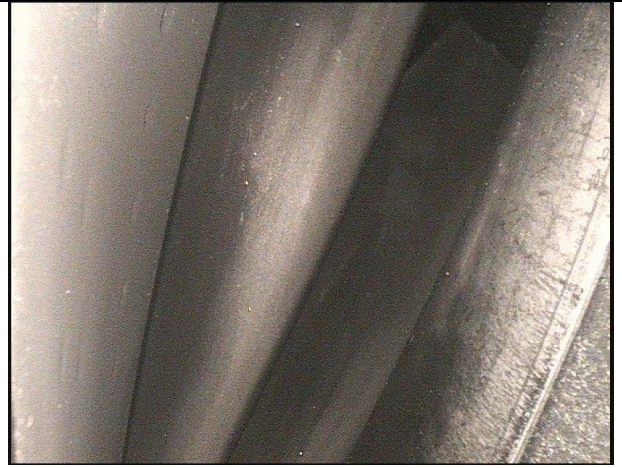
Picture 04: stg 1 IGV and stg 1 blade (middle) L.E

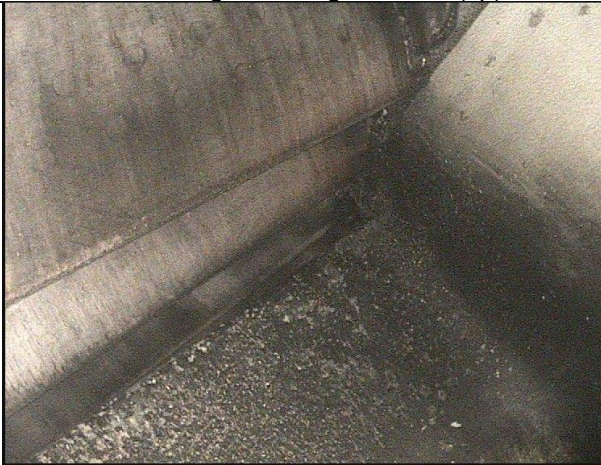
Picture 05: stg iGV (middle & root) L.E

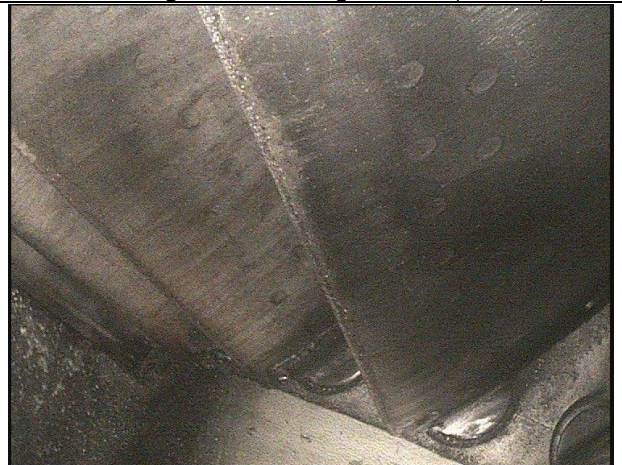
Picture 06: stg 1 IGV L.E root ( dirt pollution)

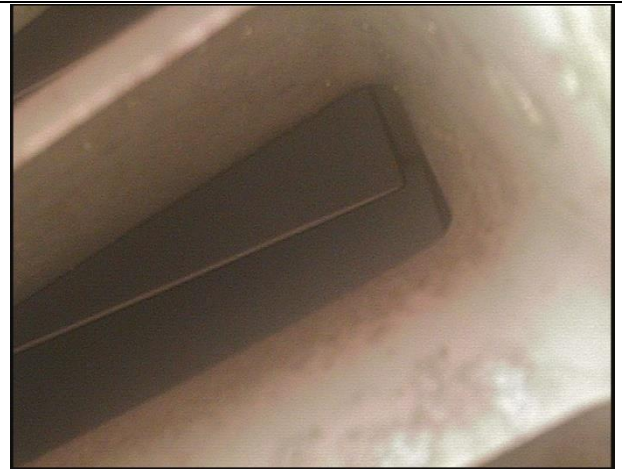
Picture 18: Stg 15 Blade ( tip) T.E

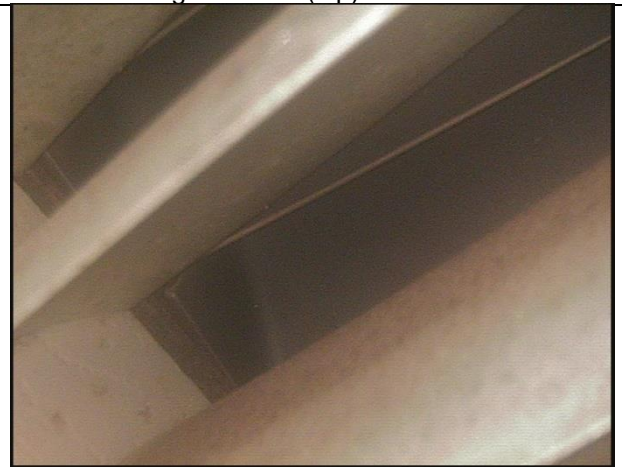
Picture 20: stg 15 blades (root)

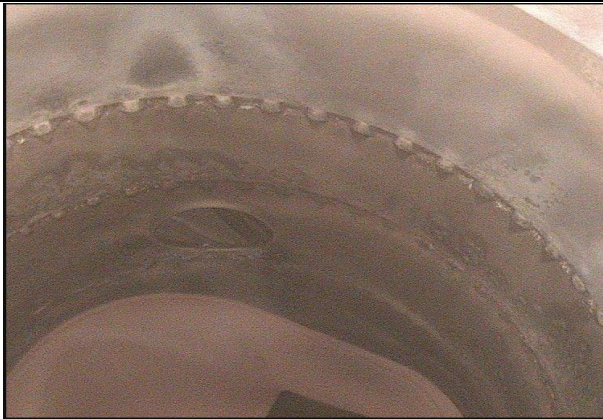
Port	Remarks	Picture
1 Burner port BI plug 2 o'clock	Visual to fuel nozzle/swirler (found in typical condition)	1-4
Fuel nozzle #3 (9 o'clock)	Visual to combustor and HP turbine nozzle/blades. Found in typical condition. Minor burn spot in combustion chamber	5-7
Fuel nozzle #7 (2 o'clock)	Visual to combustor and HP turbine blades. Found in typical condition. Minor burn spots in combustion chamber	8-12

Picture 05: combustion chamber #3 (minor burn spots)

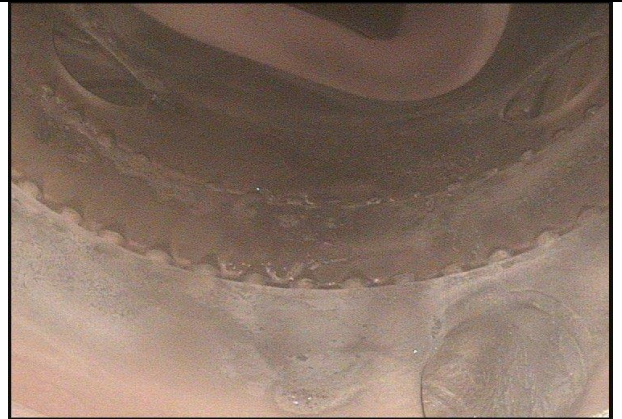
Picture 06: combustor #3 combustion chamber (minor burn spots)

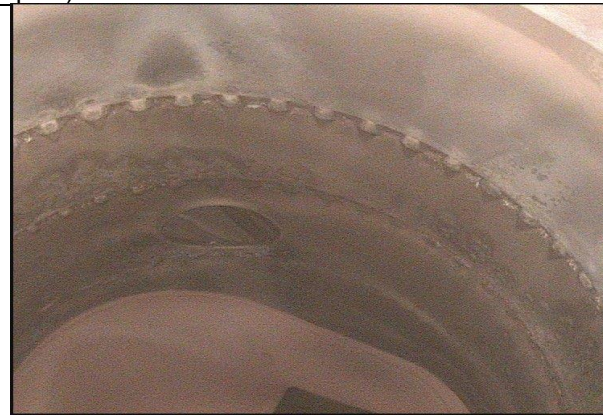
Picture 07: combustion chamber #3 (minor burn spots)

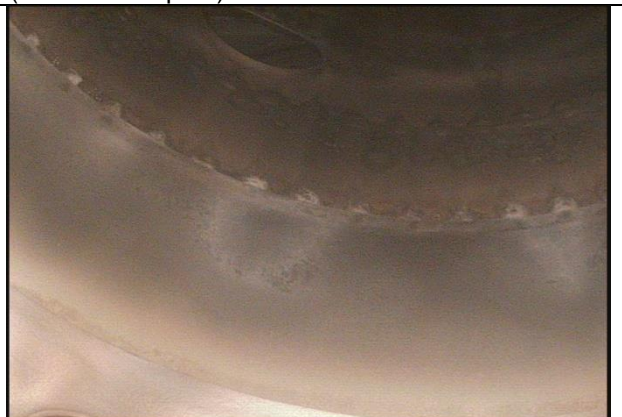
Picture 08: combustion chamber #7 (minor burn spots)

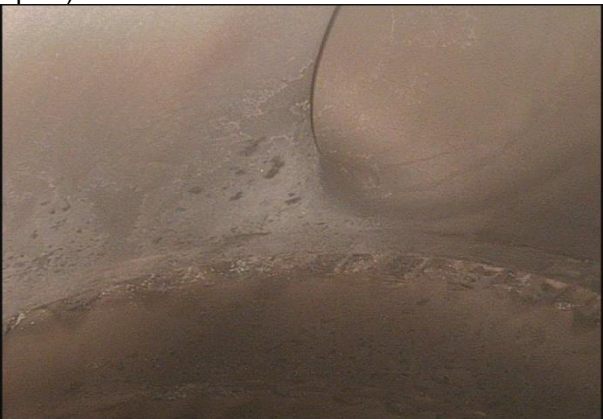
Picture 09: combustion chamber #7 (minor burn spots)

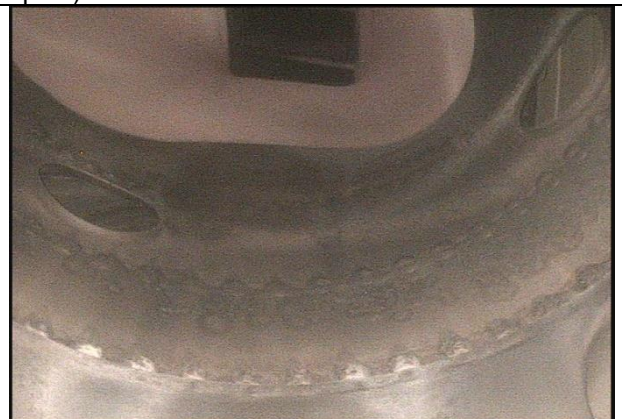
Picture 10: combustion chamber #7 (minor burn spots)

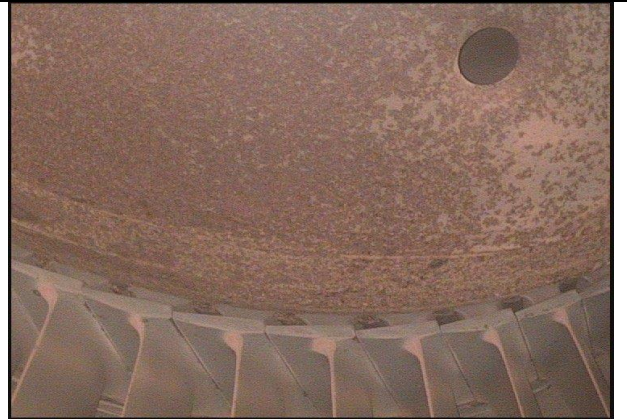
Picture 08: LP blades root & inner cone (minor corrosion)
