CFM56-7B
Borescope Inspection Report

ENGINE SERIAL NUMBER	
DATE OF INSPECTION	24/07/2025
TYPE OF INSPECTION	Full Rigid BSI
LOCATION OF INSPECTION	
INSPECTION PERFORMED BY	
ENGINE TSN	73,948
ENGINE CSN	29,973
AIRCRAFT TYPE (if installed on wing)	N/A Off Wing
AIRCRAFT MSN / REG (if installed on wing)	N/A Off Wing
ENGINE POSITION (if installed on wing)	N/A Off Wing
AERFIN REPORT REFERENCE	AF97
AERFIN WORK ORDER NUMBER	FTS 129
REPORT PREPARED BY	
ENGINE STATUS / CONDITION	SERVICEABLE

Engine condition is considered as SERVICEABLE after Borescope inspection.

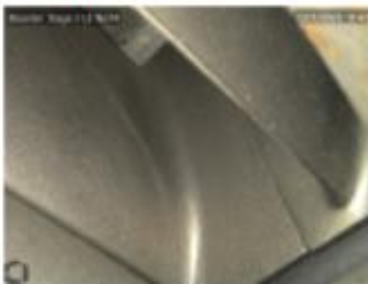
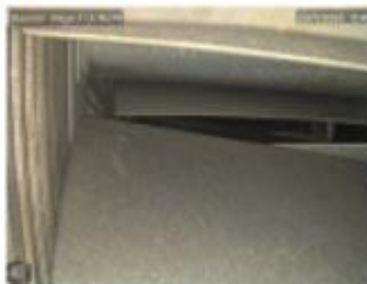
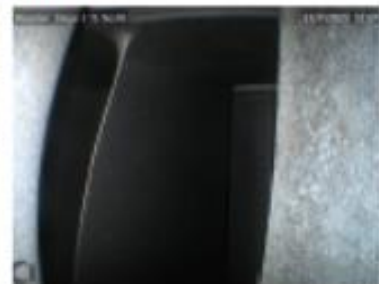
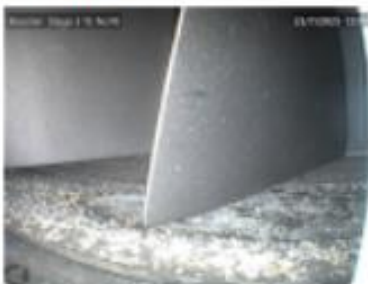
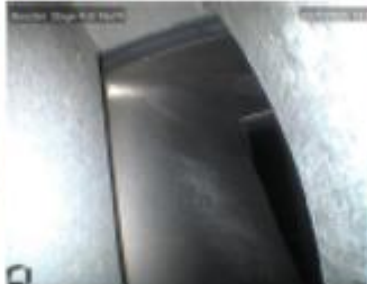
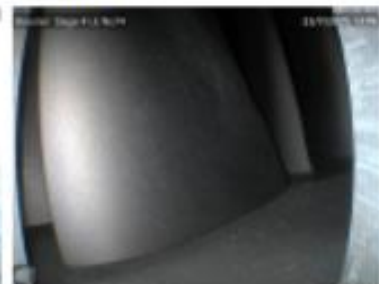
Stage	Within limits	Observations	Image ref
STAGE 2	YES	<ul style="list-style-type: none">Minor Nicks & Dents.Environmental Deposits.Shrouds show signs of Rubbing.No Significant Findings Noted.	1 2
STAGE 3	YES	<ul style="list-style-type: none">Minor Nicks & Dents.Environmental Deposits.Craters Noted on Shrouds.No Significant Findings Noted.	3 4
STAGE 4	YES	<ul style="list-style-type: none">Minor Nicks & Dents.Environmental Deposits.No Significant Findings Noted.	5 6

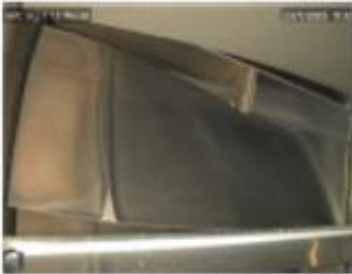
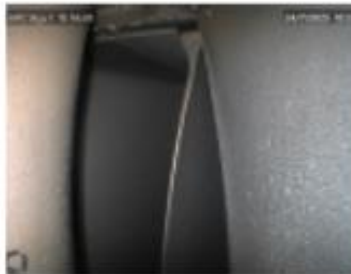
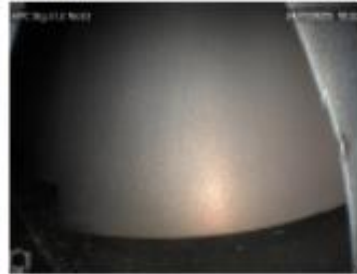
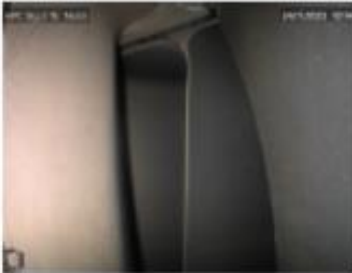
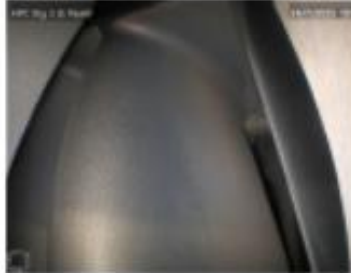
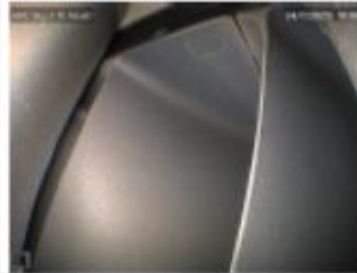
Stage	Within limits	Observations	Image ref
STAGE 1	YES	<ul style="list-style-type: none"> Mineral & Environmental Deposits Noted. Minor Nicks & Dents Noted. No Significant Findings Noted. 	1 2
STAGE 2	YES	<ul style="list-style-type: none"> Mineral & Environmental Deposits Noted. Minor Nicks & Dents Noted. No Significant Findings Noted. 	3 4
STAGE 3	YES	<ul style="list-style-type: none"> Mineral & Environmental Deposits Noted. Minor Nicks & Dents Noted. No Significant Findings Noted. 	5 6

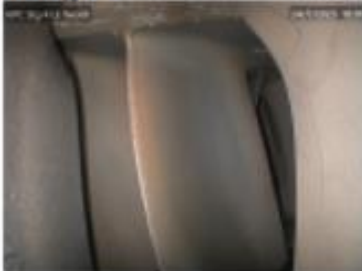
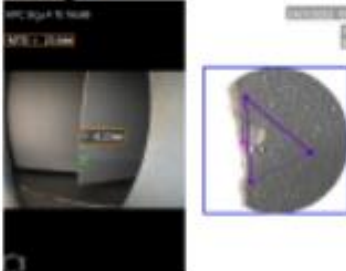
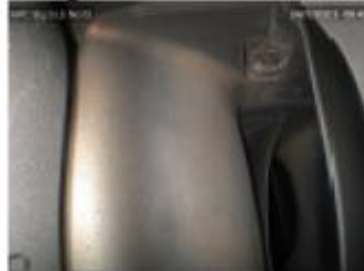
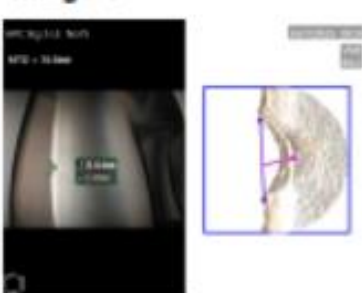
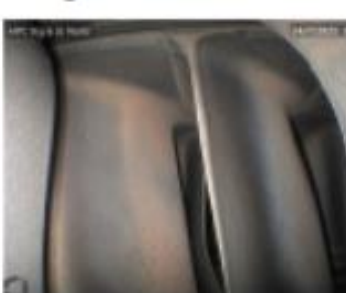
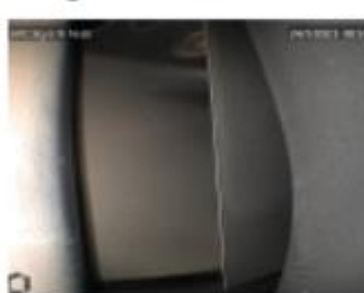
Stage	Within limits	Observations	Image ref
STAGE 4	YES	<ul style="list-style-type: none"> Mineral & Environmental Deposits Noted. Minor Nicks & Dents Noted within limits. No Significant Findings Noted. 	1 2
STAGE 5	YES	<ul style="list-style-type: none"> Mineral & Environmental Deposits Noted. Minor Nicks & Dents Noted. Largest Nick (with a depth of 0.64mm) found on Leading Edge in Dim B within limits IAW AMM: 72-00-00-290-011-F00 Para (3)(k) 1) "No maximum number of tears, nicks, missing material and erosion if the damage is less than 0.04 inch (1.0 mm) in depth". No Significant Findings Noted. 	3 4
STAGE 6	YES	<ul style="list-style-type: none"> Mineral & Environmental Deposits Noted. Minor Nicks & Dents Noted. No Significant Findings Noted. 	5 6

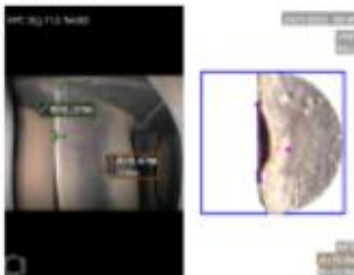
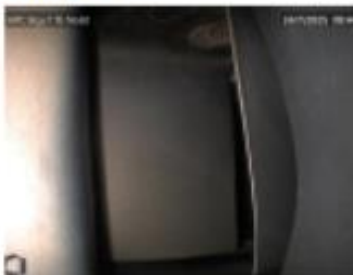
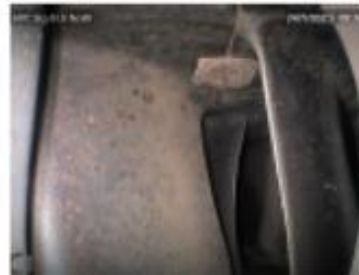
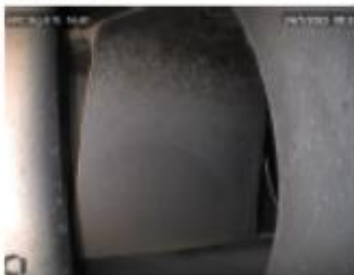
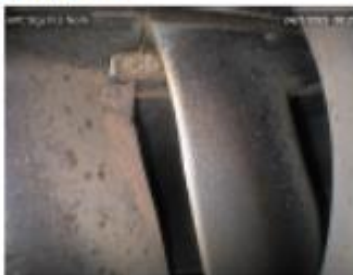
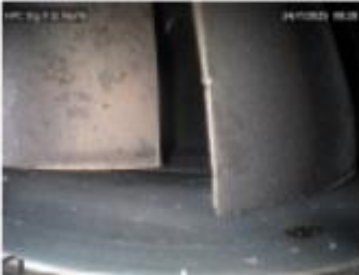
Stage	Within limits	Observations	Image ref
STAGE 7	YES	<ul style="list-style-type: none"> Mineral & Environmental Deposits Noted. Minor Nicks & Dents Noted. Largest Nick (with a depth of 0.47mm) found on Leading Edge in Lower 25%, within limits IAW AMM: 72-00-00-290-009-F00 Para (2) (h) 2) "There is no limit of nicks, dents and missing material if the damage is less 0.03 inch (0.8 mm) in depth". No Significant Findings Noted. 	
STAGE 8	YES	<ul style="list-style-type: none"> Mineral & Environmental Deposits Noted. Minor Nicks & Dents Noted. No Significant Findings Noted. 	
STAGE 9	YES	<ul style="list-style-type: none"> Mineral & Environmental Deposits Noted. Minor Nicks & Dents Noted. No Significant Findings Noted.

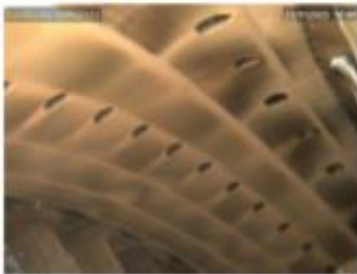
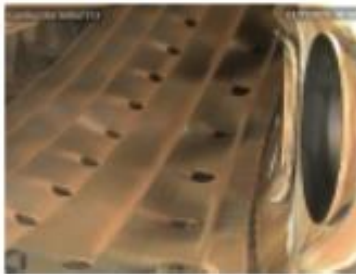
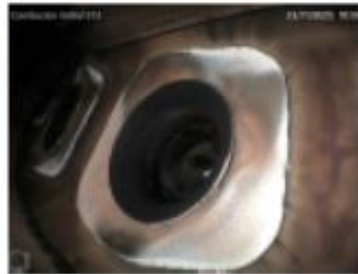
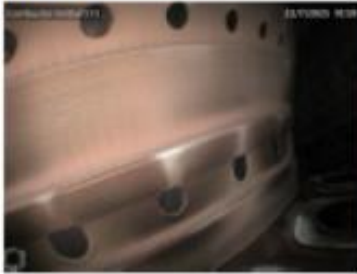
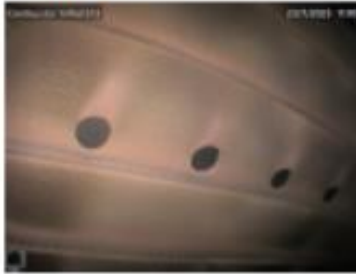
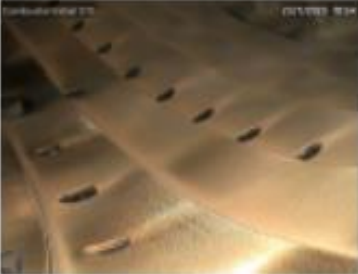
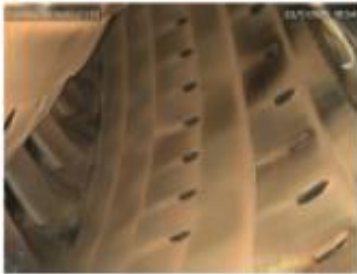
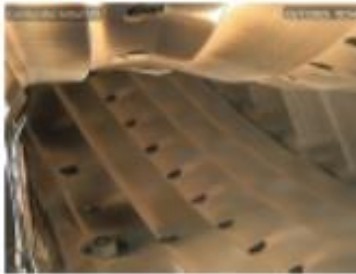
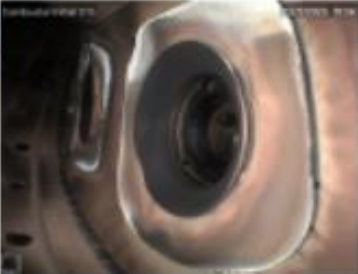
Section	Within limits	Observations	Image ref
COMBUSTION LINERS AND DOME AREAS	YES	<ul style="list-style-type: none">• Minor Coating Loss.• Minor Carbon Build-Up around Fuel Nozzles.	1-9

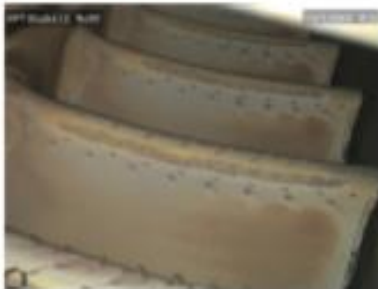
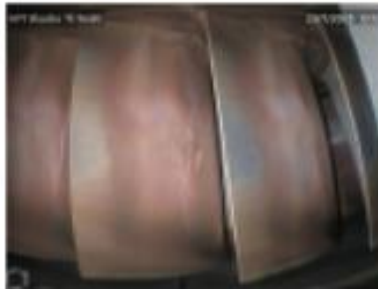
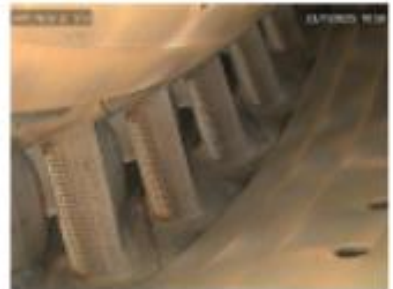
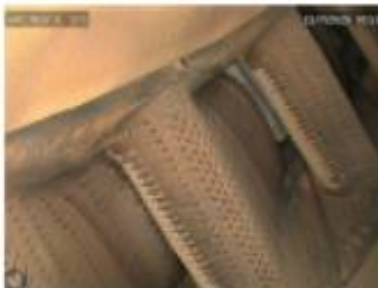
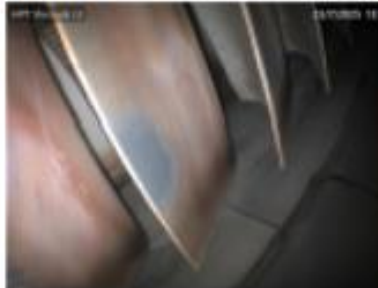
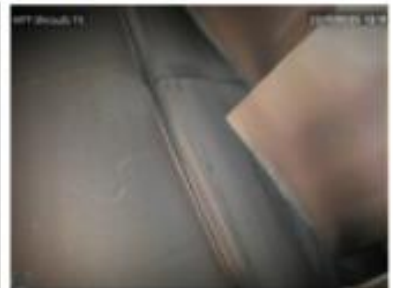
STAGE	Within limits	Observations	Image ref
BLADES	YES	<ul style="list-style-type: none">• Minor Coating Loss.• Mineral Deposits.• No Significant Findings Noted.	
NOZZLE GUIDE VANES	YES	<ul style="list-style-type: none">• Minor Coating Loss.• No Significant Findings Noted.	
SHROUDS	YES	<ul style="list-style-type: none">• Minor Deposits Noted.• Minor Oxidation Build-Up Noted.• No Significant Findings Noted.

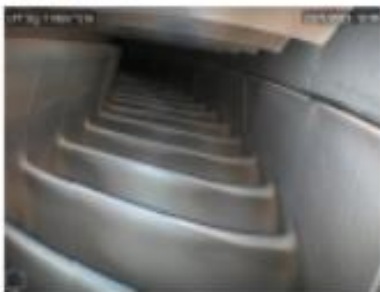
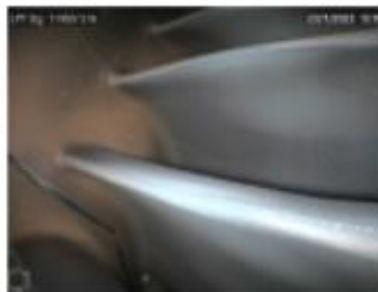
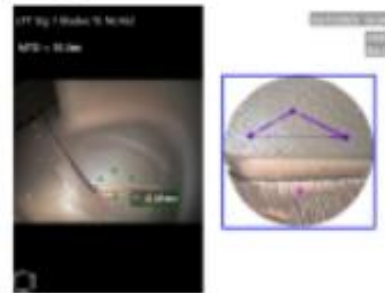
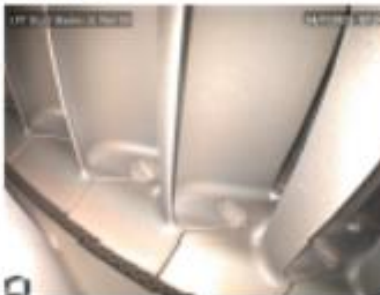
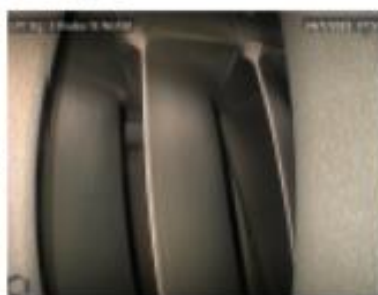
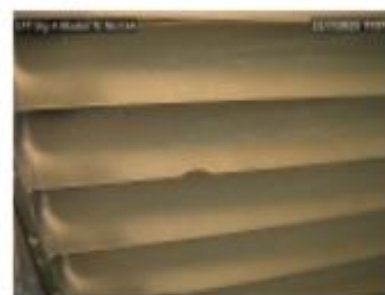
Stage	Within limits	Observations	Image ref
NOZZLE STAGE 1	YES	<ul style="list-style-type: none"> Minor Nicks & Dents Noted. Minor Mineral Deposits Noted. No Significant Findings. 	1 2
STAGE 1	YES	<ul style="list-style-type: none"> Minor Nicks & Dents Noted. Minor Mineral Deposits Noted. Tip shroud noted to be out of flush, within limits: IAW AMM 72-00-00-210-065-P00 Para (2)(k) 1) a) "Not more than 0.0472 in. (1.20 mm), and not more than 0.0413 in. (1.05 mm) on the hard faces". 	3
STAGE 2	YES	<ul style="list-style-type: none"> Minor Nicks & Dents Noted. Minor Mineral Deposits Noted. No Significant Findings. 	4
STAGE 3	YES	<ul style="list-style-type: none"> Minor Nicks & Dents Noted. Minor Mineral Deposits Noted. No Significant Findings. 	5
STAGE 4	YES	<ul style="list-style-type: none"> Minor Nicks & Dents Noted. Minor Mineral Deposits Noted. Previous Bled Repair Noted on Trailing Edge. No Significant Findings. 	6
