1 x GE LM2500+ SAC PK Model GenSet 30.3MW (60Hz. 13,8kV) for ISO Conditions

Model: LM2500+ SAC 7LM2500-PK-MD GE Gas Turbine Generator (GTG) Set

BORESCOPE REPORT

(Performed March 2024)

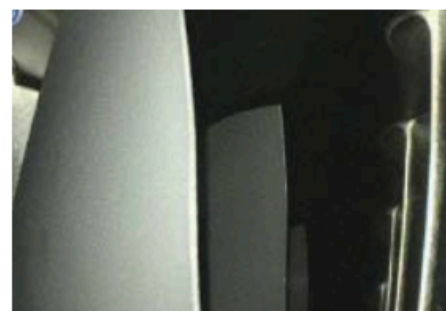
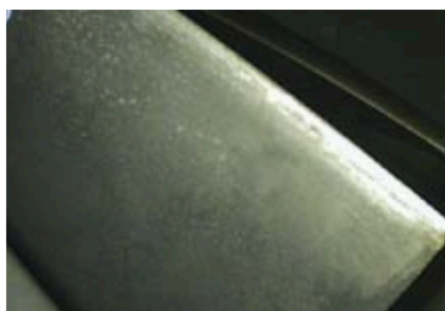
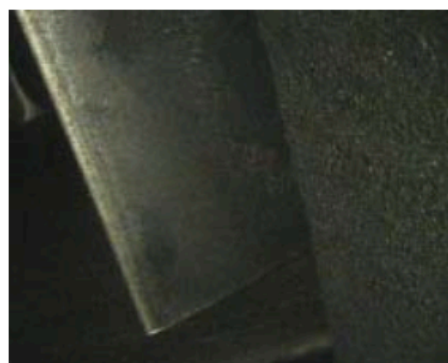
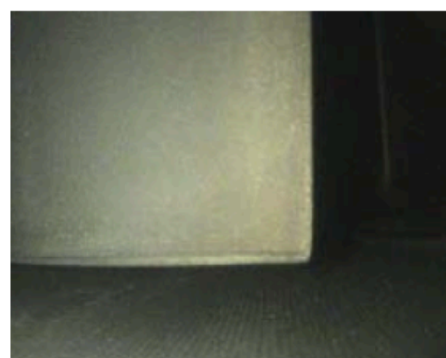
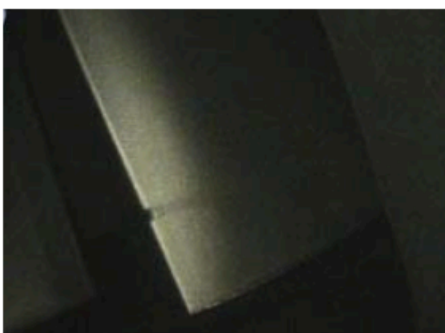
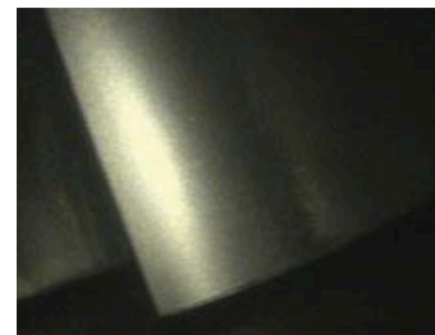
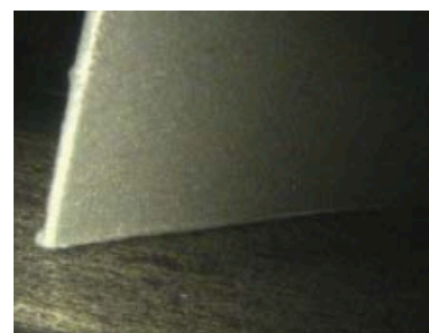
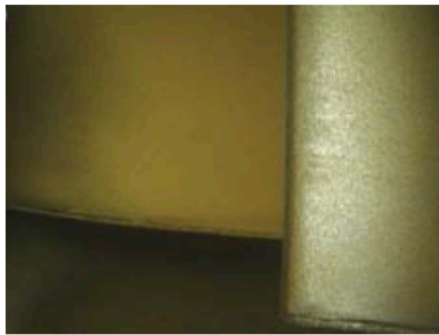
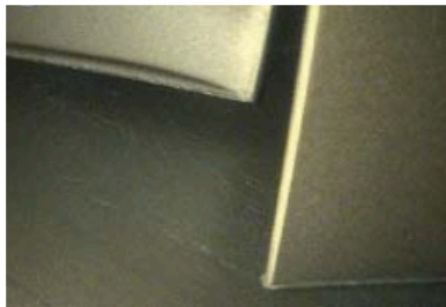
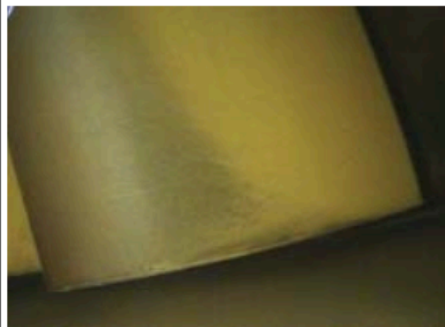
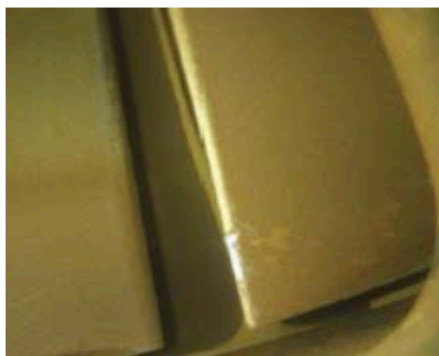
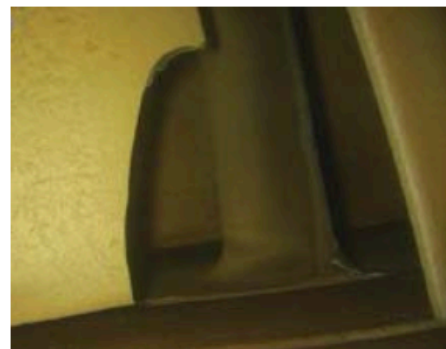
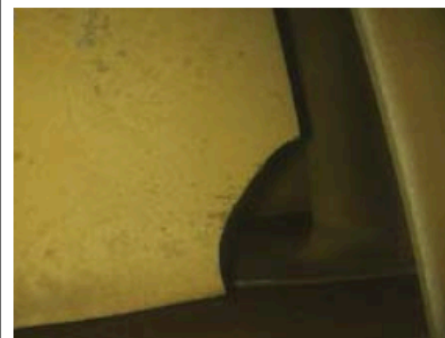
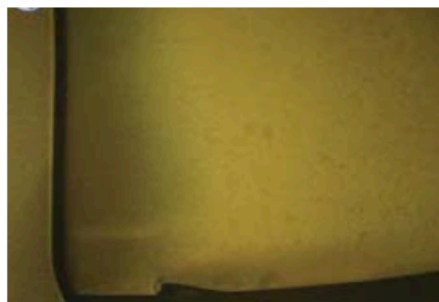
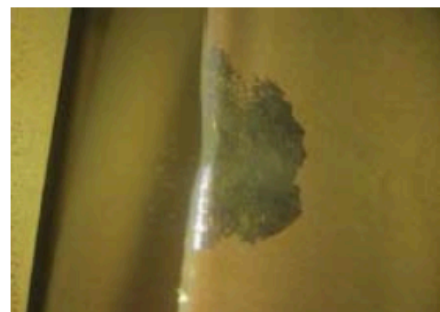
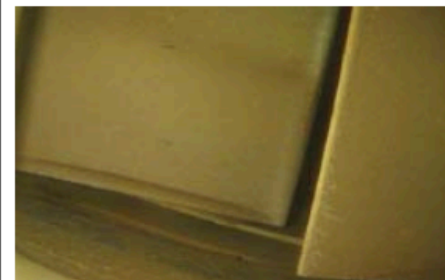
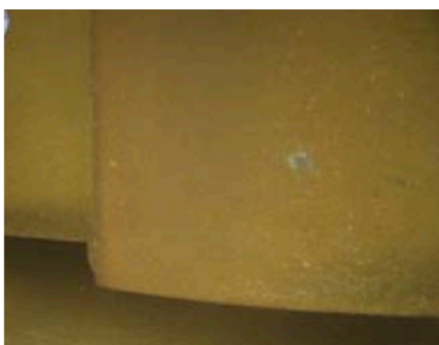
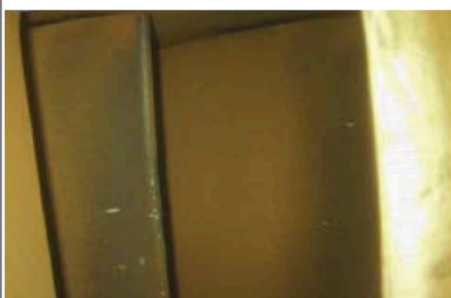
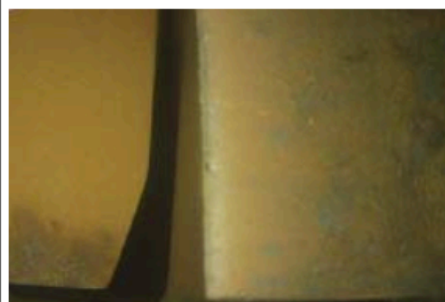
1. High Pressure Compressor

IGV Port	BSI ports 1.....	<i>No Remarks</i>
Stage 0	BSI ports 2.....	<i>No Remarks</i>
Stg1 Blades (Qty 26) & Vanes, BSI ports 3.....		<i>No Remarks</i>
Stg2 Blades (Qty 26) & Vanes, BSI ports 4.....		<i>No Remarks</i>
Stg3 Blades (Qty 42) & Vanes, BSI ports 5.....		<i>No Remarks</i>
Stg4 Blades (Qty 45) & Vanes, BSI ports 6.....		<i>No Remarks</i>
Stg5 Blades (Qty 48) & Vanes, BSI ports 7.....		<i>1 ea Nick on L/E side (Serviceable Limits)</i>
Stg6 Blades (Qty 54) & Vanes, BSI ports 8.....		<i>No Remarks</i>
Stg7 Blades (Qty 56) & Vanes, BSI ports 9.....		<i>No Remarks</i>
Stg8 Blades (Qty 64) & Vanes, BSI ports 10.....		<i>No Remarks</i>
Stg9 Blades (Qty 66) & Vanes, BSI ports 11.....		<i>No Remarks</i>
Stg10 Blades (Qty 66) & Vanes, BSI ports 12.....		<i>No Remarks</i>
Stg11 Blades (Qty 76) & Vanes, BSI ports 13.....		<i>1 ea Nick on L/E side (Serviceable Limits)</i>
Stg12 Blades (Qty 76) & Vanes, BSI ports 14.....		<i>2 ea Missing on T/E Side (Serviceable Limits)</i> <i>1 ea Damage on Tip Cord (Serviceable Limits)</i> <i>1 ea Dent on L/E (Serviceable Limits)</i>

Stg13 Blades (Qty 76) & Vanes, BSI ports 14.....		<i>No Remarks</i>
Stg14 Blades (Qty 76) & Vanes, BSI ports 15.....		<i>No Remarks</i>
Stg15 Blades (Qty 76) & Vanes, BSI ports 16.....		<i>No Remarks</i>
Stg16 Blades (Qty 76) & Vanes, BSI ports 16.....		<i>No Remarks</i>

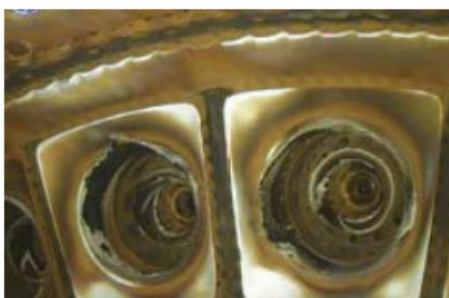
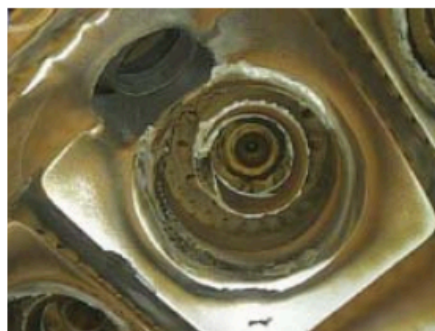
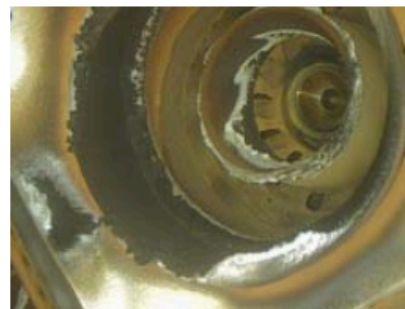
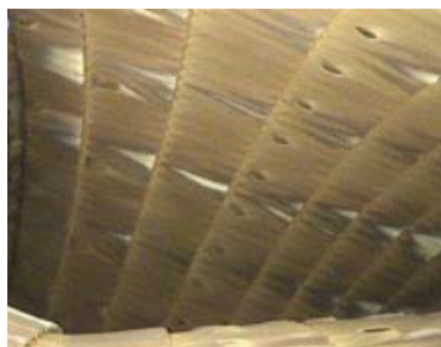
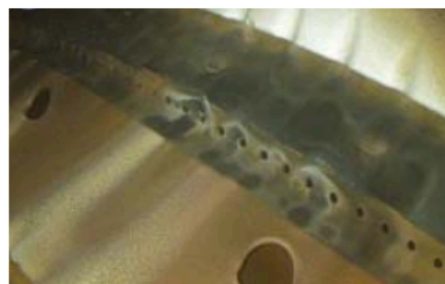
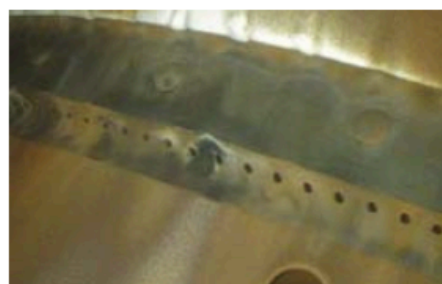
2. Combustion Chamber

CC Found in serviceable conditions.

Swirlers.....Deposits
Venturi's.....Deposits, TBC
Missing on Splash Plate
Trumpets.....Deposits
Dome Plate.....No remarks
Inner/Outer Liners.....Discoloration
1st Stage Nozzle.....Deposits
Igniter Tube Area.....No remarks

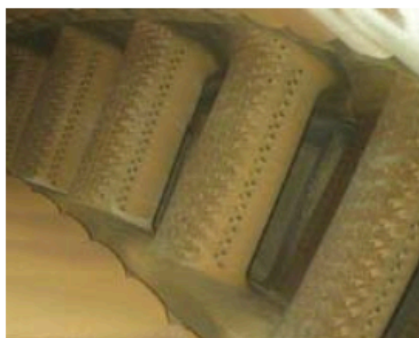
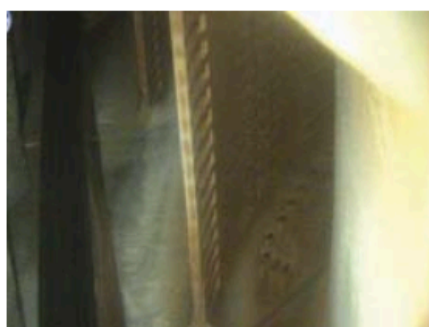
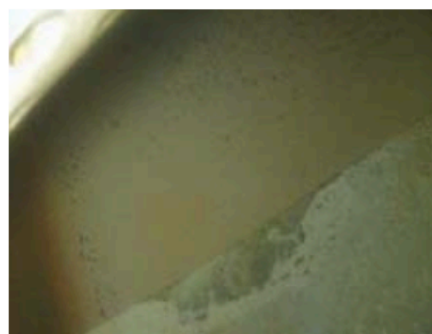
3. HPT STG1 Nozzle Assy.

Found in serviceable conditions

LE..... No Remarks

TE..... Erosions on two nozzles

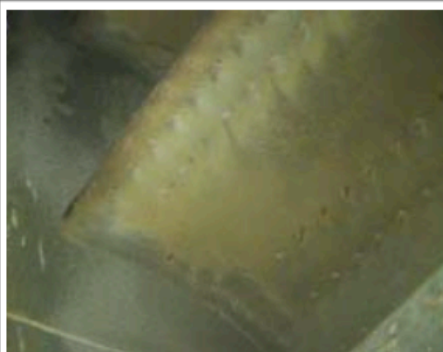
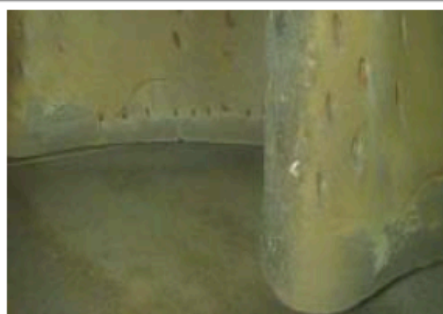
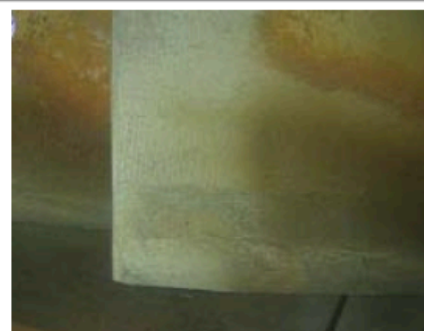
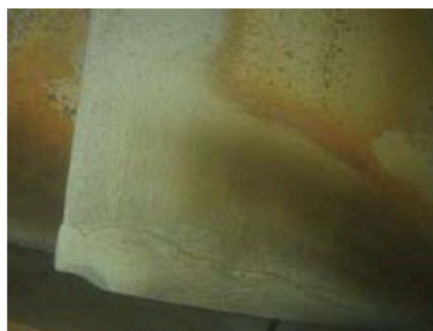
4. HPTR STG1 Blade

Notes:
Found in serviceable conditions

LE (18)..... *Discoloration, TBC Missing*
TE (19)..... *Discoloration, Missing on Tip Cap (1 blade)*

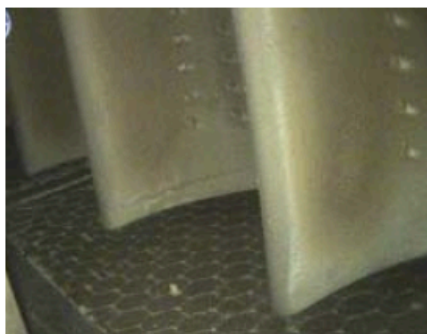
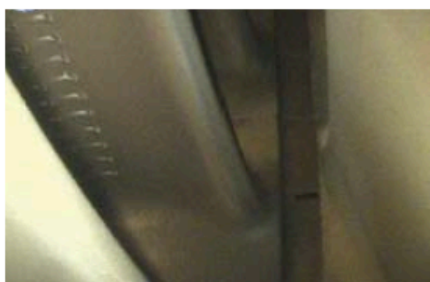
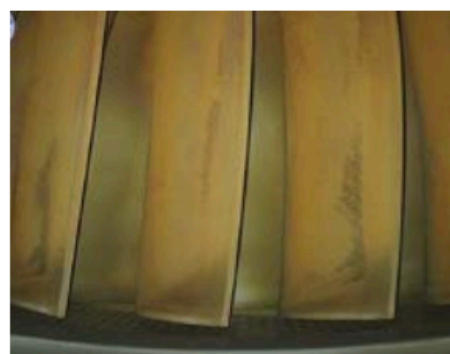
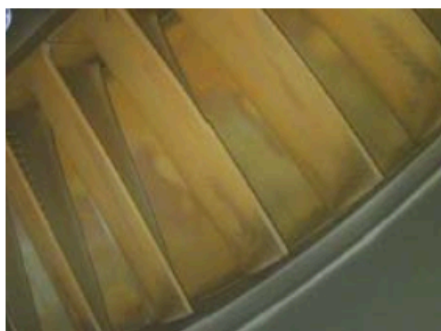
5. HPTR STG2 Blade

Notes:
Found in servicable conditions

LE (90ea., port 19)... *No Remarks*

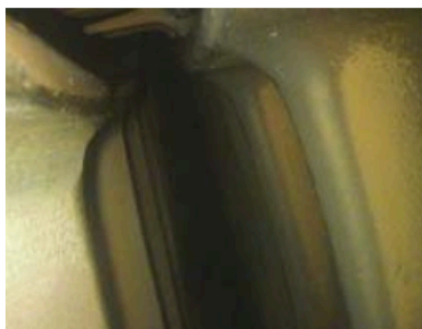
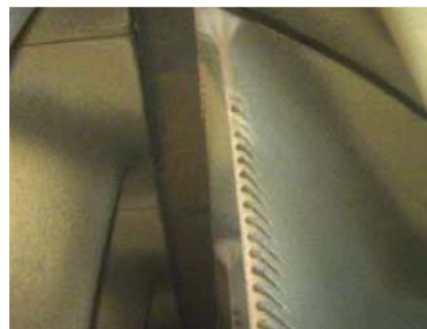
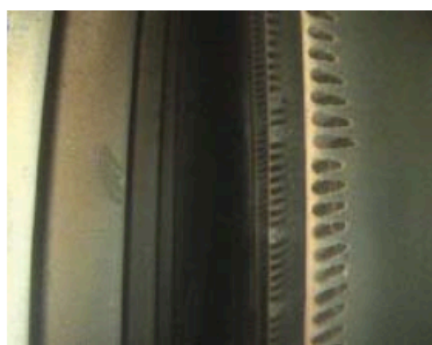
6. HPT STG2 Nozzle Assy.

Notes:
Found in serviceable conditions

STG2N..... Discoloration

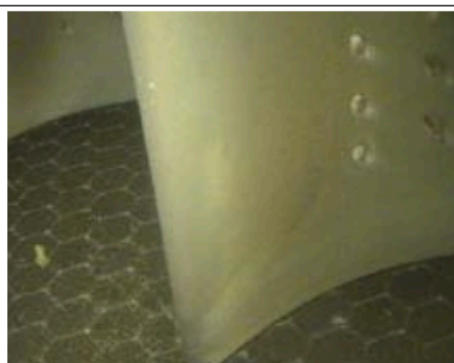
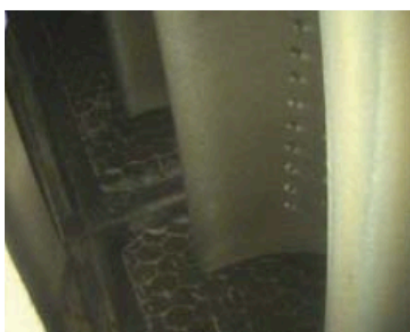
7. HPT STG1&2 Shrouds

Found in serviceable conditions

STG1S..... *Rubbing and Corrosion*

STG2S..... *No Remarks*

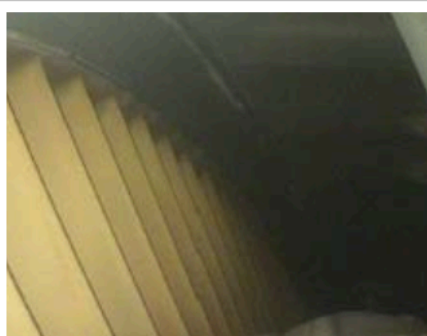
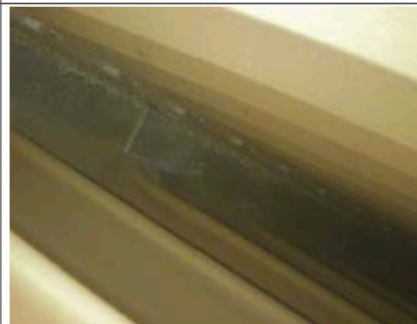
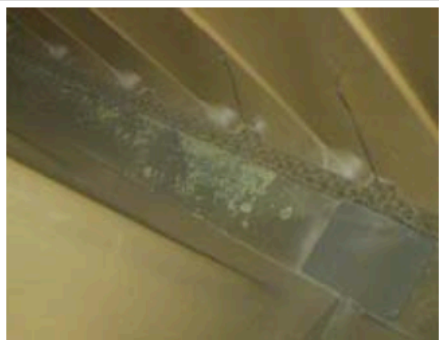
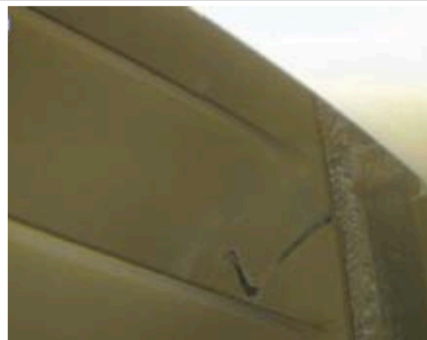
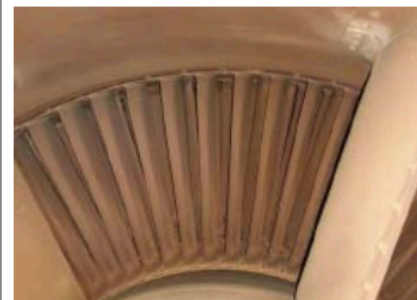
2.8. PT

Notes:
Found in serviceable conditions

T 5.4 Port.....*No Remarks*
