AEROLIAS DEL CONTINENTE AMERICANO S AEROLIAS DEL CONTINENTE AMERICANO S 8901005776 AVENIDA CALLE 26 59-15, BOGOTA COLOMBIA CDO-001		W/O 101851564 Original	Station BOG	Registration HK-4999 AT7 ATR72 -212A
Type S SCHED	Origin EOD Doc: ENGINEERING ORDER DETAIL	ATA 72 ENGINE GENERAL	Position ENGLH LEFT ENGINE	Zone N/A	Barcode

MANDATORY: PERFORM EOD- EOD-AT7-72-0005-R00 COMPONENT (ENGINEERING ORDER DETAIL) REV. 00
 PARTNO : PW127N / SERIALNO : PCE-ED1034
 ENGINE ATR72
 POS: ENGLH

POWERPLANT - HPT, COMBUSTION CHAMBER AND SMALL EXIT DUCT BSI

Subject: ENGINE - HP TURBINE, COMBUSTION

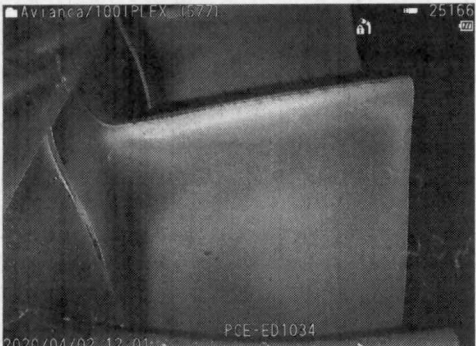
16. REMARKS:					
<p>BOROSCOPE INSPECTION WAS ACCOMPLISHED TO HPT (BLADES, SHROUDS AND VANES RING SEGMENTS), COMBUSTION CHAMBER AND SMALL EXIT DUCT.</p> <ul style="list-style-type: none"> HPT (Blades and Shrouds): No damages were found. HPT Guide Vanes: Cracks at Trailing edge, Acceptable in accordance MM. Combustion Chamber: Missing coating loss. Acceptable in accordance MM Small Exit Duct. No Damages were found. <p style="text-align: center;">CONCLUSION: NO ACTION REQUIRED</p>
