TG50D5 – Std
GT Serial Number 354

POWER PLANT ex Turbigio group “G”

Major Overhaul

Title: TG50D5 Std S/N:354 GR “G” – MAJOR OVERHAUL

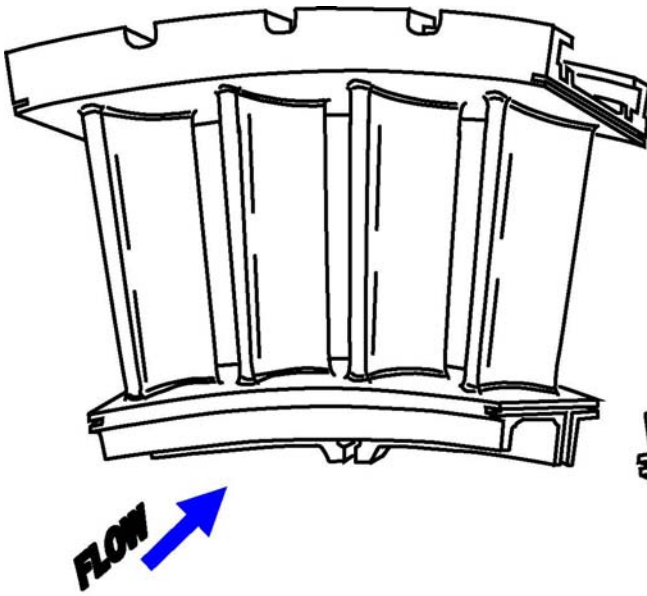
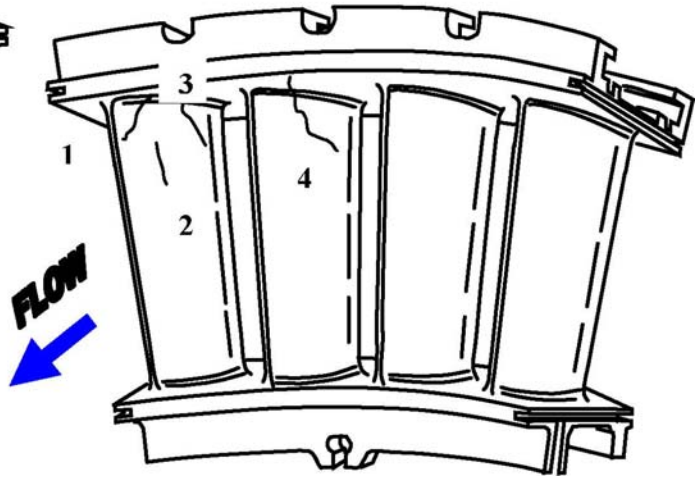
S/N: U3K433	DWG: 4282T81	POSITION : 1	FIRING HRS : 48954	STARTS NO.: 1295	TESTED: PT <input type="checkbox"/> VT <input type="checkbox"/>
----------------	-----------------	-----------------	-----------------------	---------------------	--

Position	Damage description	Position	Damage description
1	CRICCA 5mm	10	
2	CRICCA 5mm	11	
3	CRICCA 4mm	12	
4	CRICCA 80mm	13	
5		14	
6		15	
7		16	
8			
9

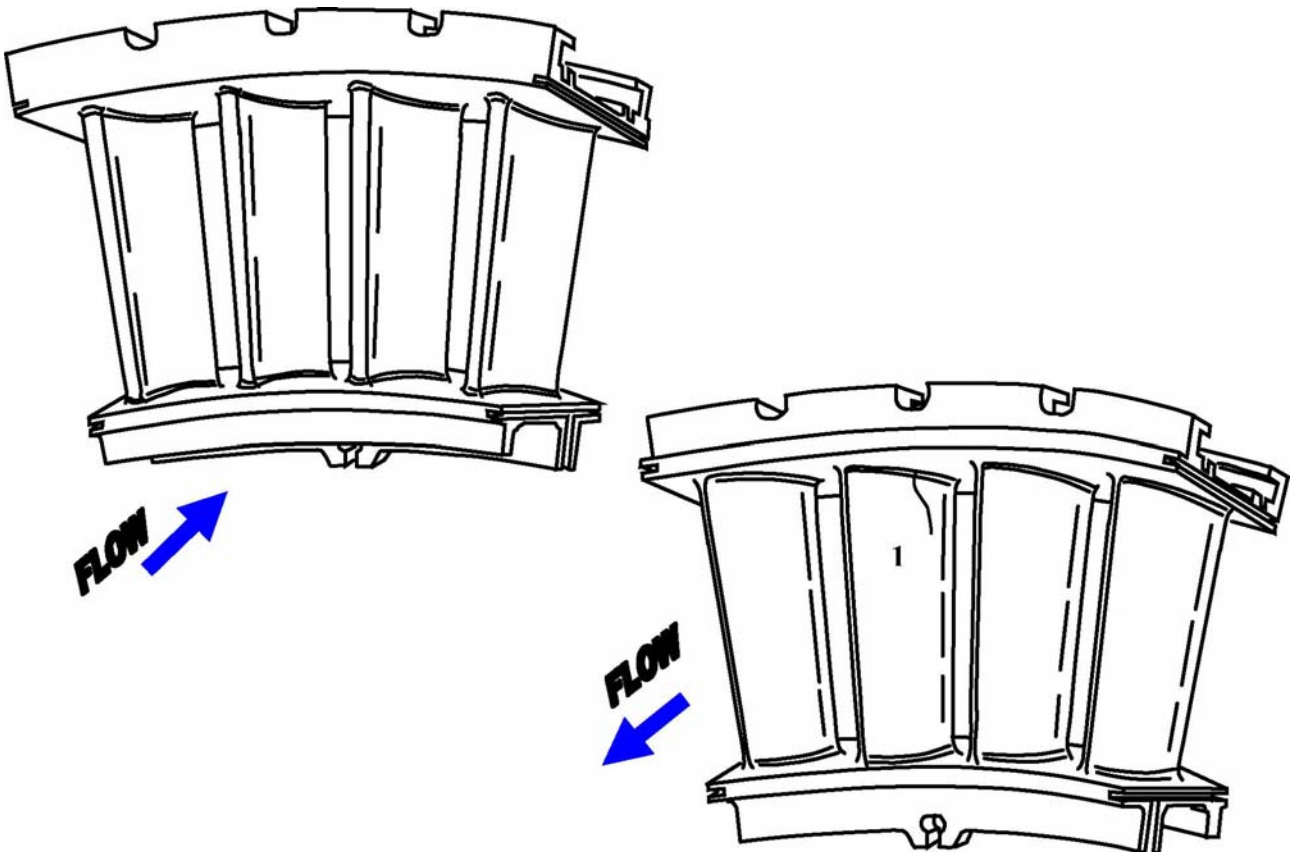
S/N: U3K434	DWG: 4282T81	POSITION : 2	FIRING HRS : 48954	STARTS NO.: 1295	TESTED: PT <input type="checkbox"/> VT <input type="checkbox"/>
----------------	-----------------	-----------------	-----------------------	---------------------	--

Position	Damage description	Position	Damage description
1	CRICCA 28mm	10	
2		11	
3		12	
4		13	
5		14	
6		15	
7		16	
8			
9

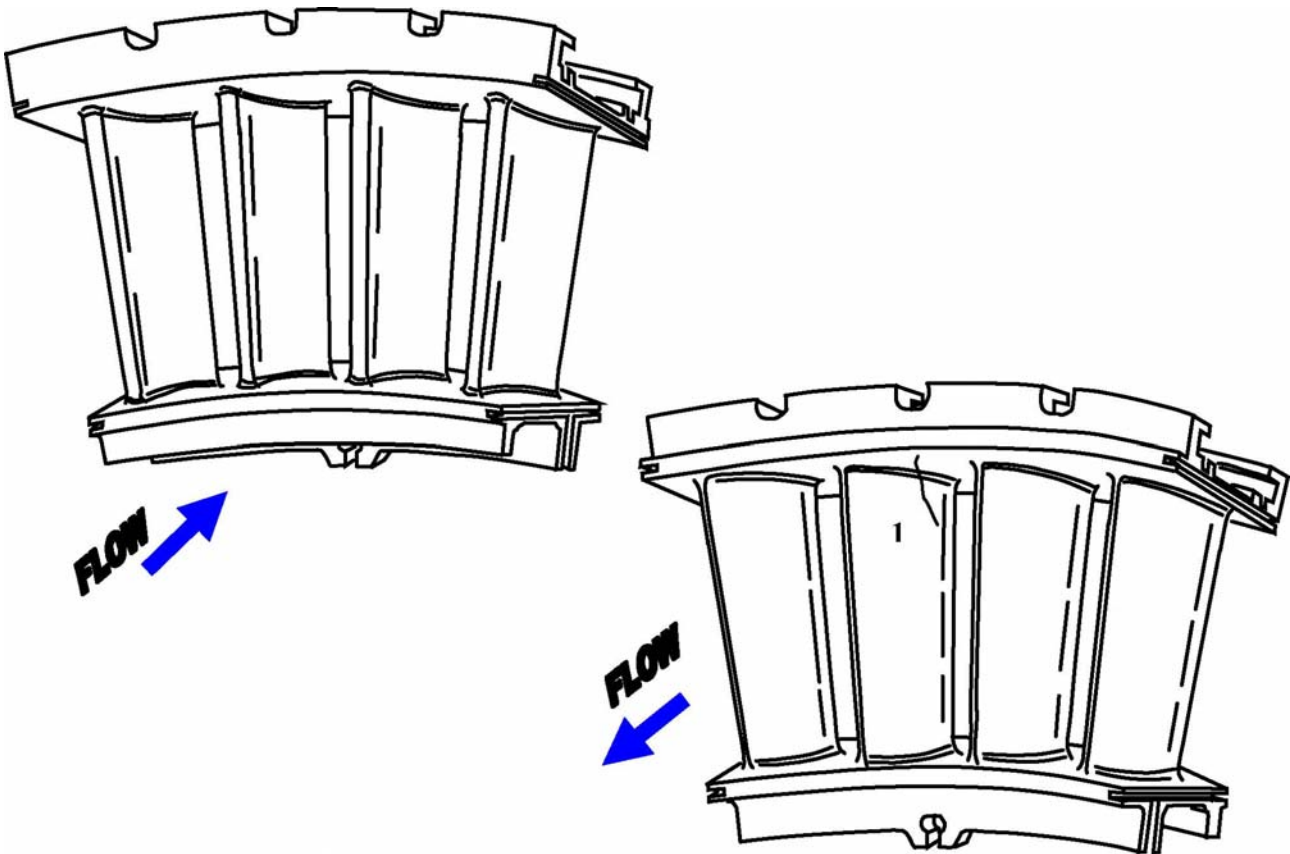
S/N: U3K443	DWG: 4282T81	POSITION : 3	FIRING HRS : 48954	STARTS NO.: 1295	TESTED: PT <input type="checkbox"/> VT <input type="checkbox"/>
----------------	-----------------	-----------------	-----------------------	---------------------	--

Position	Damage description	Position	Damage description
1	Crack 62 mm.	10	
2		11	
3		12	
4		13	
5		14	
6		15	
7		16	
8			
9

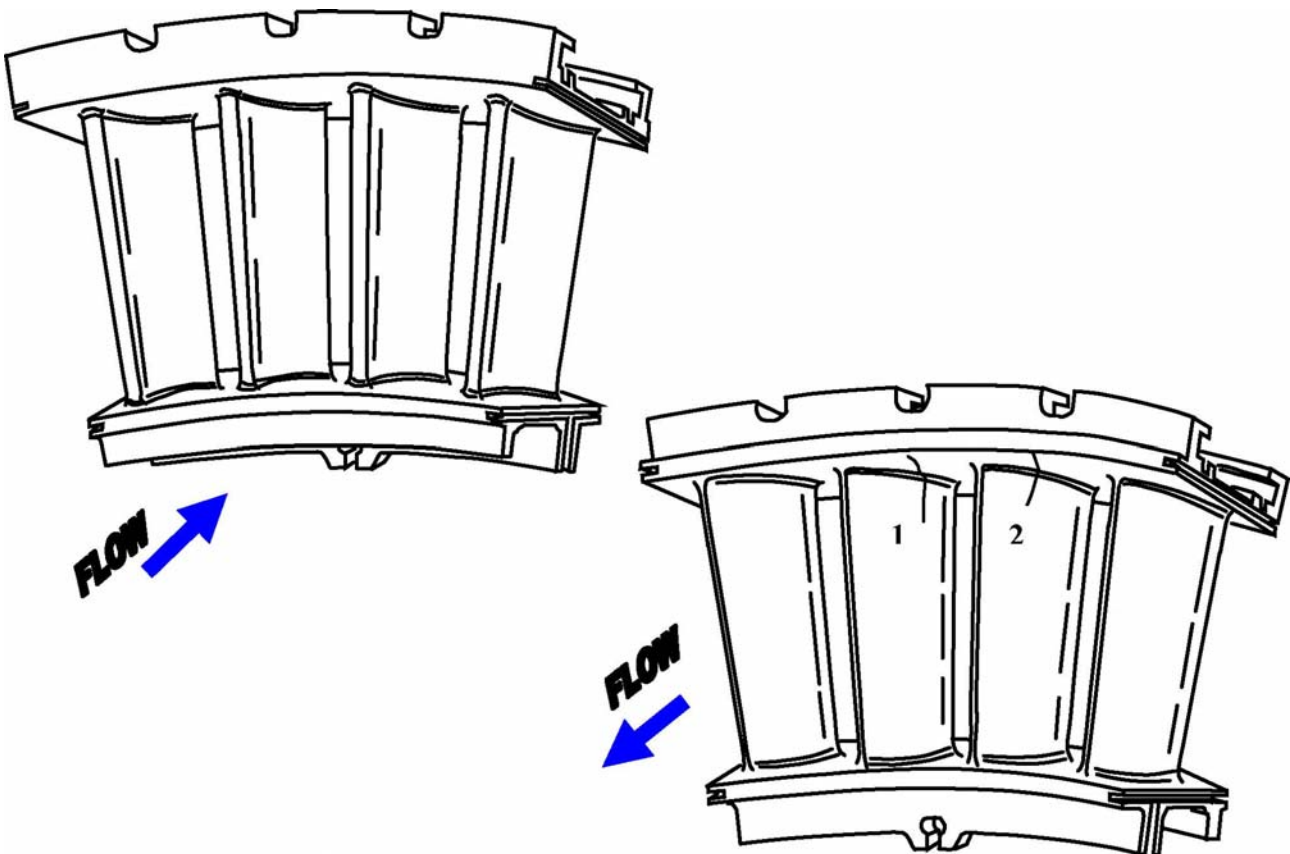
S/N: U3K435	DWG: 4282T81	POSITION : 4	FIRING HRS : 48954	STARTS NO.: 1295	TESTED: PT <input type="checkbox"/> VT <input type="checkbox"/>
----------------	-----------------	-----------------	-----------------------	---------------------	--

Position	Damage description	Position	Damage description
1	Crack 95mm.	10	
2	Crack 15 mm.	11	
3		12	
4		13	
5		14	
6		15	
7		16	
8			
9

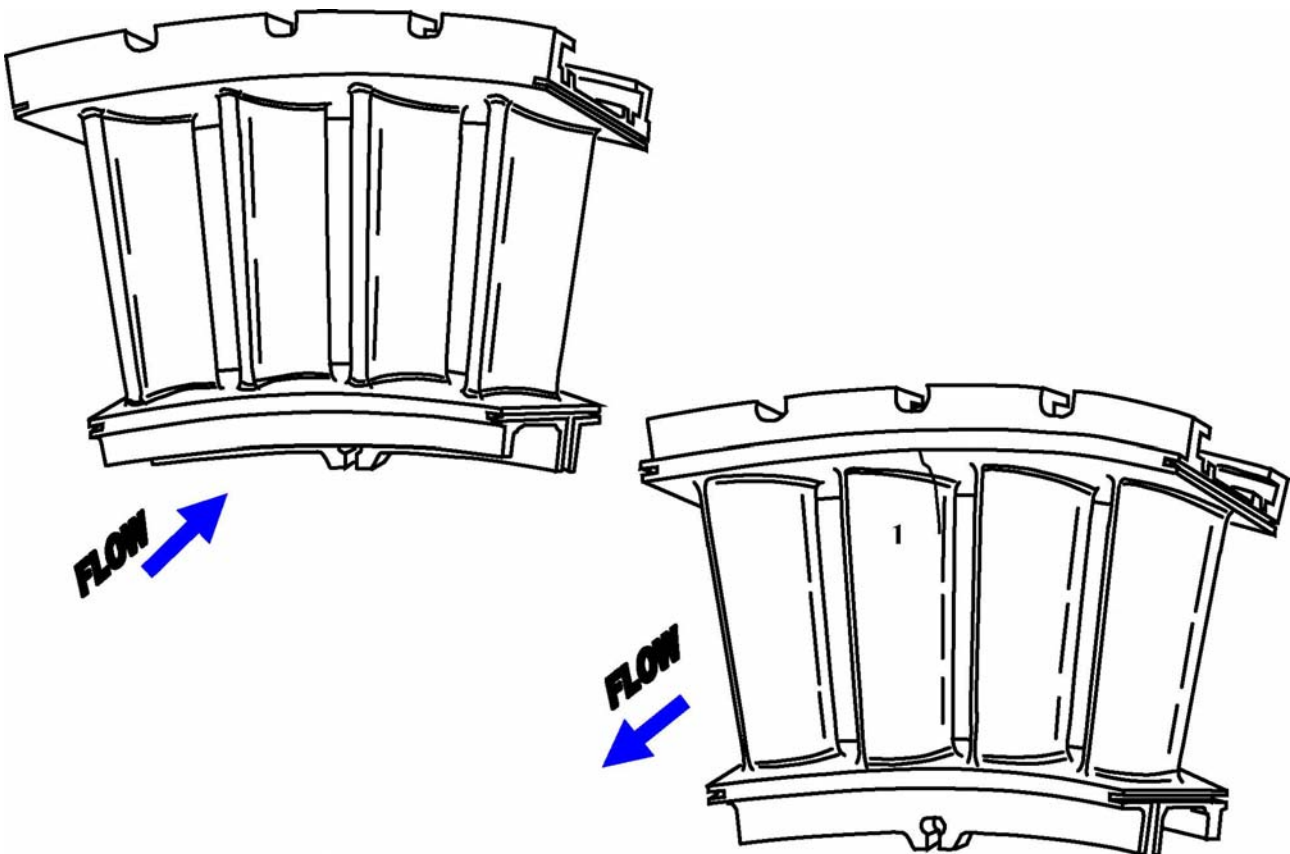
S/N: U3K436	DWG: 4282T81	POSITION : 5	FIRING HRS : 48954	STARTS NO.: 1295	TESTED: PT <input type="checkbox"/> VT <input type="checkbox"/>
----------------	-----------------	-----------------	-----------------------	---------------------	--

Position	Damage description	Position	Damage description
1	Crack 70mm.	10	
2		11	
3		12	
4		13	
5		14	
6		15	
7		16	
8			
9

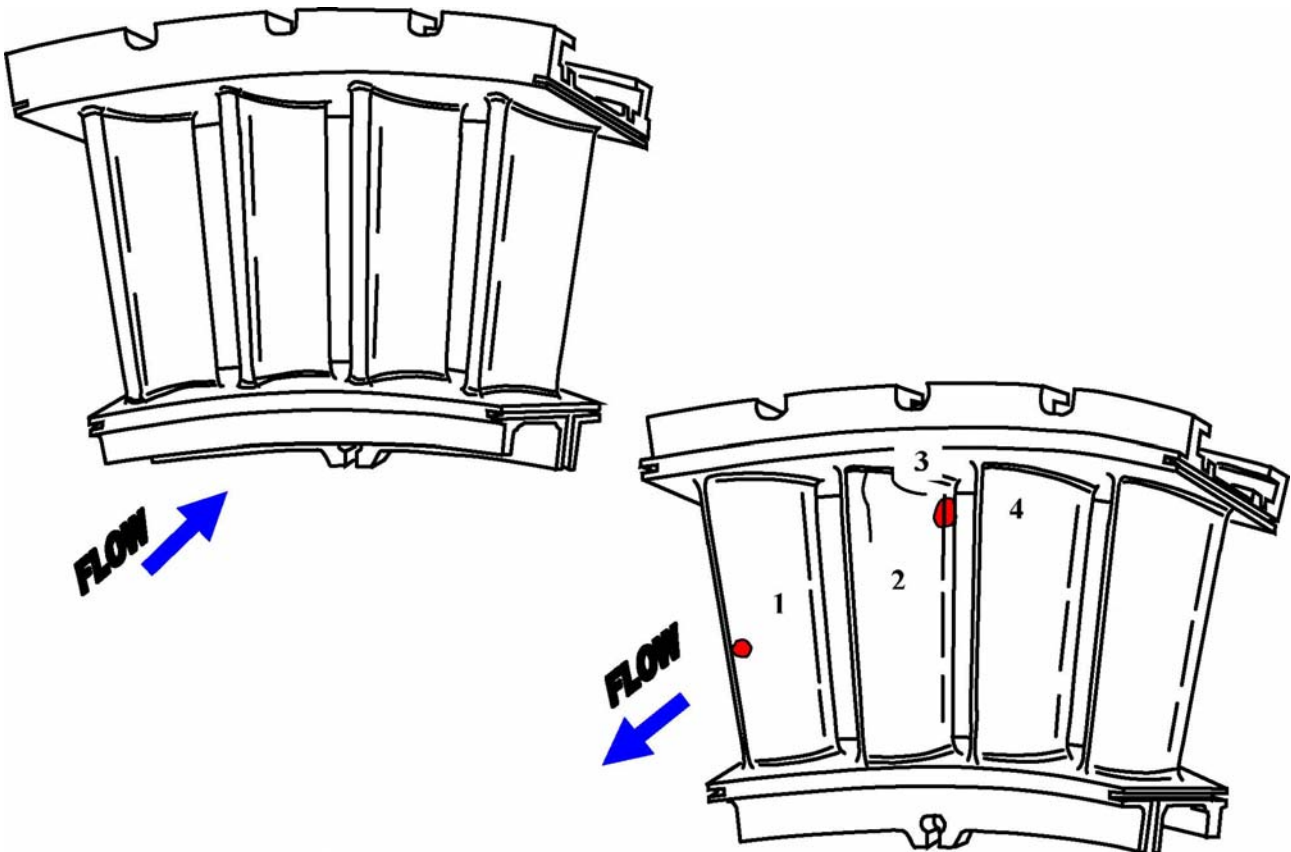
S/N: U3K437	DWG: 4282T81	POSITION : 6	FIRING HRS : 48954	STARTS NO.: 1295	TESTED: PT <input type="checkbox"/> VT <input type="checkbox"/>
----------------	-----------------	-----------------	-----------------------	---------------------	--

Position	Damage description	Position	Damage description
1	f.o. impact dia. 3 mm.	10	
2	Crack 15mm.	11	
3	Crack 22mm.	12	
4	f.o. impact dia. 7 mm.	13	
5		14	
6		15	
7		16	
8			
9

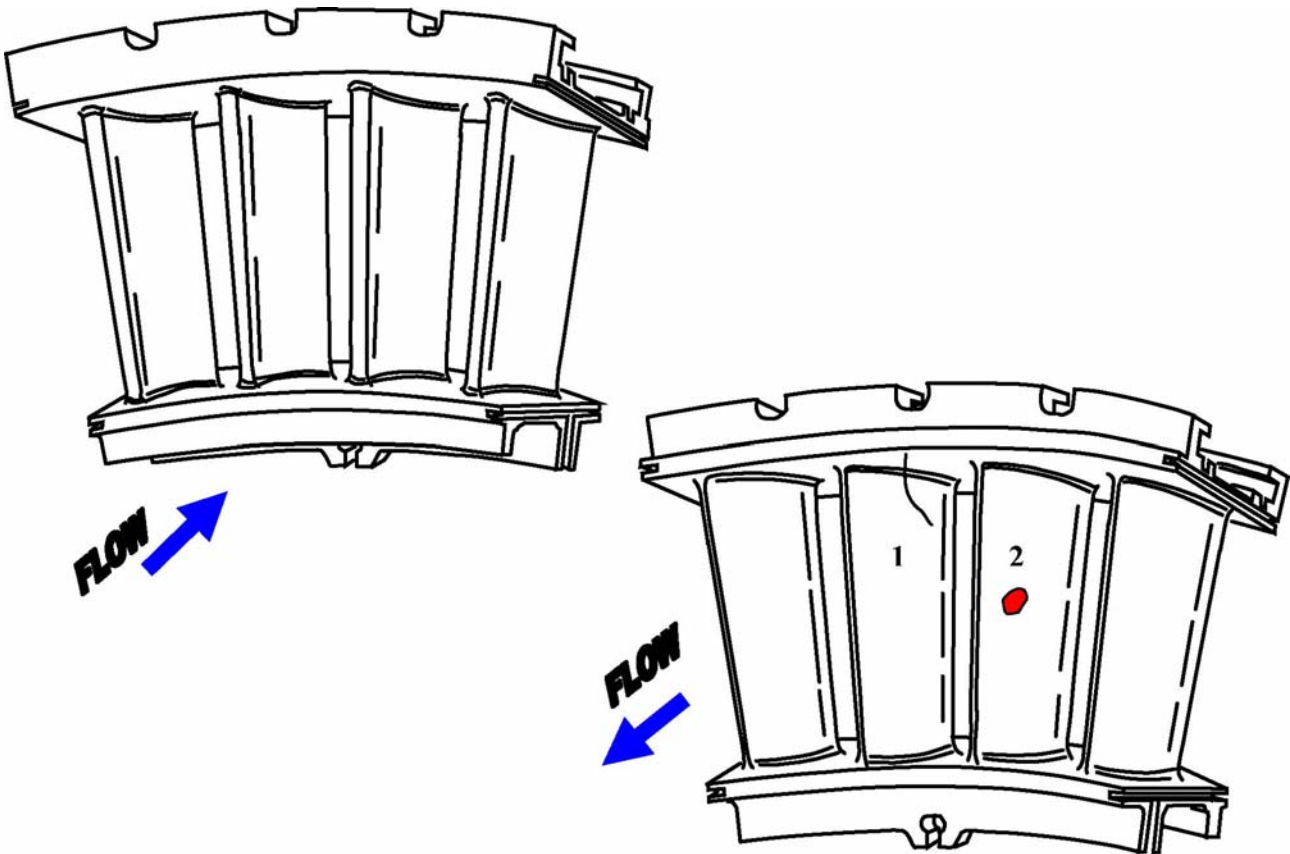
S/N: U3K438	DWG: 4282T81	POSITION : 7	FIRING HRS : 48954	STARTS NO.: 1295	TESTED: PT <input type="checkbox"/> VT <input type="checkbox"/>
----------------	-----------------	-----------------	-----------------------	---------------------	--

Position	Damage description	Position	Damage description
1	Crack 87 mm.	10	
2	f.o. impact dia. 8 mm,	11	
3		12	
4		13	
5		14	
6		15	
7		16	
8			
9

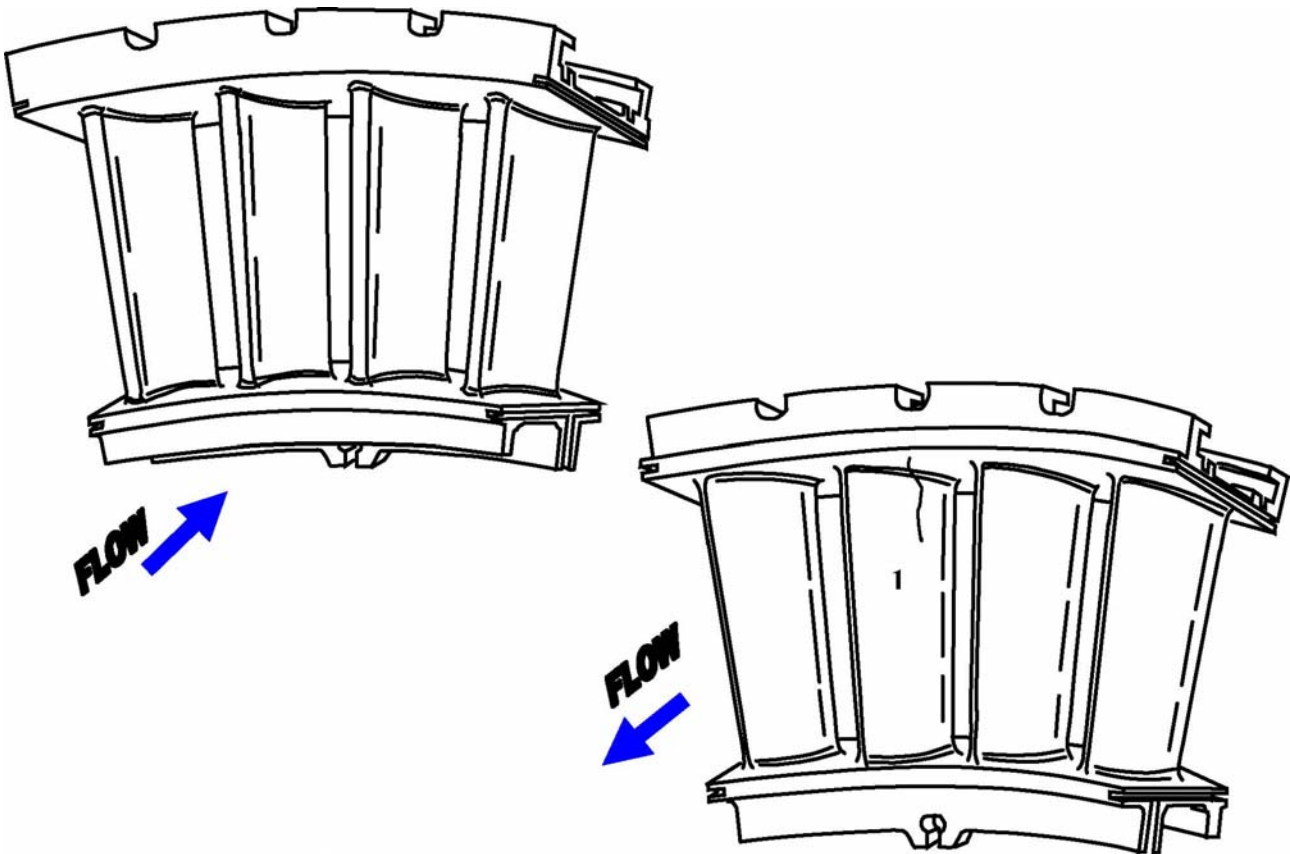
S/N: U3K440	DWG: 4282T81	POSITION : 9	FIRING HRS : 48954	STARTS NO.: 1295	TESTED: PT <input type="checkbox"/> VT <input type="checkbox"/>
----------------	-----------------	-----------------	-----------------------	---------------------	--

Position	Damage description	Position	Damage description
1	Crack 70 mm.	10	
2		11	
3		12	
4		13	
5		14	
6		15	
7		16	
8			
9

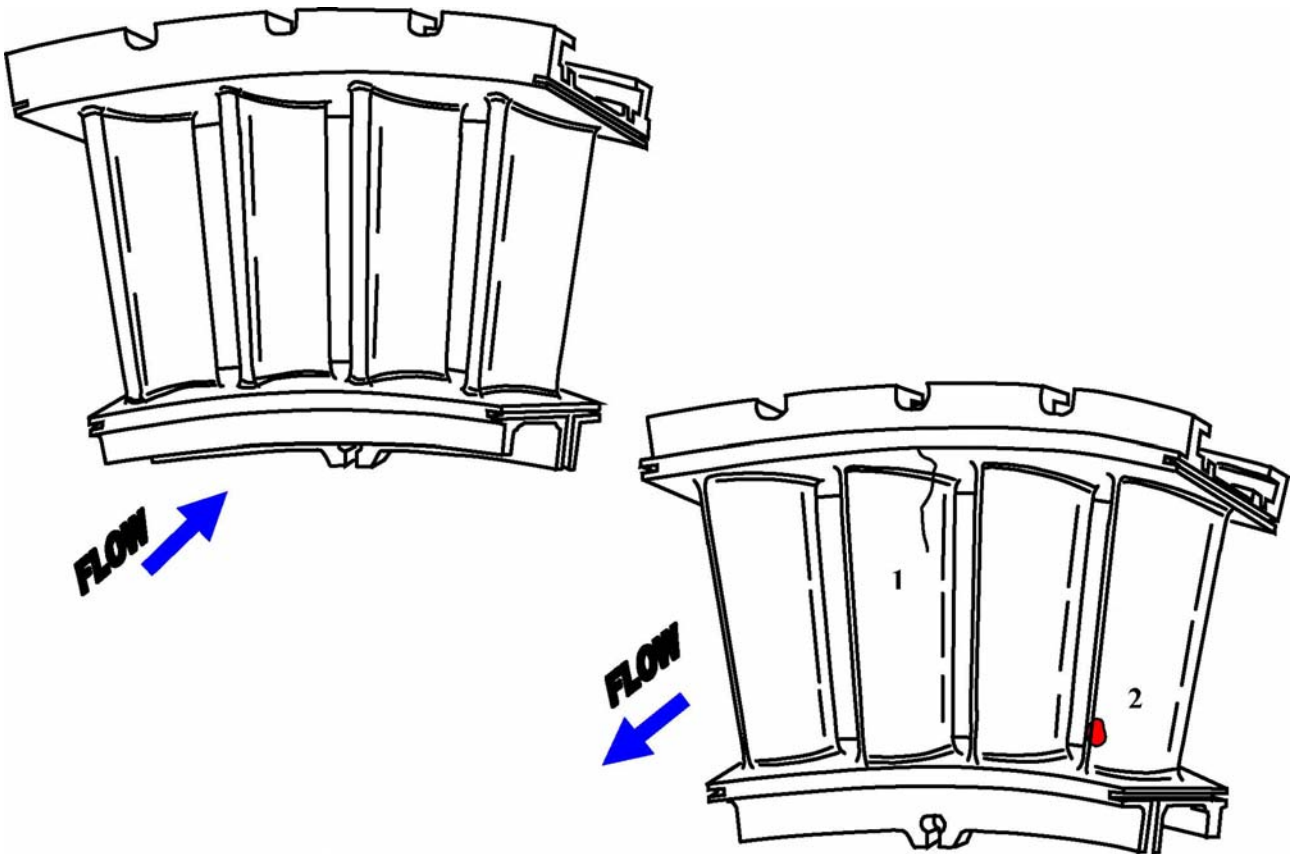
S/N: U3K441	DWG: 4282T81	POSITION : 10	FIRING HRS : 48954	STARTS NO.: 1295	TESTED: PT <input type="checkbox"/> VT <input type="checkbox"/>
----------------	-----------------	------------------	-----------------------	---------------------	--

Position	Damage description	Position	Damage description
1	Crack 96 mm.	10	
2	f.o. impact dia. 3 mm.	11	
3		12	
4		13	
5		14	
6		15	
7		16	
8			
9

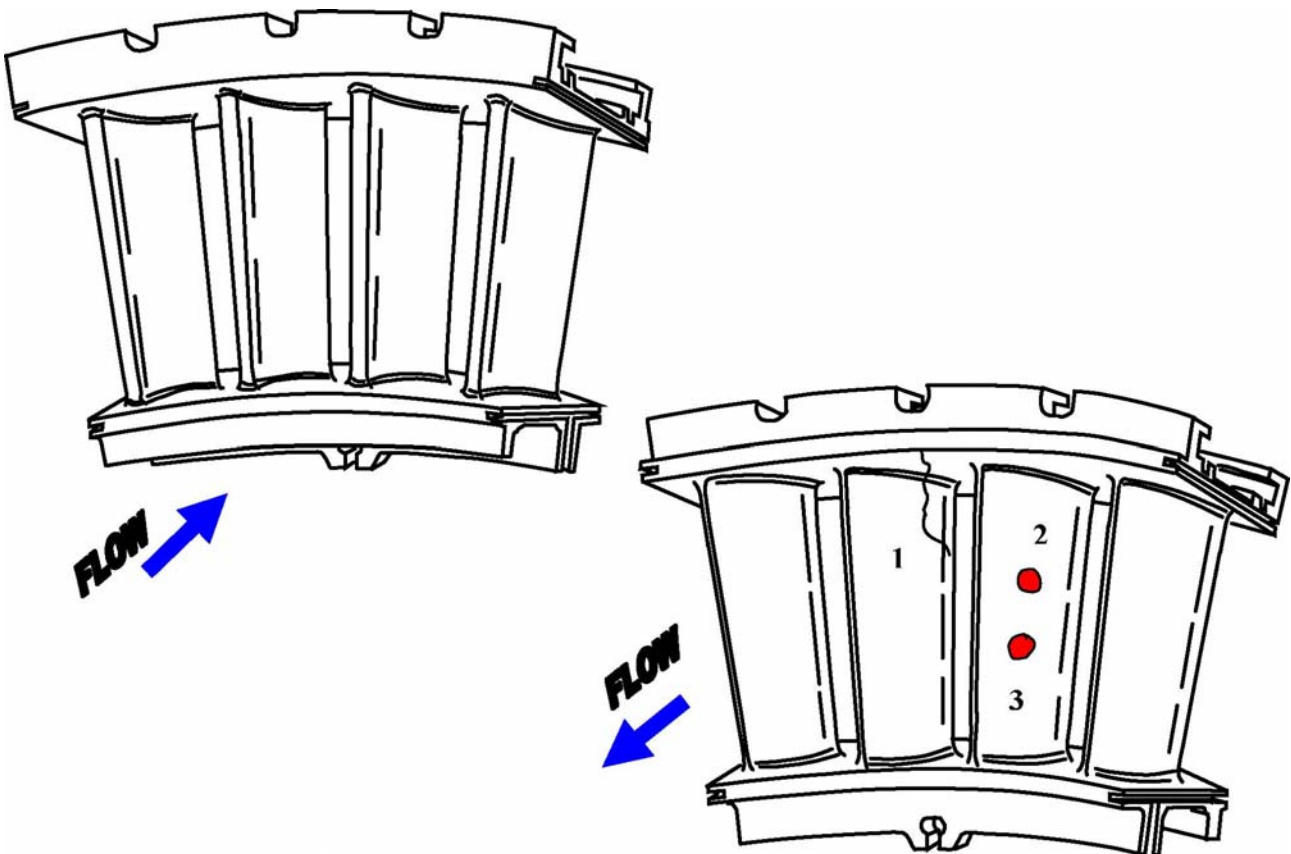
S/N: U3K442	DWG: 4282T81	POSITION : 11	FIRING HRS : 48954	STARTS NO.: 1295	TESTED: PT <input type="checkbox"/> VT <input type="checkbox"/>
----------------	-----------------	------------------	-----------------------	---------------------	--

Position	Damage description	Position	Damage description
1	Crack 73 mm.	10	
2	f.o. impact dia. 5 mm.	11	
3	f.o. impact dia. 3 mm.	12	
4		13	
5		14	
6		15	
7		16	
8			
9

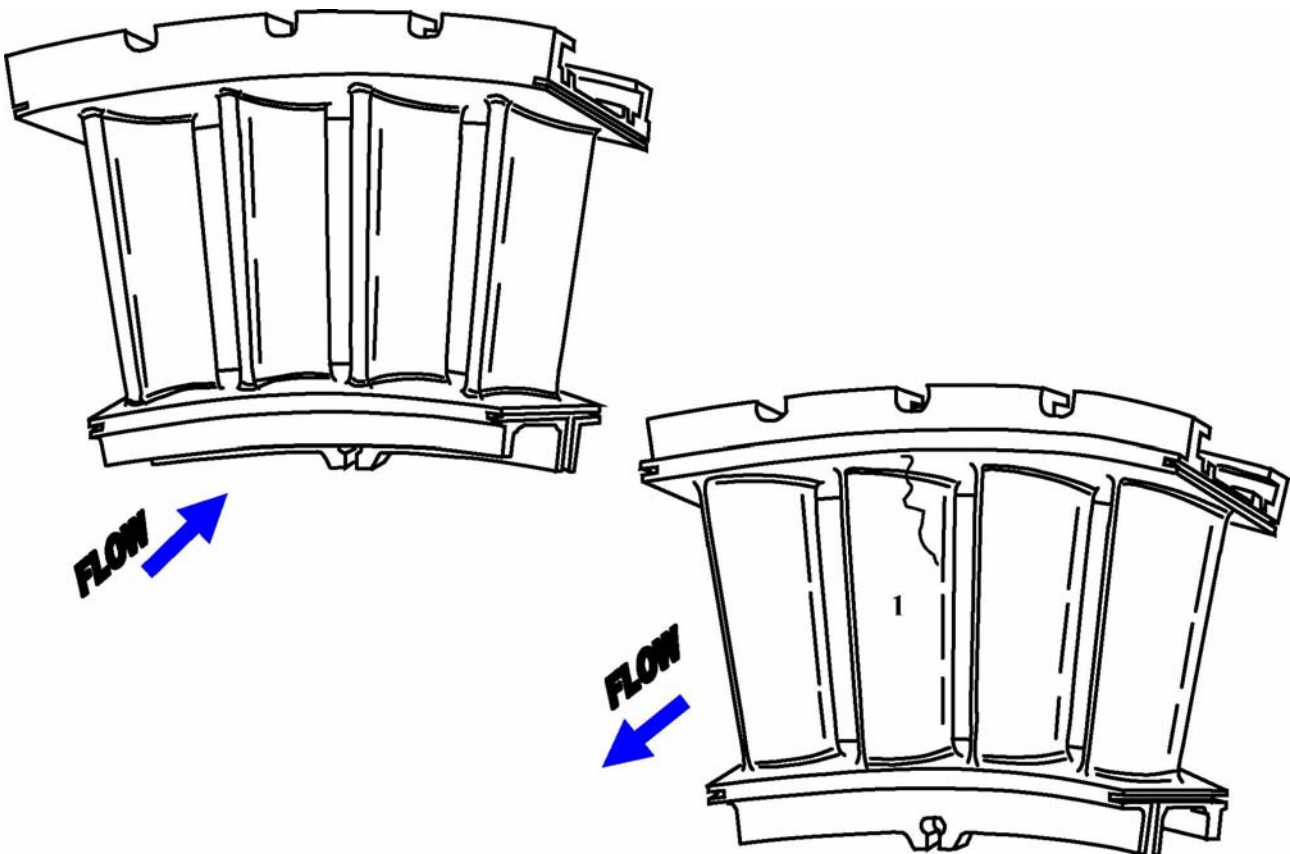
S/N: U3K444	DWG: 4282T81	POSITION : 12	FIRING HRS : 48954	STARTS NO.: 1295	TESTED: PT <input type="checkbox"/> VT <input type="checkbox"/>
----------------	-----------------	------------------	-----------------------	---------------------	--

Position	Damage description	Position	Damage description
1	Crack 62 mm.	10	
2		11	
3		12	
4		13	
5		14	
6		15	
7		16	
8			
9

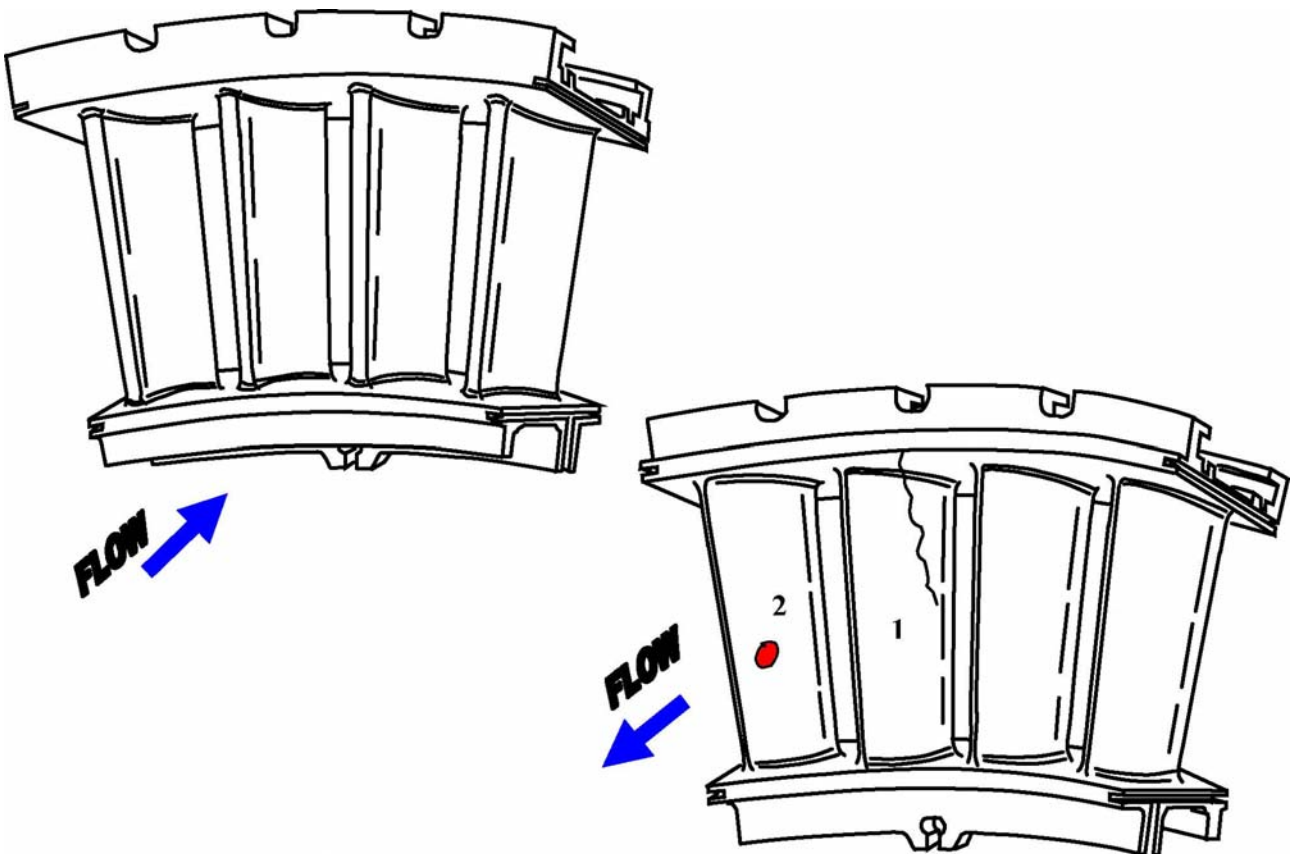
Position	Damage description	Position	Damage description
1	Crack 98 mm.	10	
2	f.o. impact dia. 3 mm.	11	
3		12	
4		13	
5		14	
6		15	
7		16	
8			
9

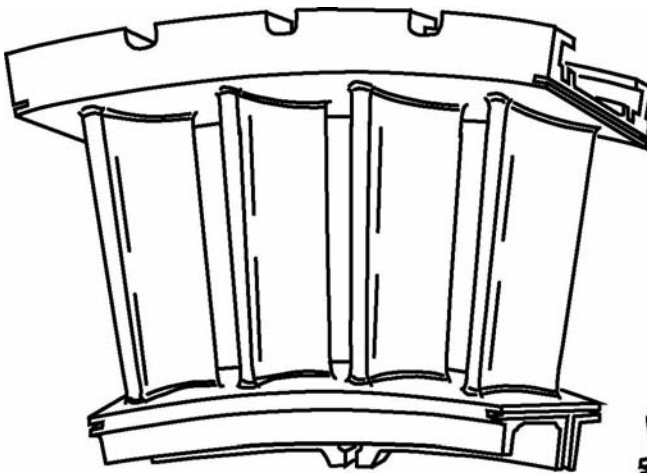
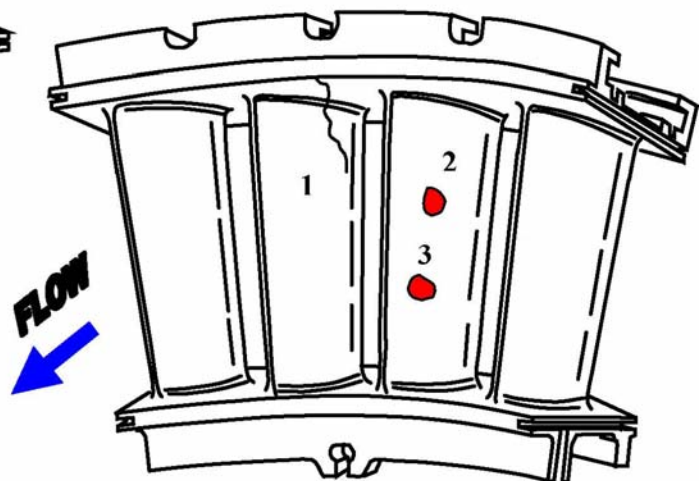
Position	Damage description	Position	Damage description
1	Crack 35 mm.	10	
2	f.o. impact dia. 8 mm.	11	
3	f.o. impact dia. 3 mm.	12	
4		13	
5		14	
6		15	
7		16	
8			
9

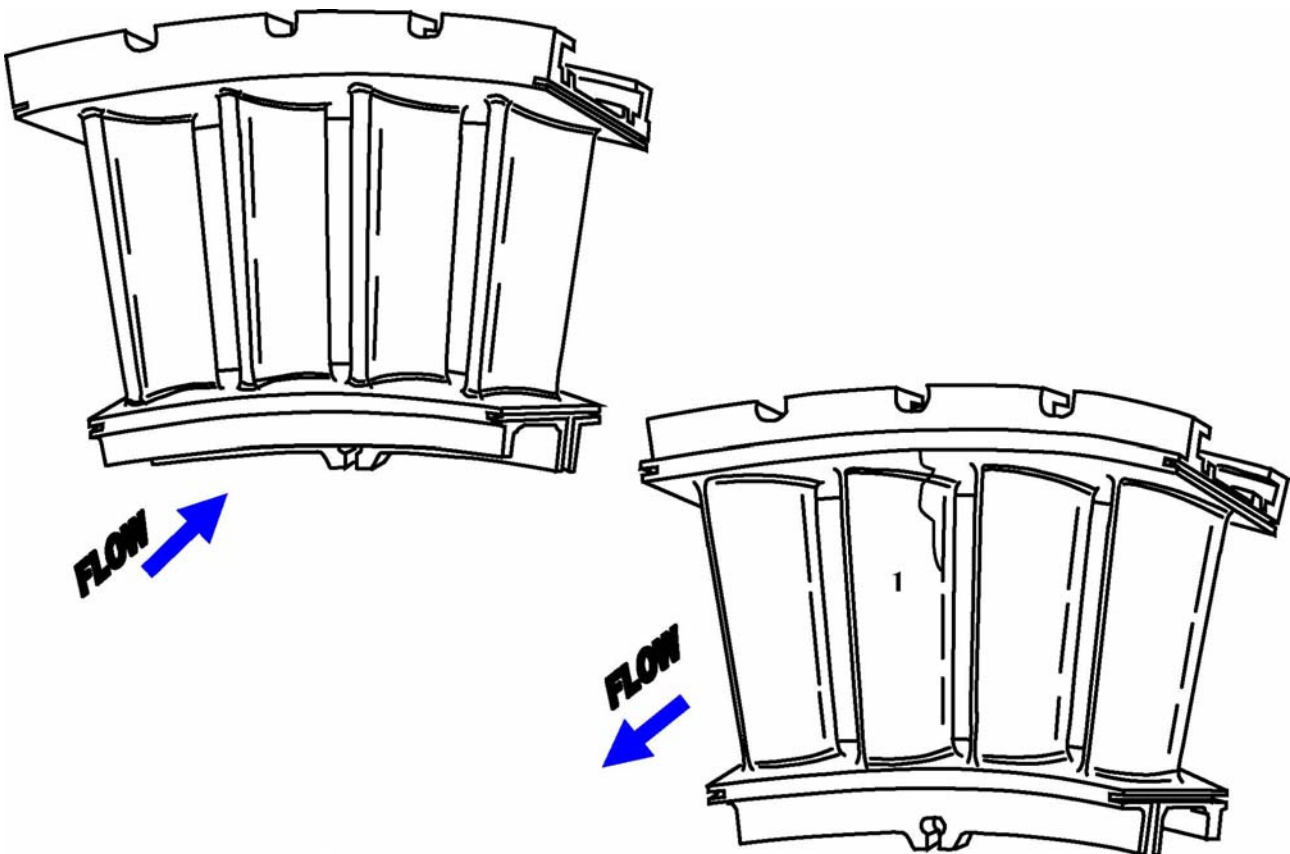
Position	Damage description	Position	Damage description
1	Crack 64 mm.	10	
2		11	
3		12	
4		13	
5		14	
6		15	
7		16	
8			
9

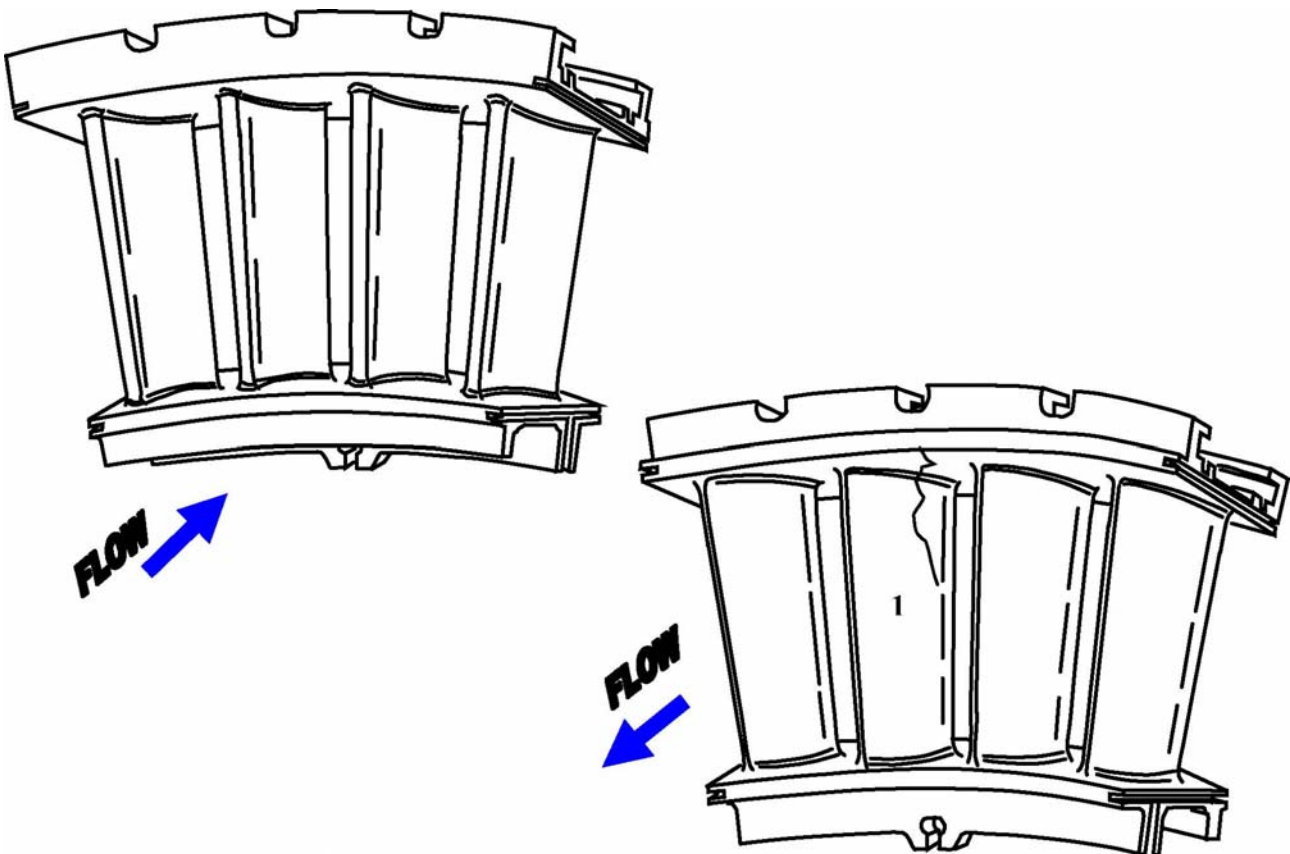
Position	Damage description	Position	Damage description
1	Crack 87 mm.	10	
2		11	
3		12	
4		13	
5		14	
6		15	
7		16	
8			
9

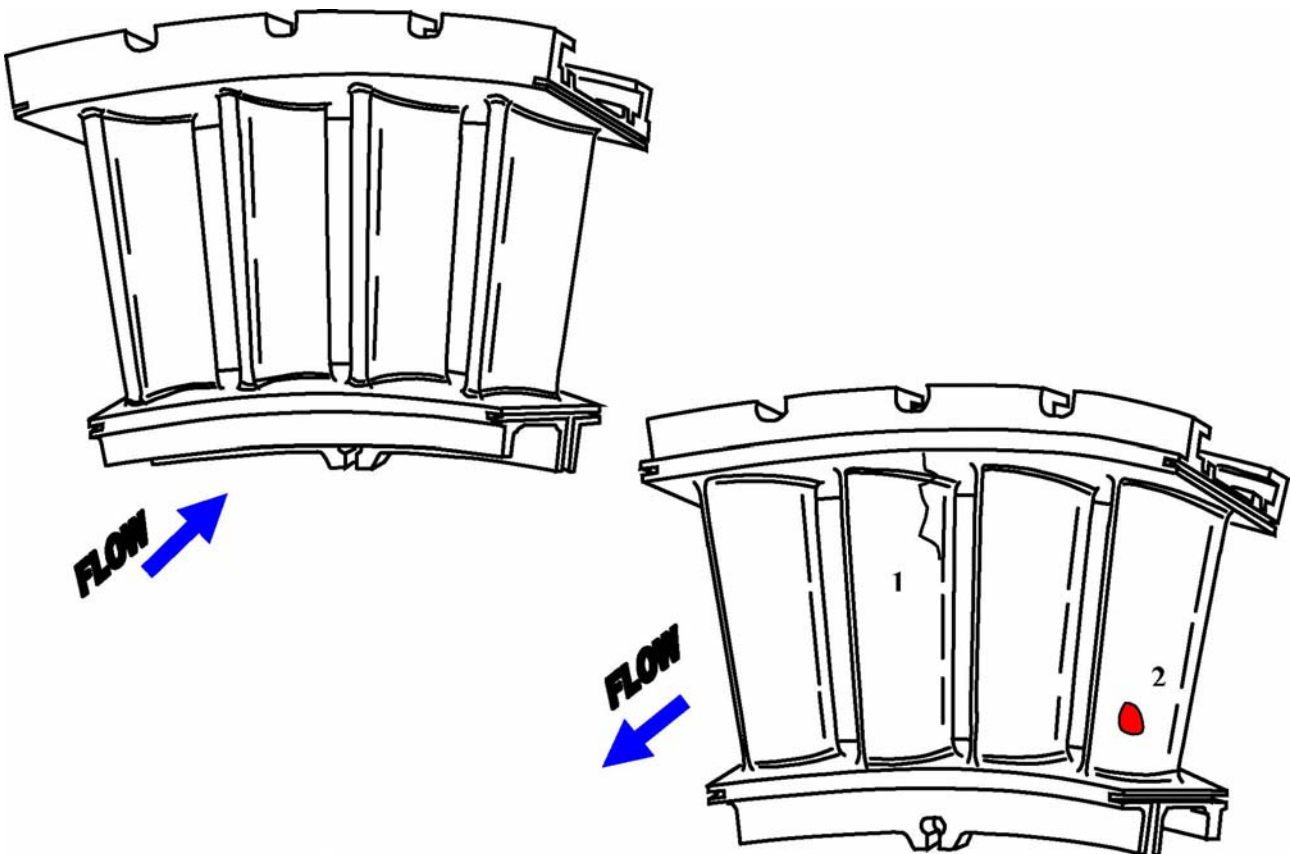
Position	Damage description	Position	Damage description
1	Crack 46 mm.	10	
2	f.o. dia 3 mm.	11	
3		12	
4		13	
5		14	
6		15	
7		16	
8			
9
