**PROPOSAL FOR CEN B6 ARMORED TOYOTA  
LANDCRUISER 300 SERIES [DATED: Nov 23, 2022]**

**OEM SPECIFICATIONS:**

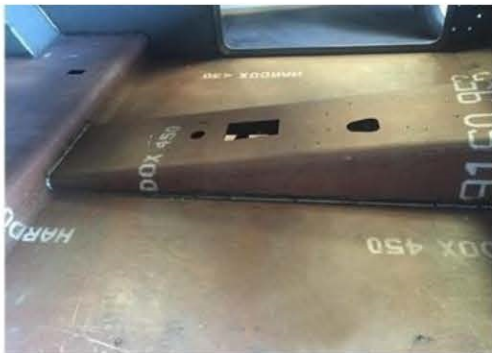
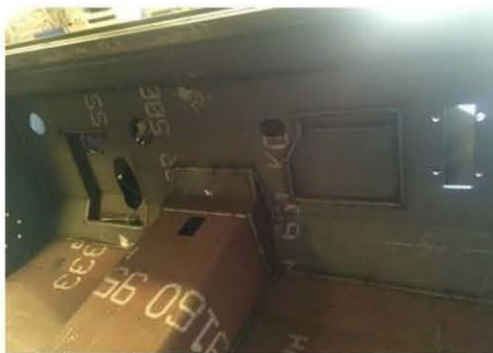
Floor of the vehicle fitted with blast protection to protect occupants against fragmentation from simultaneous detonation of 2 DM-51 German ordnance hand grenades or equivalent. In addition, the floor also offers protection against anti-personnel mines.

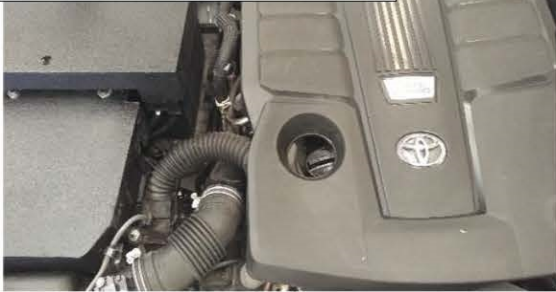
ECM + Battery Protection

- Hinge mounting points are reinforced both in the pillars and in the doors in a way that the armoring of the door is supported by the armoring of the pillar.
- Heavy-duty door hinges with in-built doorstop.
- Fuel tank protected with steel armor plates.
- All doors and bulkhead areas are protected with high-quality armor steel.
- The battery and control module of the engine is protected with high-quality armor steel.

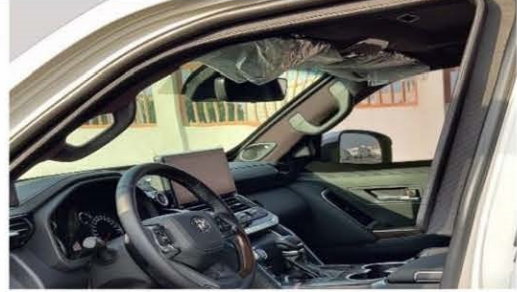
Bullet Catcher

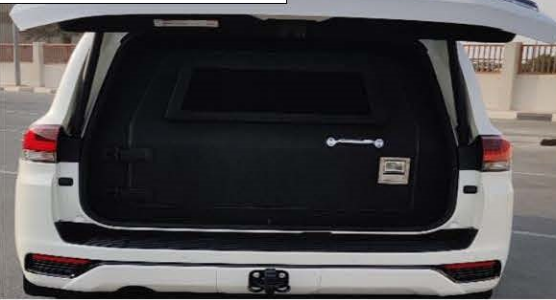
Rear Bulkhead

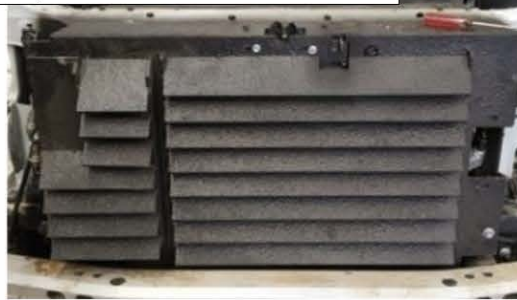
Optional Front Grill Protection

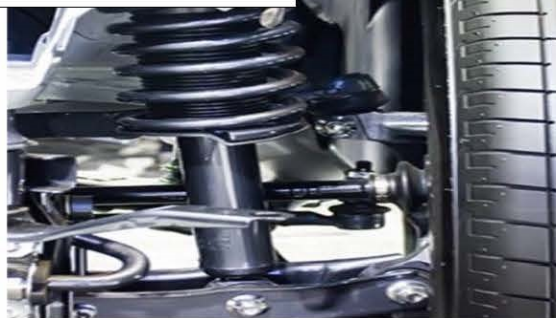
Upgraded Suspensions

Suspension upgrade - Ironman / Outback armor Australia.

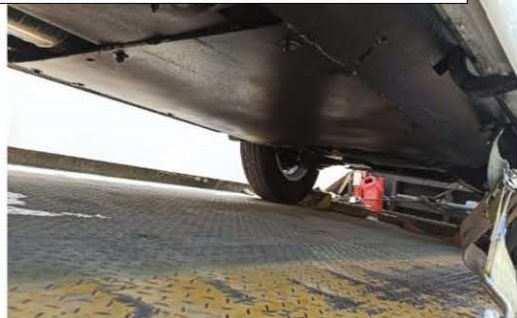
Underbelly Protection

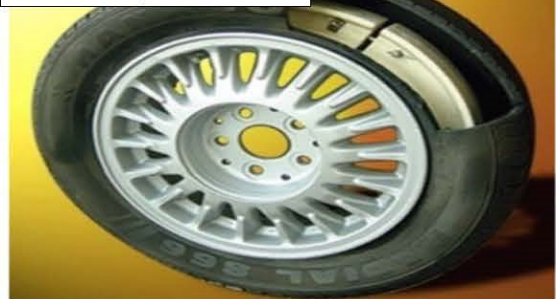
Run-flat System

Run-flat Insert - Hutchinson USA

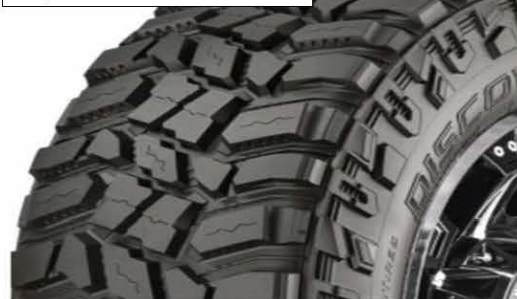
Optional HD tires
