**One New 2016 Siemens  
SGT5-4000F Turbine Generator  
Package**

Special Inspection

Project: POLO ENERGETICO ZARATE 23  
Shop Order No: MB000169  
Event ID: NA  
Period of Time: 2024-09-02 to 2024-09-05

The gas turbine MB000169 has been preserved and kept in storage at Hamburg Harbour since 2016. Before its delivery, the conservation procedures were refreshed to guarantee optimal preservation. As part of this process, a boroscope inspection was performed on September 3rd, 2024, to evaluate and document the unit's condition. The inspection concluded that the turbine remains in good condition.

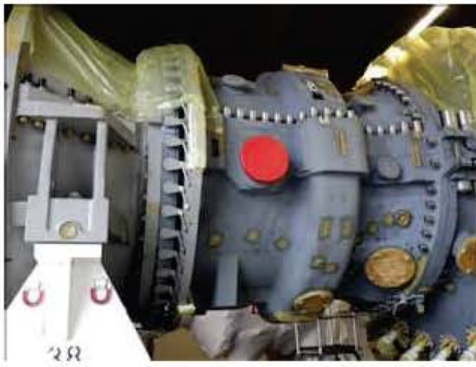
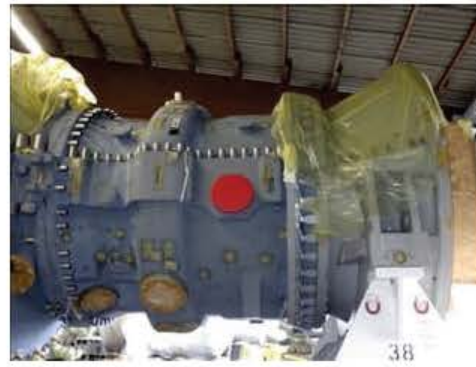
The Compressor casing Surface, the IGV and the IGV support roller were found in good condition, no sign of corrosion.

RHS overview

RHS Compressor

RHS compressor (1)

LHS compressor side

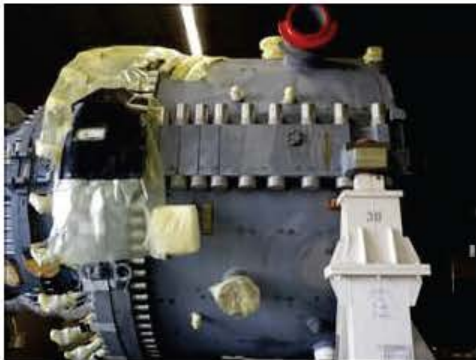
RHS turbine side

1. The turbine exit casing (TEC) exhibited signs of surface corrosion in several areas.
2. Two of the half joint bolts showed signs of paint loss and corrosion.

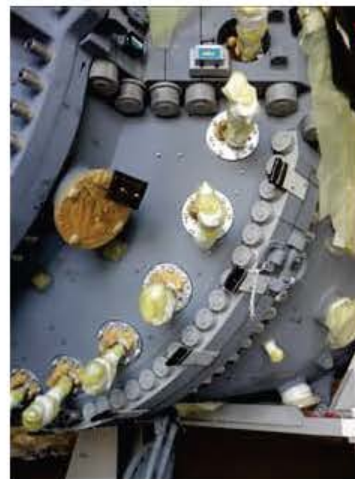
RHS Burner part

6. The burner supports were observed to have corrosion spots on their surfaces, particularly at the contact points with the casing and on the connecting elements.

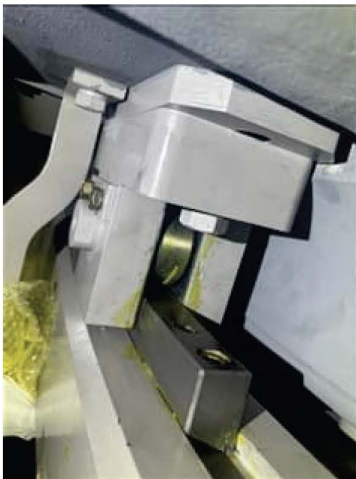
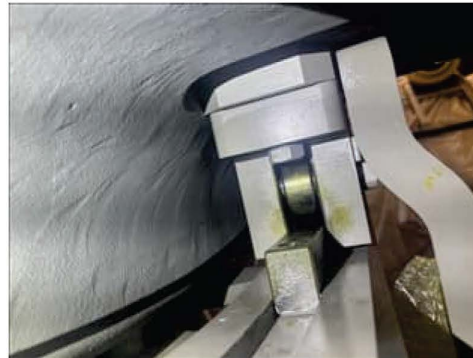
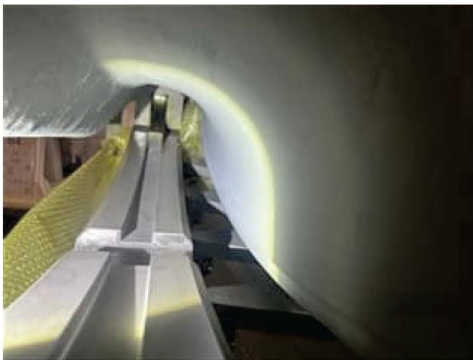
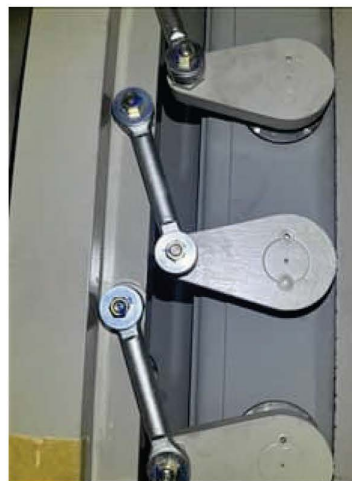
IGV support roller

IGV support roller (1)

IGV ring

IGV levers

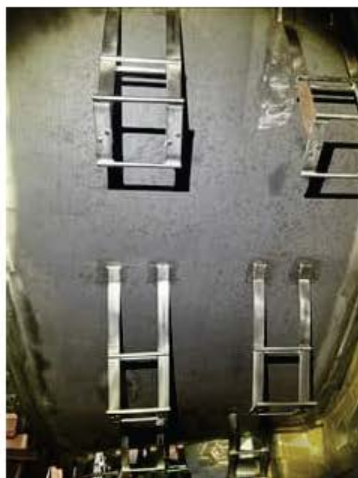
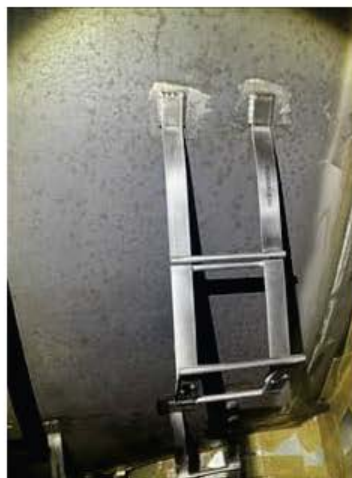
1. The turbine exit casing (TEC) exhibited signs of surface corrosion in several areas.
2. Two of the half joint bolts showed signs of paint loss and corrosion.

The turbine exit casing (TEC)

The turbine exit casing (TEC) (1)

The findings can be left as found.

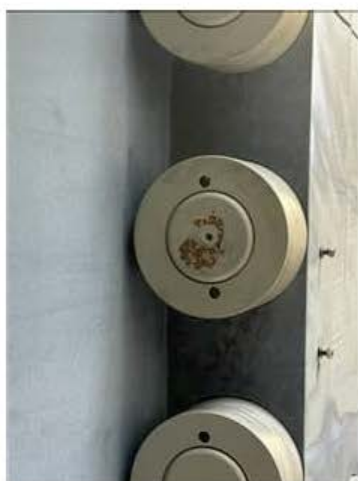
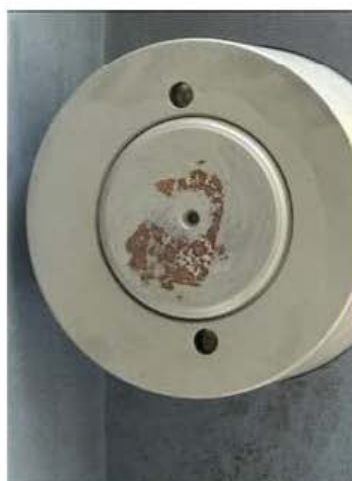
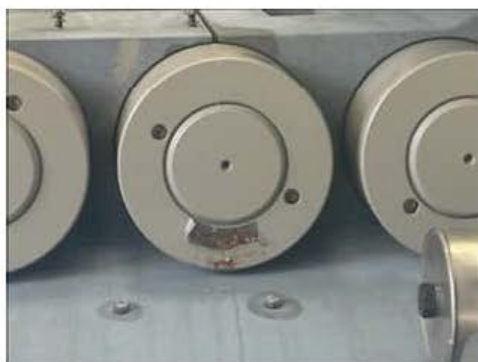
The half joint bolt

The half joint bolt (1)

The half joint bolt (2)

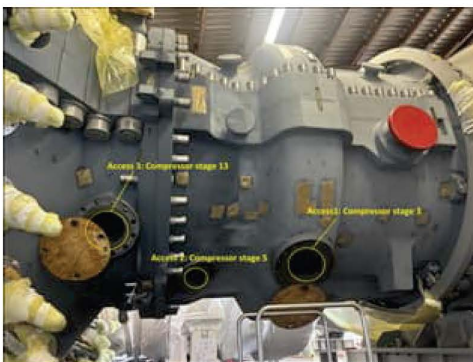
The compressor inspection was carried out through the openings at the compressor extraction points, as depicted in the images labeled "Accessibilities." These openings allowed for the examination of compressor stages #5, #9, and #13.

To inspect the gas passage of the premix burner, we accessed the gas pipe connection, as shown in the image titled "Premix Burner Gas Passage." A boroscope was used to inspect three premix burners: #10, #12, and #14.

Additionally, the turbine inspection was performed through the turbine exit casing, illustrated in the image labeled "Turbine Accessibilities."

Accessibilities

Turbine accessibilities

Burner #14 overview

Premix gas passage burner #12

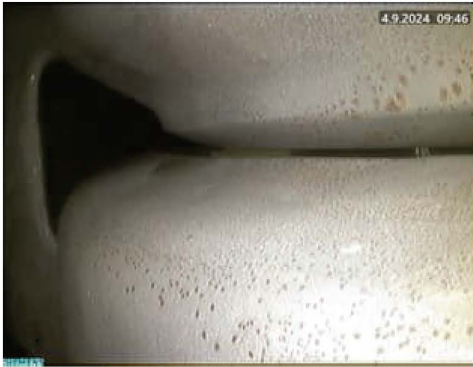
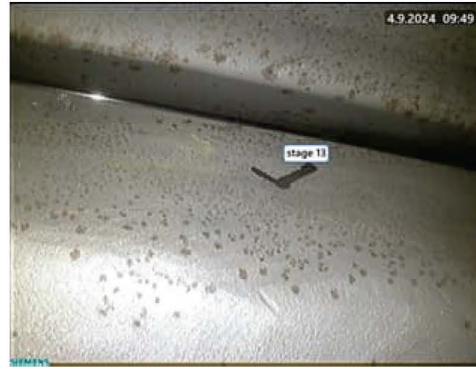
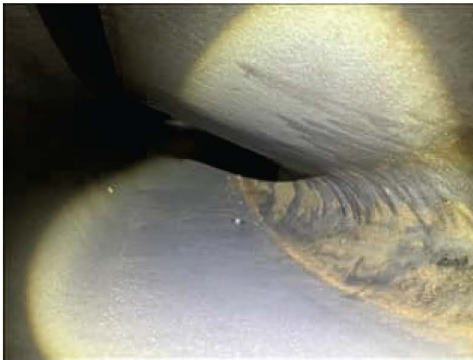
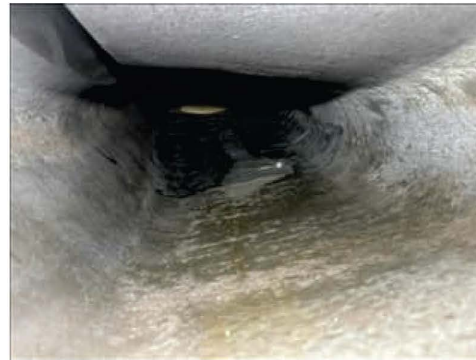
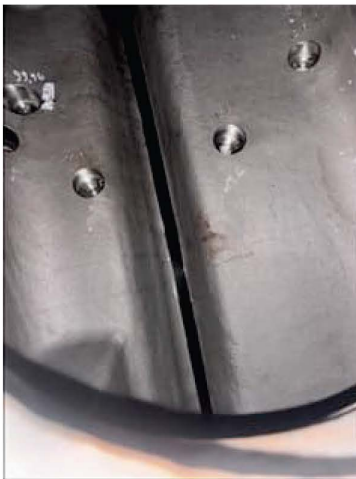
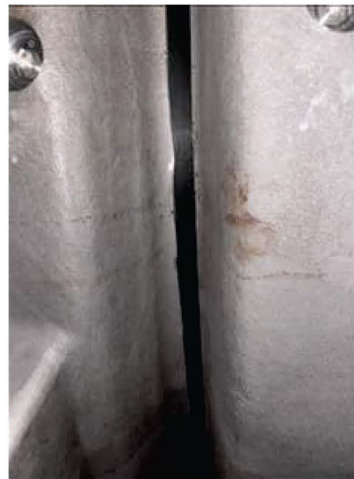
The outer surface of the compressor vane carriers showed signs of corrosion. The pictures were taken from the access points to compressor stages #5, #9, and #13.

The finding can be left as found.

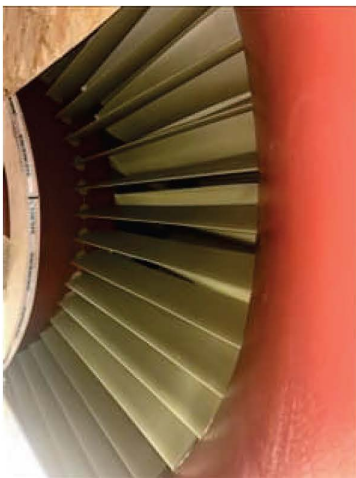
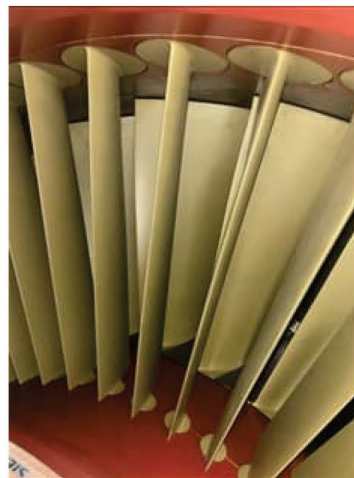
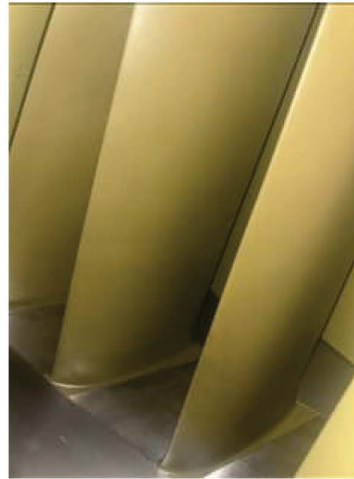
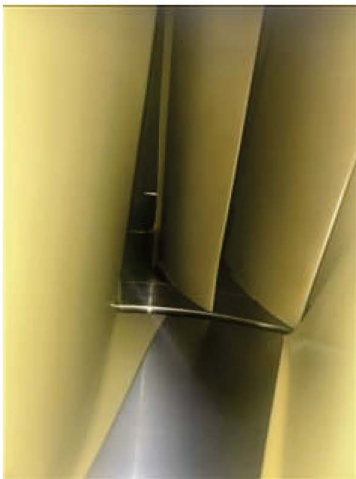
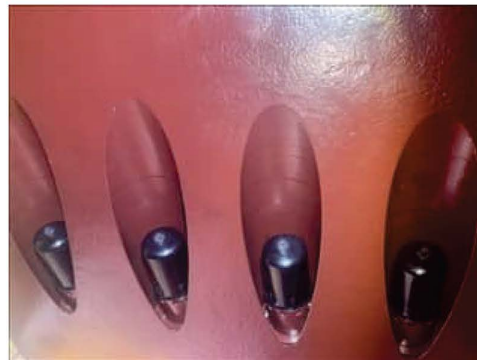
The compressor inlet area and the IGV region were assessed to be in good condition, with no indications of corrosion observed.

The findings can be left as they are, with ongoing monitoring to be conducted during future inspection.

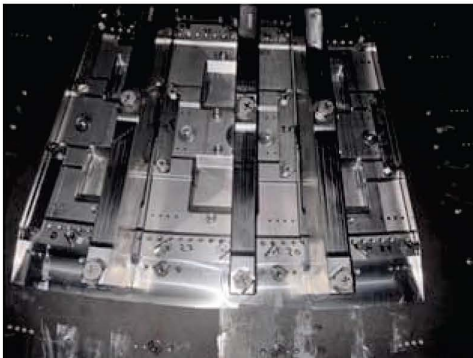
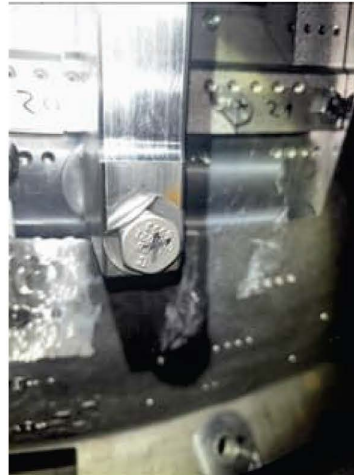
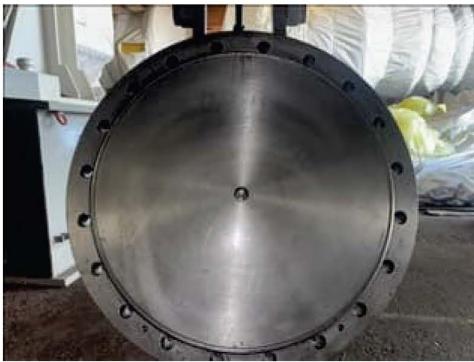
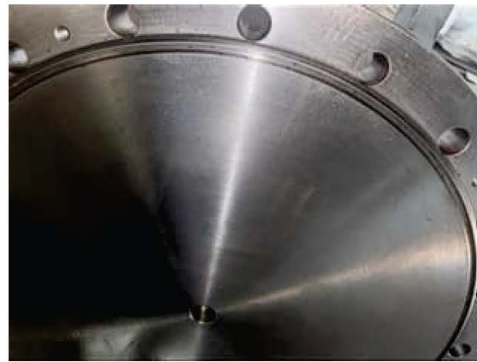
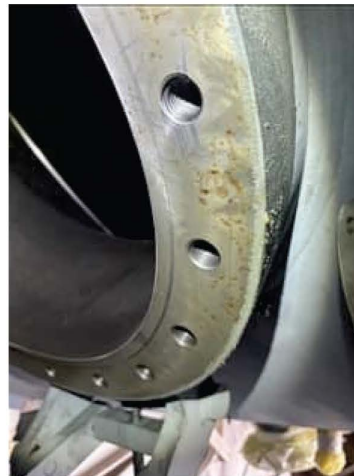
The lower outer manhole cover and the lower inner manhole connecting elements were found with a sign of corrosion.

The lower inner manhole

The lower outer manhole

The finding can be left as found.

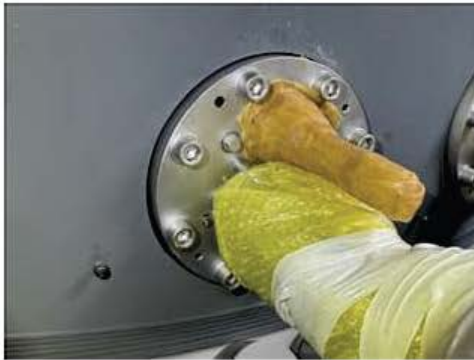
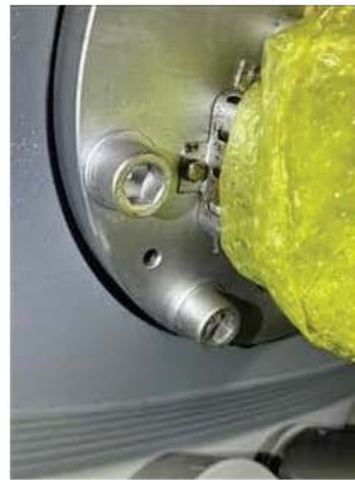
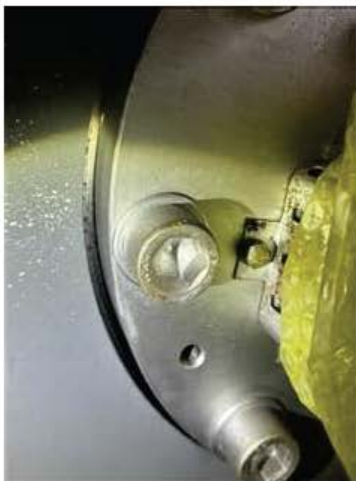
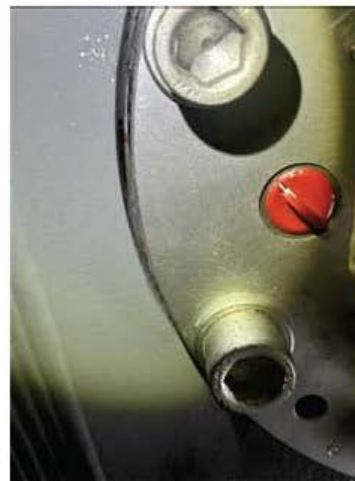
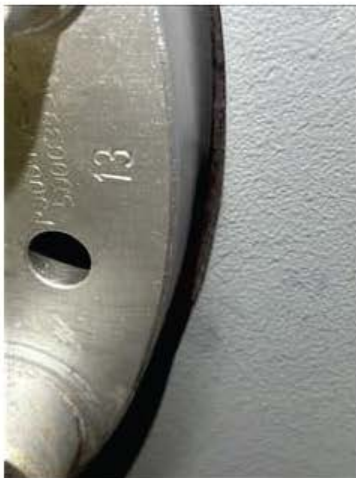
The burner supports were observed to have corrosion spots on their surfaces, particularly at the contact points with the casing and on the connecting elements.

Burner overview

Burner support

The finding can be left as found.

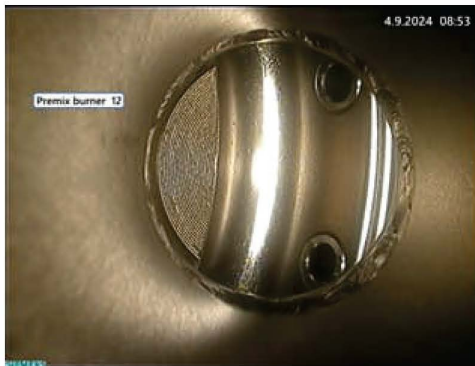
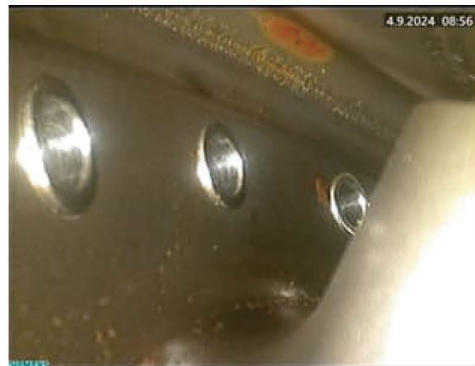
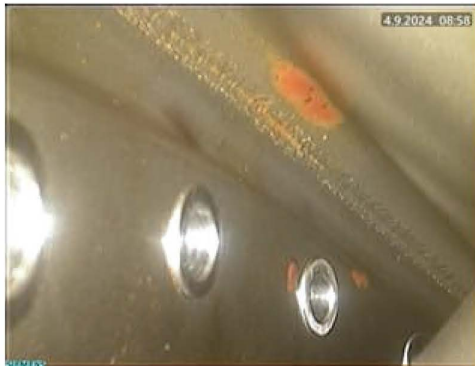
The gas passages of three premix burners (positions #10, #12 and #14) were examined, leading to the following observations:

1. The burners displayed brownish/reddish deposits in the vane holes.
2. Slight corrosion was noted in the ring channel.
3. Very small droplets of water were found in inner chanel of the burner #10.

Burner #12 Premix gas passage

Burner #12 inner Chanel

The finding can be left as found.

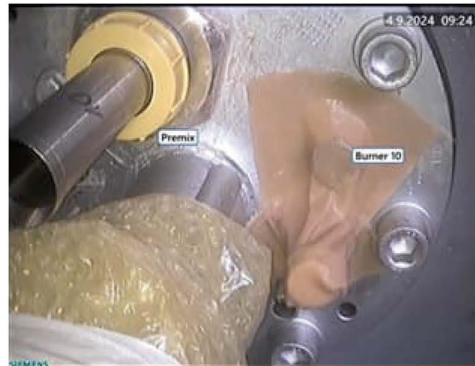
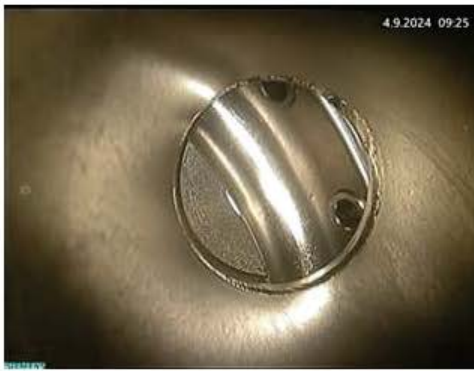
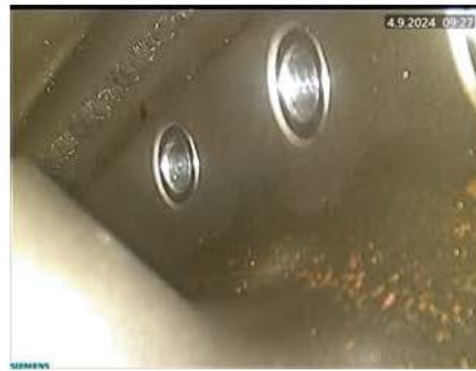
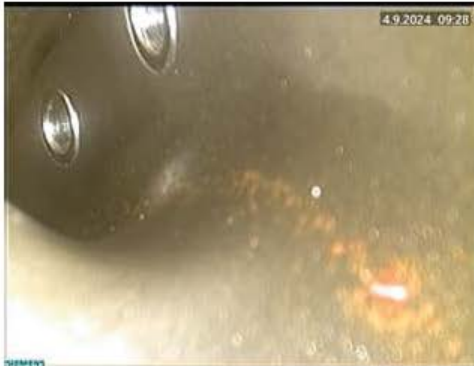
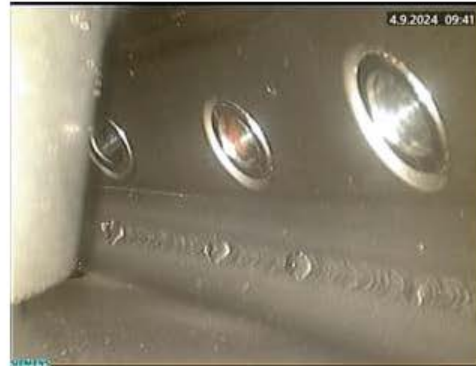
Burner #10

Burner #10 Premix gas passage

Burner #10 inner Chanel

Burner #10 inner chanel with droplets of water

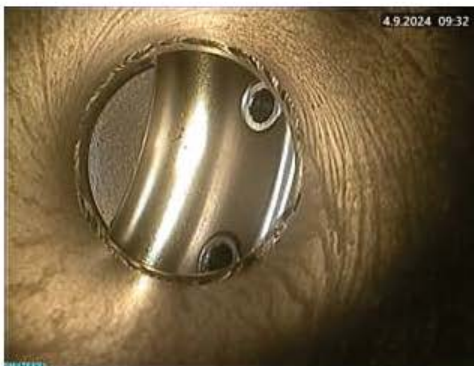
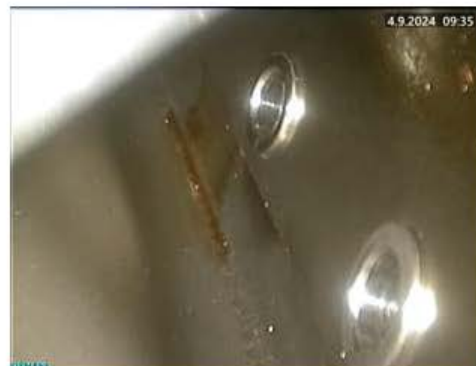
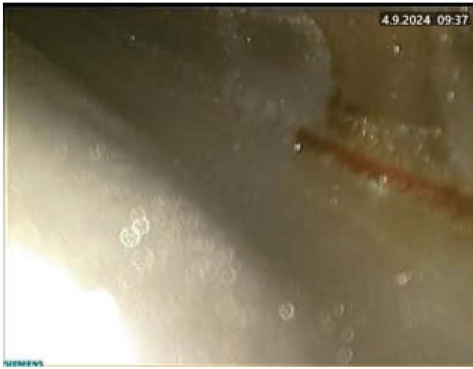
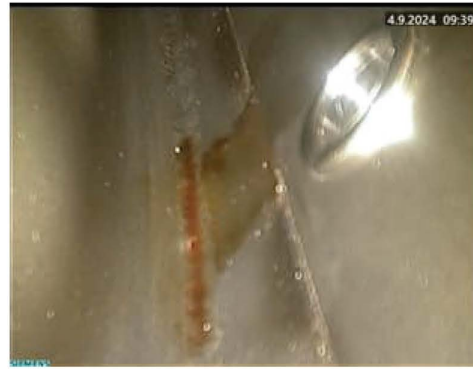
Burner #14 Premix gas passage

Burner #14 inner Chanel
