3	Old and Used Gas Engine Generators with Standard Accessories	8.73	W20V34SG	PAAE 012111	WARTSILA FINLAND OY LIMITED	06/2005
4	Old and Used Gas Engine Generators with Standard Accessories	8.73	W20V34SG	PAAE 012112	WARTSILA FINLAND OY LIMITED	06/2005
5	Old and Used Gas Engine Generators with Standard Accessories	8.73	W20V34SG	PAAE 012114	WARTSILA FINLAND OY LIMITED	06/2005
6	Old and Used Gas Engine Generators with Standard Accessories	8.73	W20V34SG	PAAE 012115	WARTSILA FINLAND OY LIMITED	06/2005
7	Old and Used Gas Engine Generators with Standard Accessories	8.73	W20V34SG	PAAE 012113	WARTSILA FINLAND OY LIMITED	06/2005
8	Old and Used Gas Engine Generators with Standard Accessories	8.73	W20V34SG	PAAE 024055	WARTSILA FINLAND OY LIMITED	08/2005
9	Old and Used Gas Engine Generators with Standard Accessories	8.73	W20V34SG	PAAE 029543	WARTSILA FINLAND OY LIMITED	09/2005
10	Old and Used Gas Engine Generators with Standard Accessories	8.73	W20V34SG	PAAE 030190	WARTSILA FINLAND OY LIMITED	11/2005

Visual Condition:

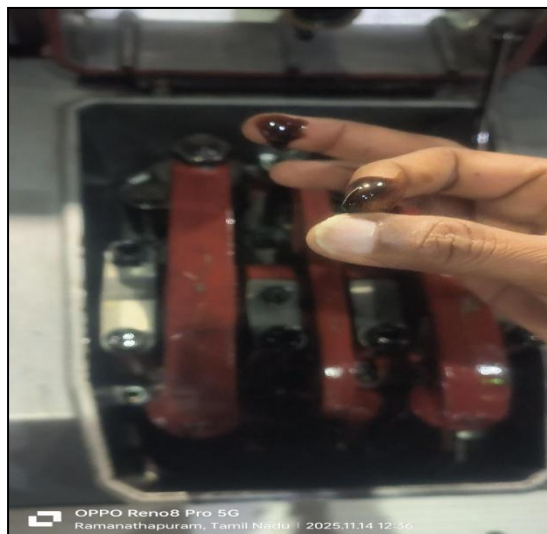
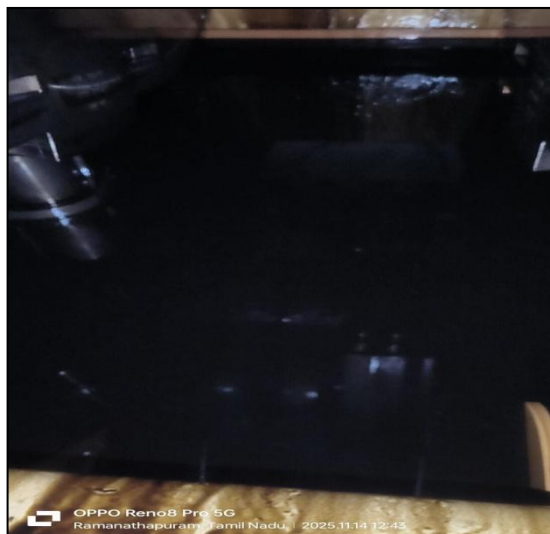
Lubrication System:

We noted that they are using different grades of lube oils for different components mentioned in the below table and lube analysis report was noted for selected engines say (Engine No.4, 6 and 14). The condition of the lube oil was also good and they were in measured levels. All the pipes are properly integrated.

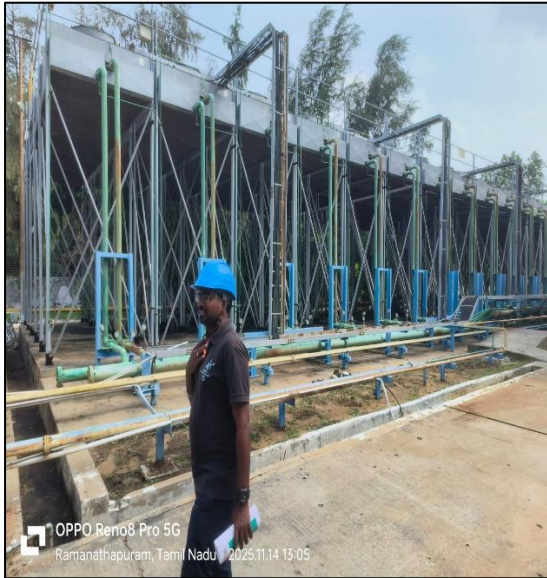
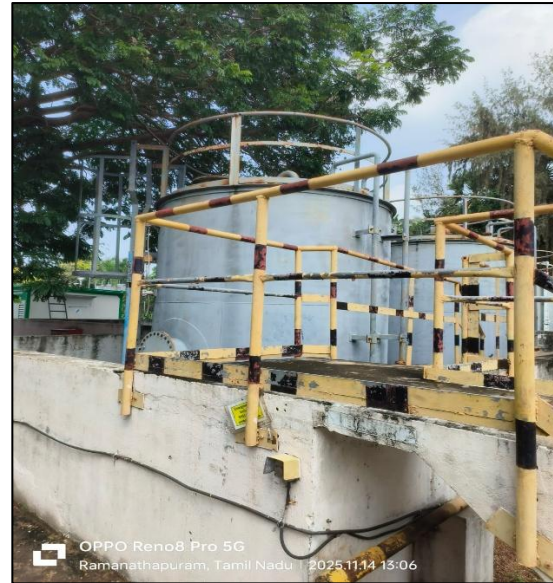
Cooling System:

We inspected the header tanks no corrosion marks are occurred, the coolant was visible and mixed with **Nalcool 2001**. And observed no leaks. All the coolant pipes are intact in that we noted very few hoses. Ground Water analysis witness with good quality of water, However DM water is using in the Engine and Radiator Cooling System.

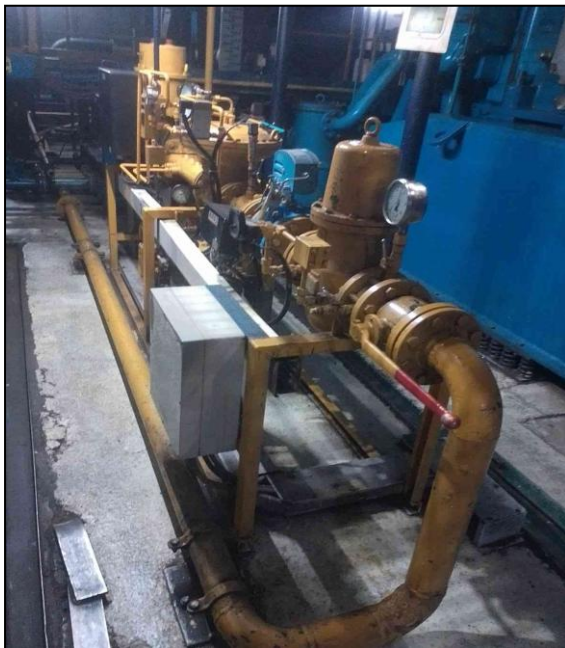
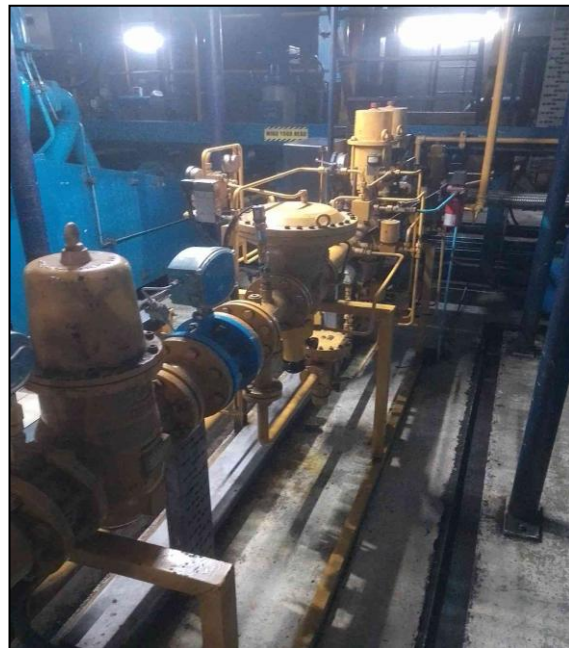
Fuel System:

All these engines are operated in **Natural Gas**. All the gas train modules (Gas Regulating Units) are placed with Particle filter, Pressure Control Valves, Safety shut down Valves and Vent Valves which is linked to PLC and Operating in good condition. Gas filters renewed as per Schedules. Gas leakages were controlled by PLC and local detection system is placed. Time to time MCC Valves and PCC Valves as well as Gas chamber valves are maintaining /Renewing as per Schedule recommended by Wartsila.

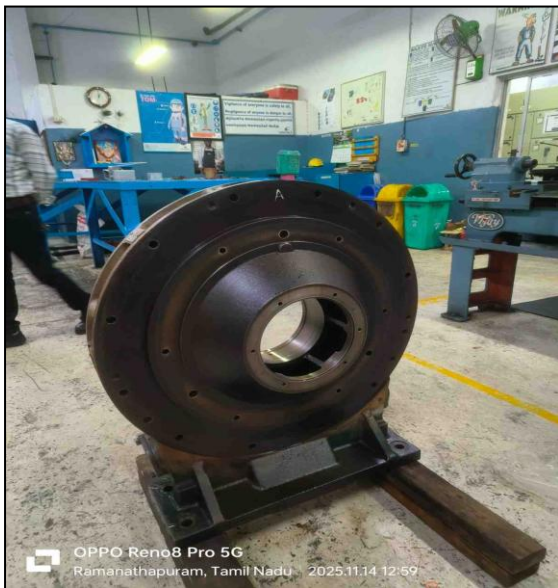
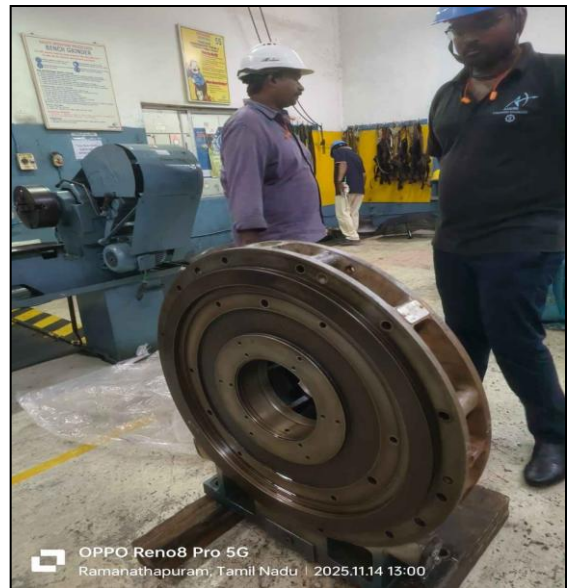
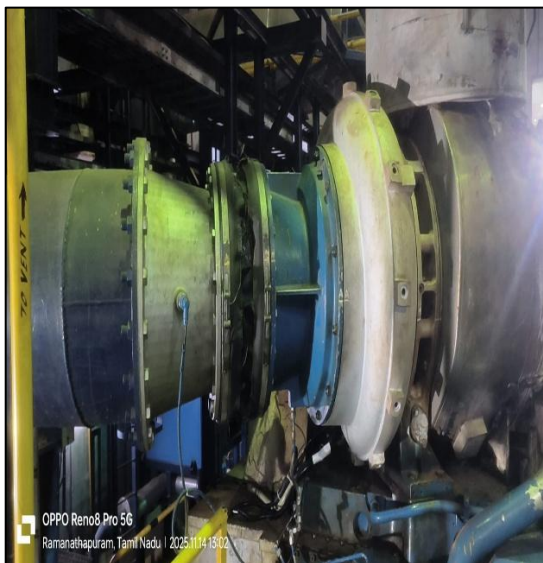
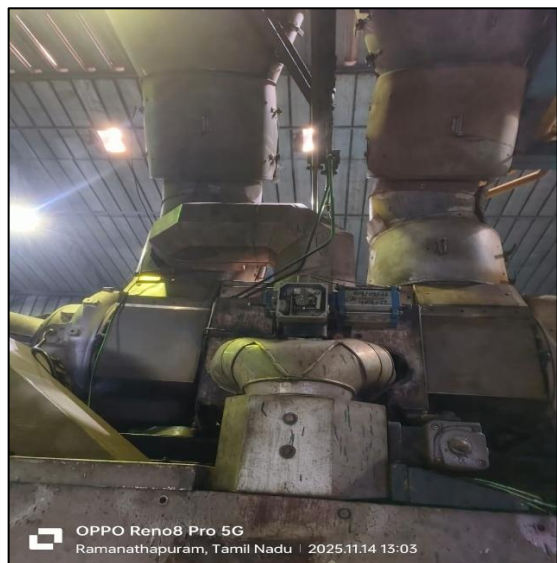
Turbochargers / Intake:

During inspection the entire turbo charger are in-line with their respective engines and 02 no's of turbo chargers were dismantled for maintenance purpose and in that both Rotors are sent to Wartsila workshop for balancing purpose. All the turbochargers were supplied by Napier NA357. The charge air filters are equipped with Turbochargers which are kept outside. These CA filters are rotating type and oil bath Filters. Customer is renewing the oil as per Schedule and Rotation of Filters checked ok. Fouling play of the Impeller are sounds good though some of the engines are working and some are in standby condition.

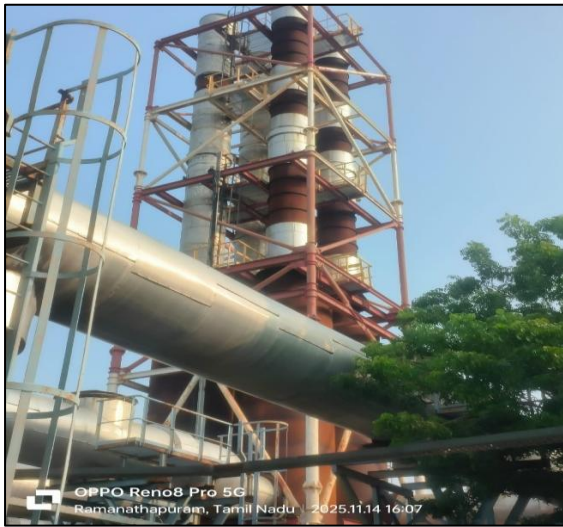
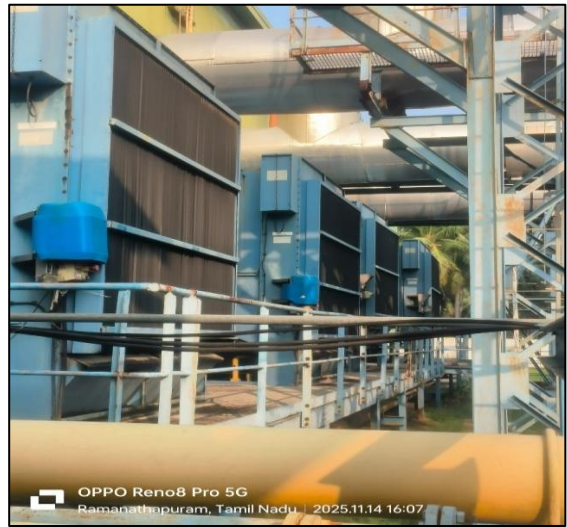
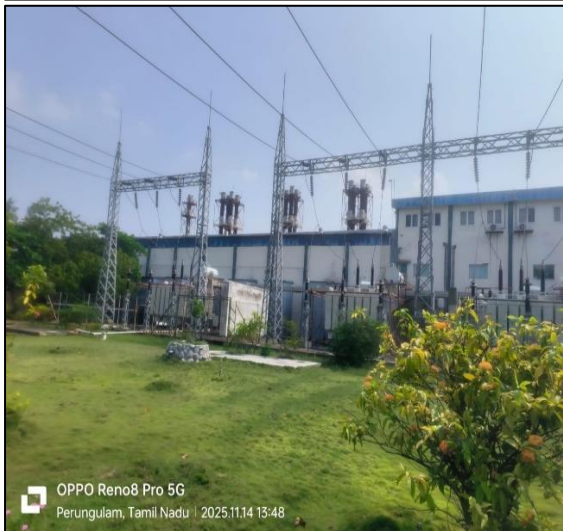
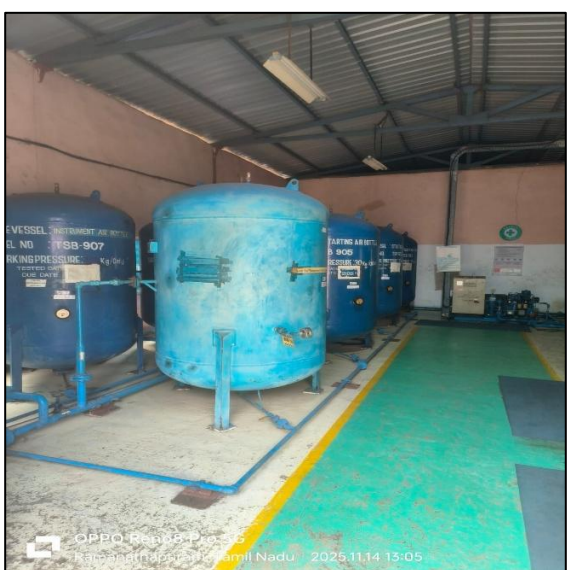
Expansion joints and bellow joints are intact with them engines are the exhaust gases are thrown away through silencer and no leaks found in it. The exhaust system is insulated wherever needed.

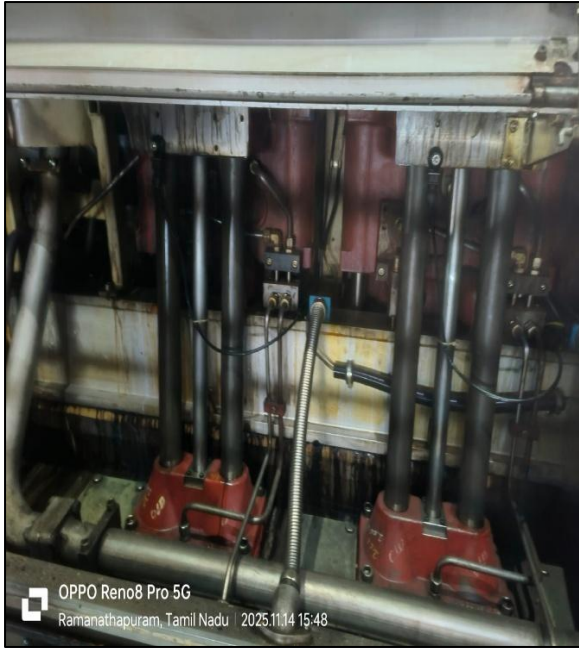
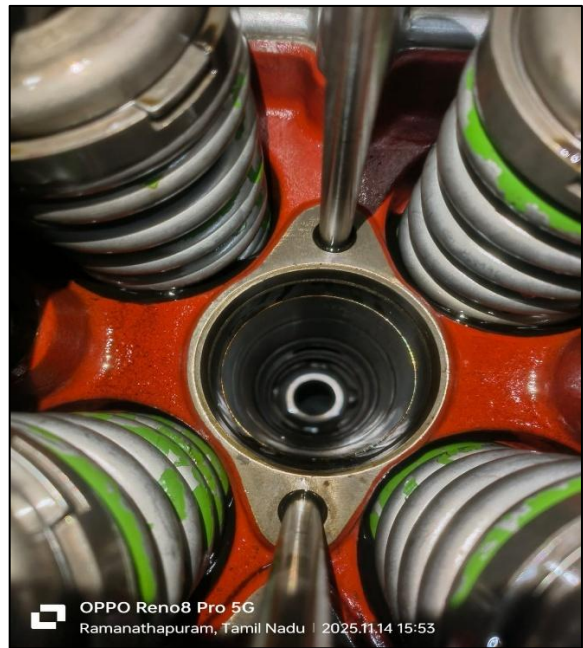
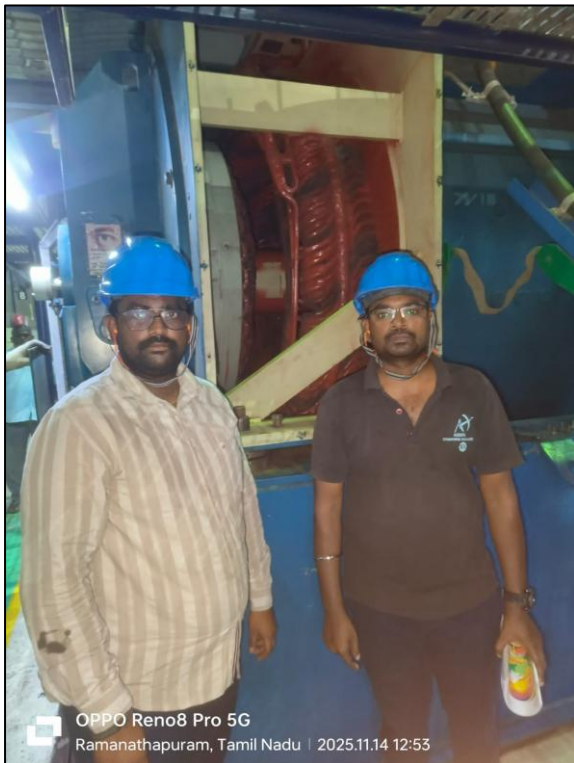
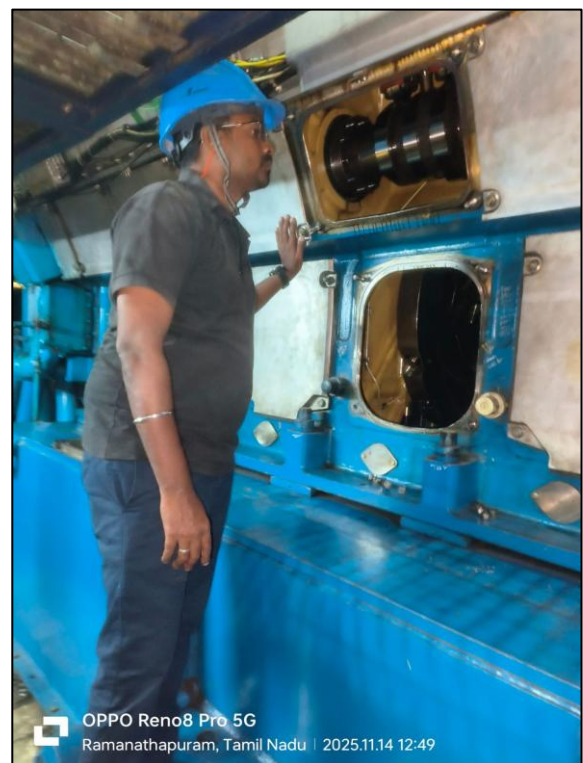
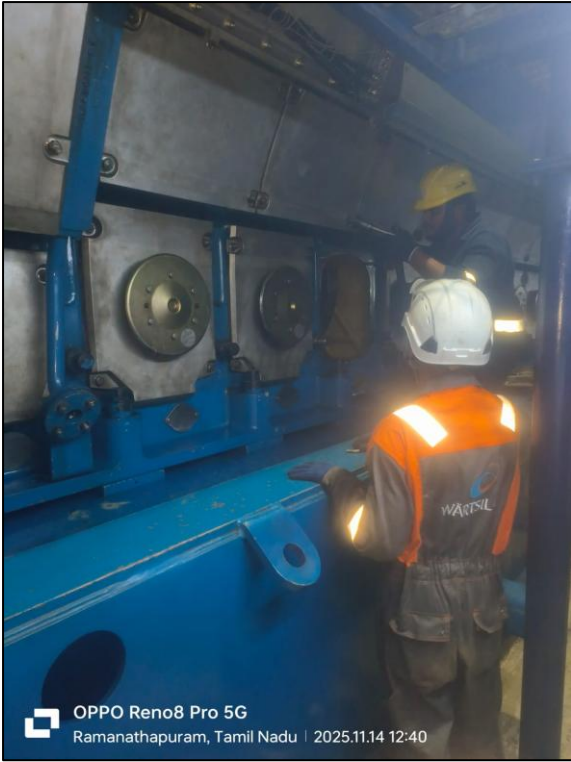
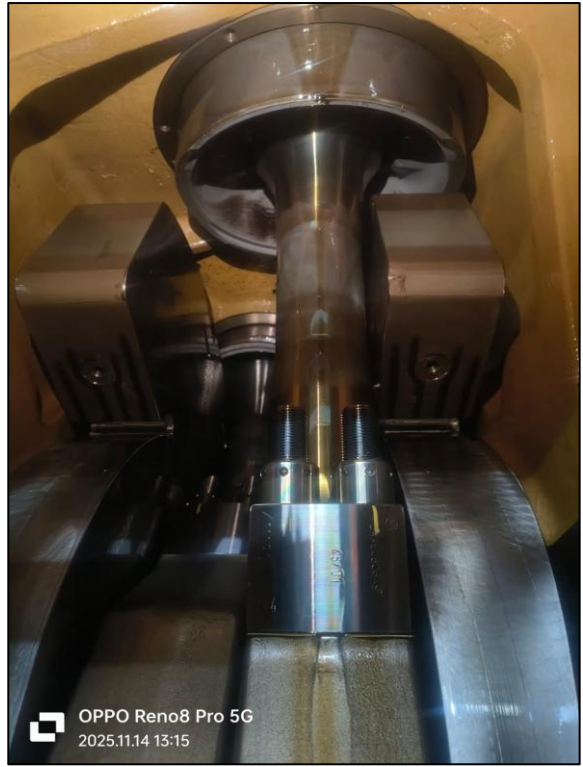
Crank / Alignment:

During visual inspection we manually rotated the engine and checked the play of the crank that seems to be good. However we have gone through the maintenance records of Wartsila, all those records are upto date. At the time of inspection 4 engines were in operational from that we have observed that no bearing noise, no metallic sound and vibrations are under the permissible limit.

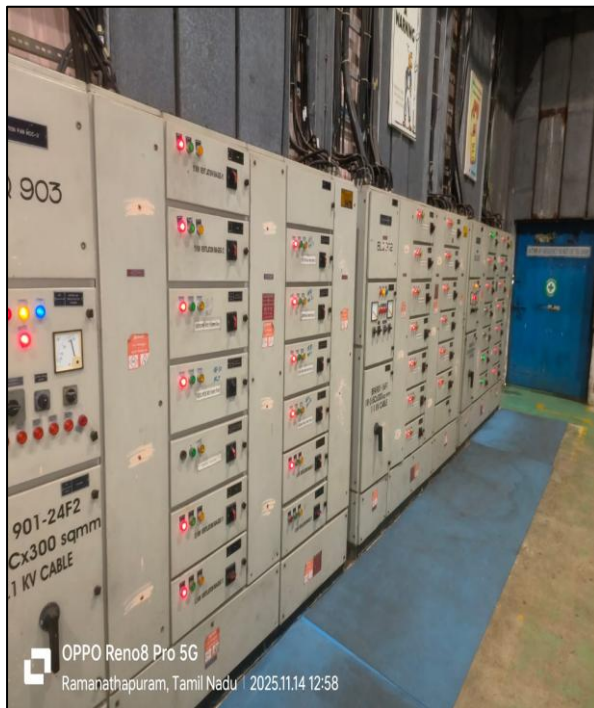
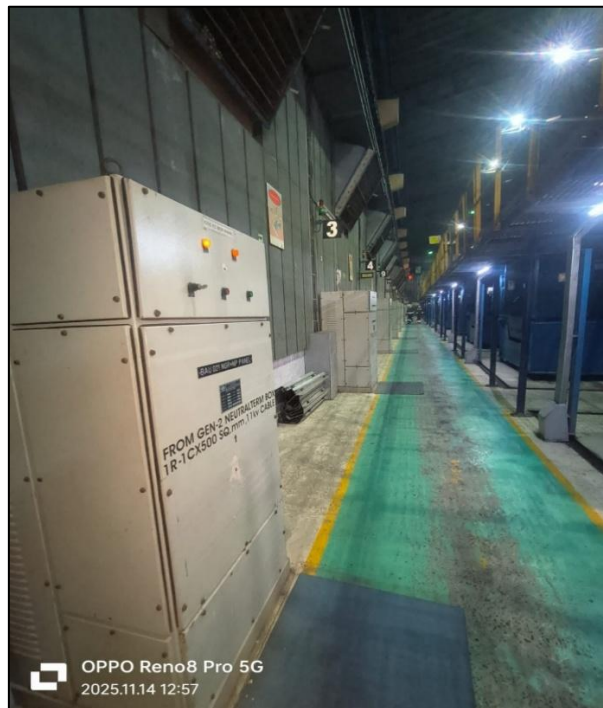
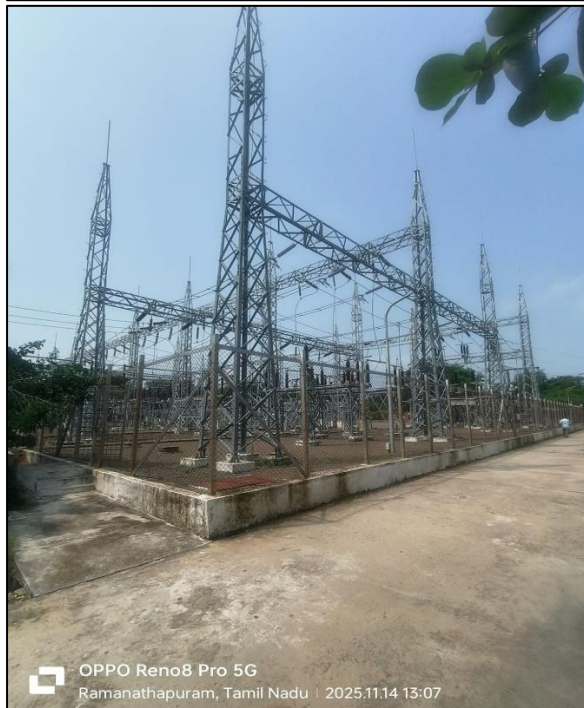
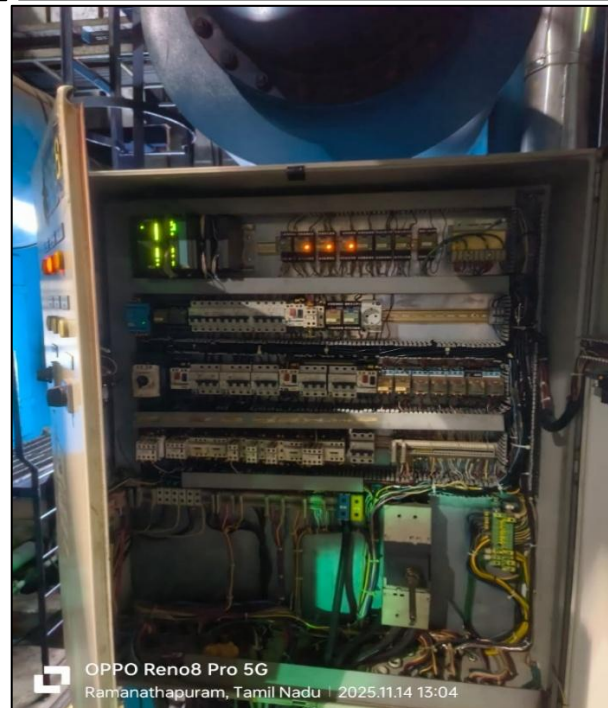
Electrical Coupling:

All the electrical cables and the other couplings are aligned properly with the safety system to the engines. Earthing's are properly channelled in the ground in the safe manner.

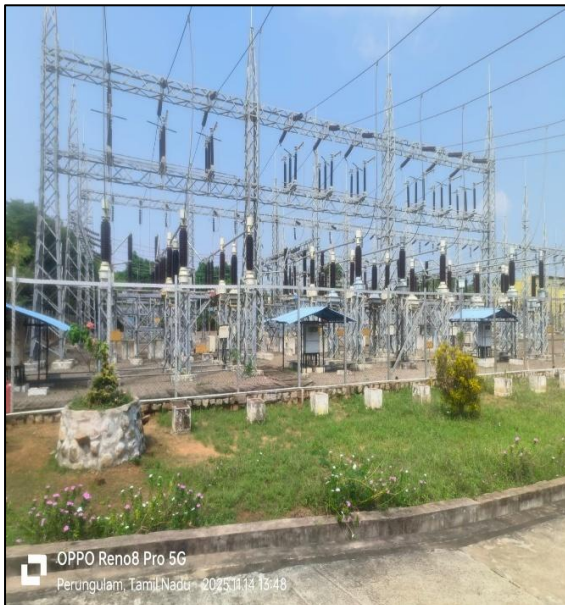
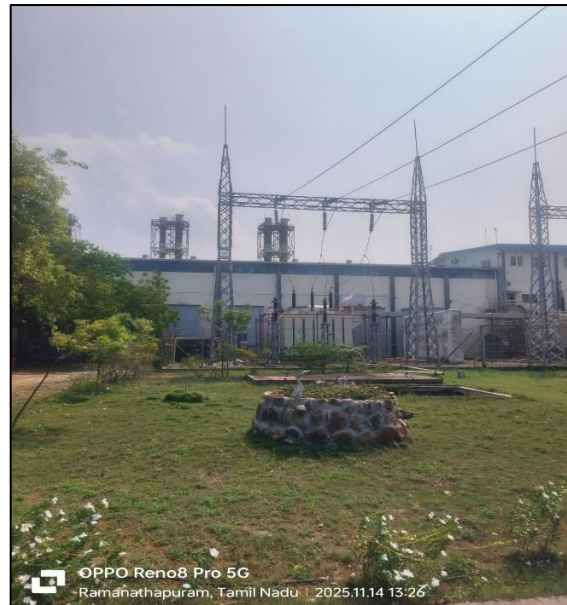
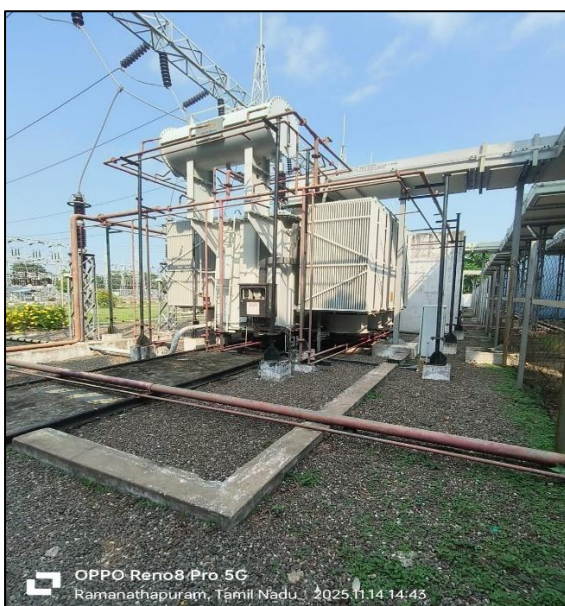
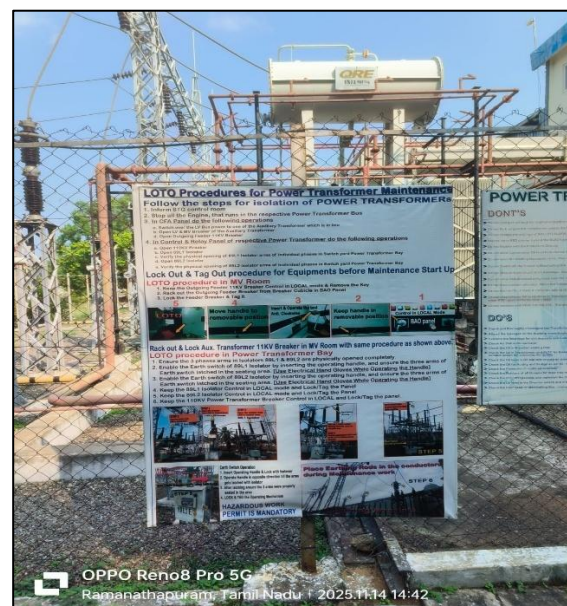
Transformer:

The oil level and the colour of the oil is visually inspected. Breather condition was not able to take since the plant is in running condition.

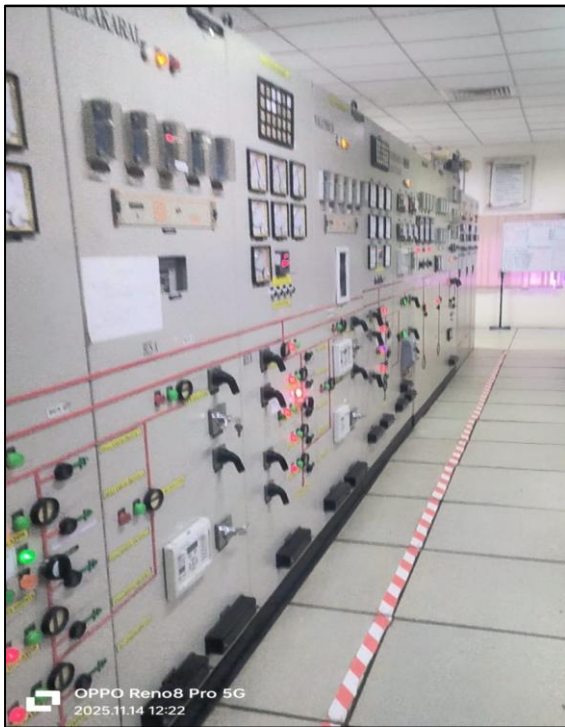
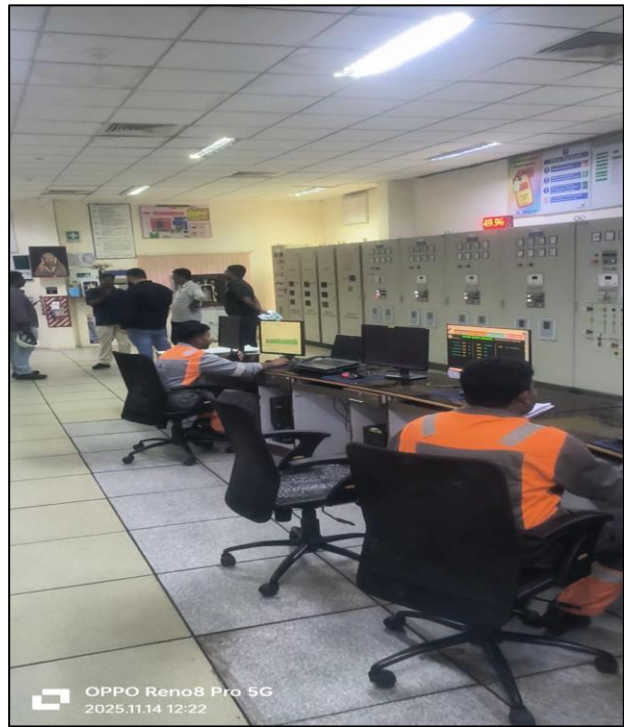
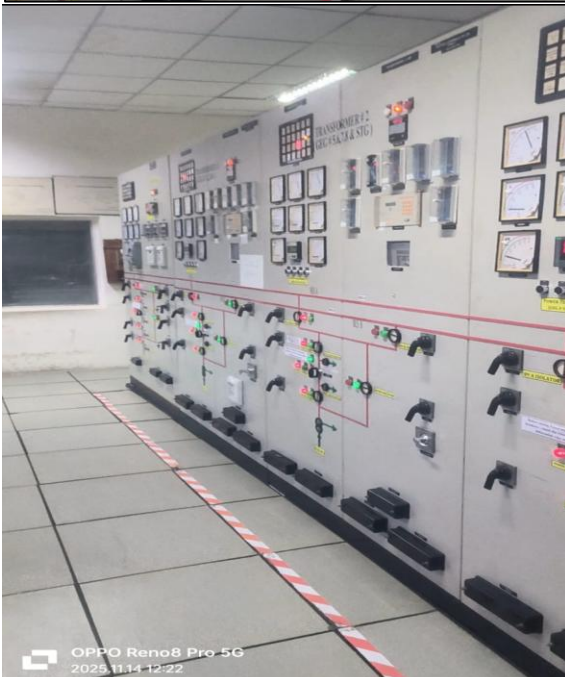
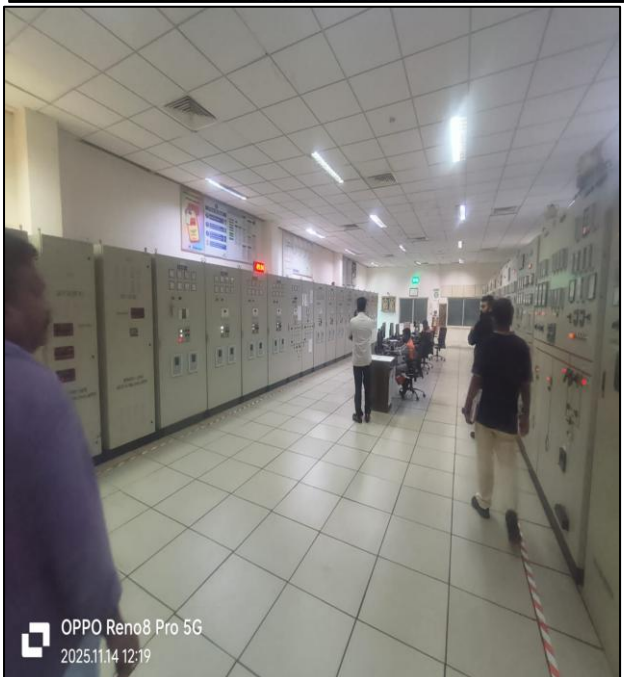
Control and relay panels:

We verified PLC and HMI of all the 16 engines are maintained in one control room. The wiring and labelling conditions are properly intact with the engine systems. Relay panels and safety systems were in place and Testing and Calibration was done as per Schedules with outside Agency under the Supervision of Wartsila.

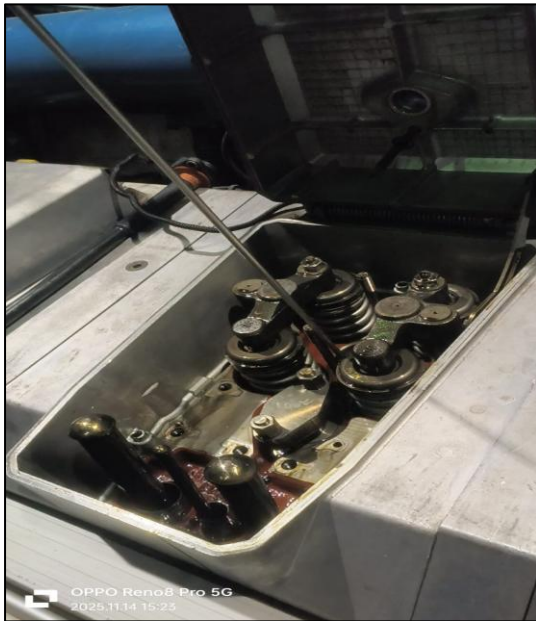
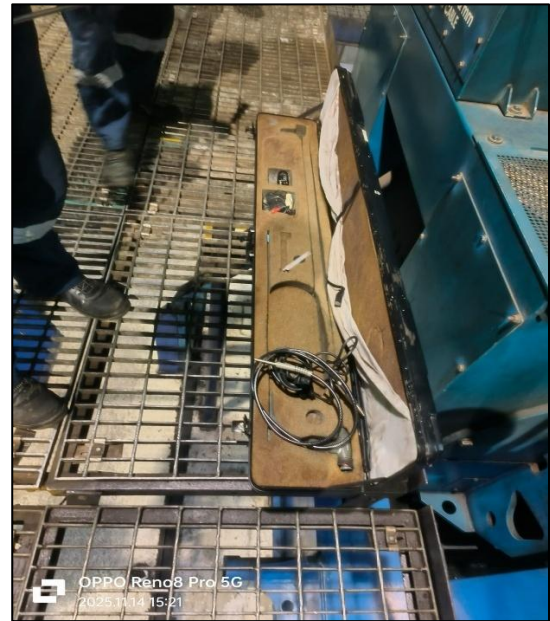
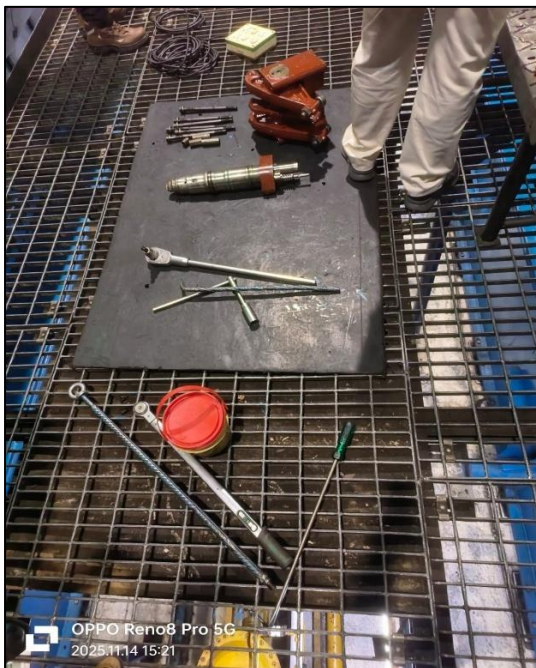
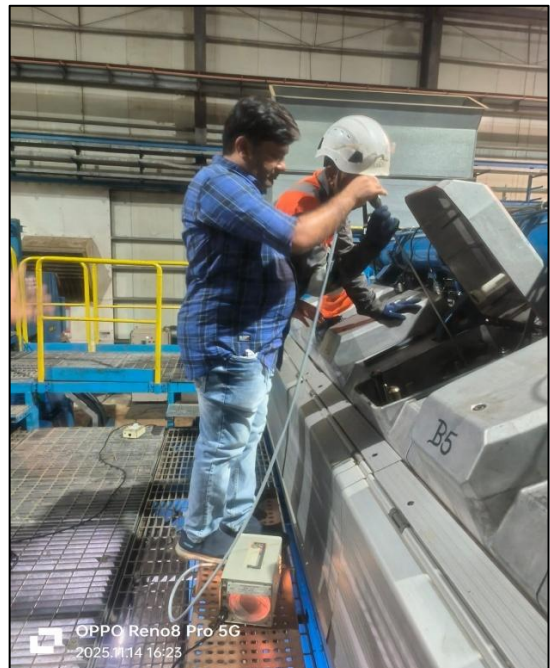
Technical Inspection (Borescope):

Out of 16 Gas Engines, we randomly chose 3 engines (GEG#4, GEG#6, GEG#14) and performed borescope inspection. We evaluated the valves, Flame Plate area, and hatches on the Liner which were found in good condition. Surprisingly All Honing Hatches are clearly visible and good condition.

Gas Gen set #4: B-6 and A-5 units

Gas gen set # 6: A-4 and B-6 units

Gas Gen set #14: B-4 and A-7 units.

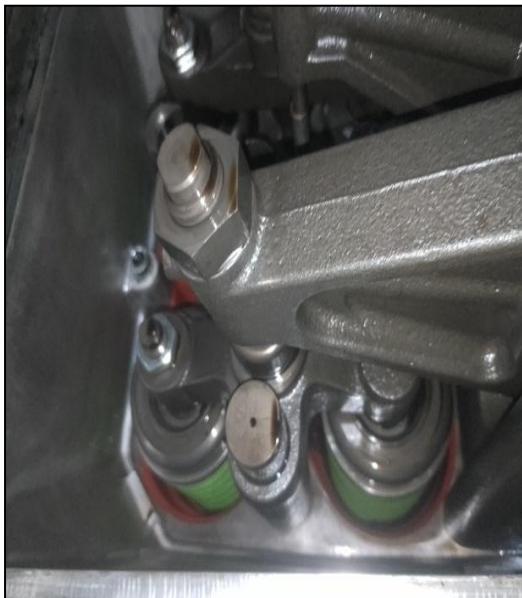
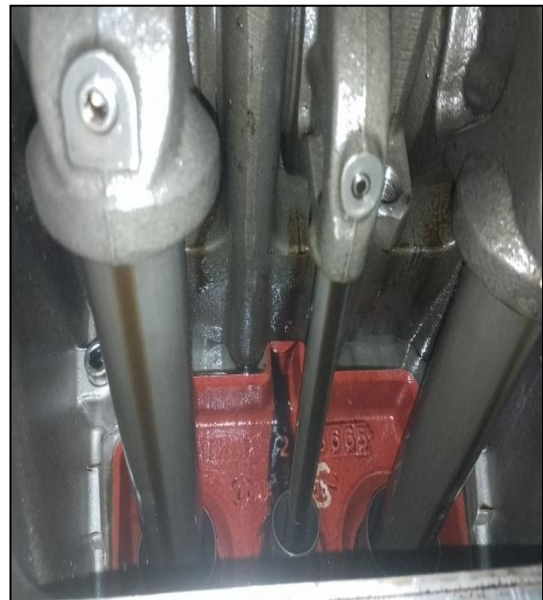
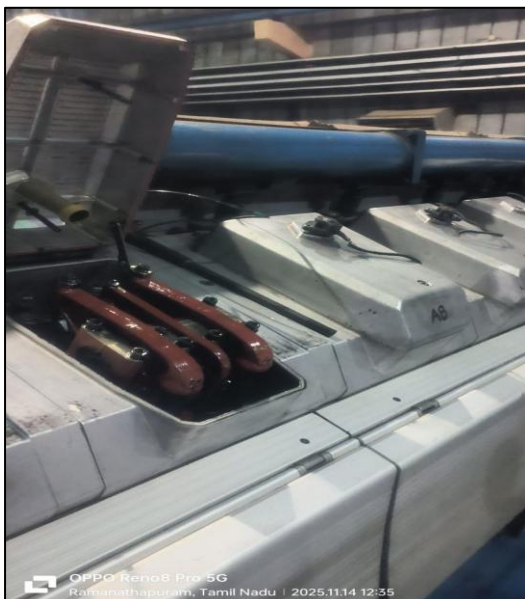
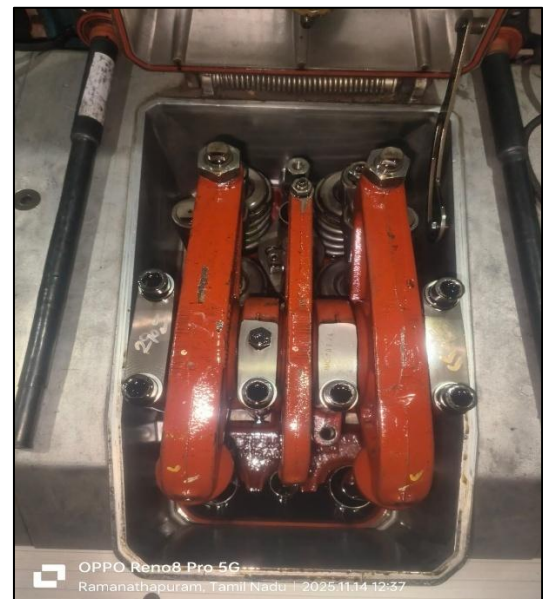
Rocker Arm Unit:

Visual Inspection Carried out for Connecting Rods, Cam shafts, Rocker arms, Engine Sump, Main Bearings and Inside the sump which are in good condition. Painting and Cleanliness is awesome.

Gas Gen set #4: A-5, B-6 Units.

Gas gen set # 6: A-7, B-3 Units.

Gas Gen set #14: A-7, B-4 Units.
