TG50D5 – Std
GT Serial Number 354

POWER PLANT ex Turbigio group “G”

Major Overhaul

Title: TG50D5 Std S/N:354 GR “G” – MAJOR OVERHAUL

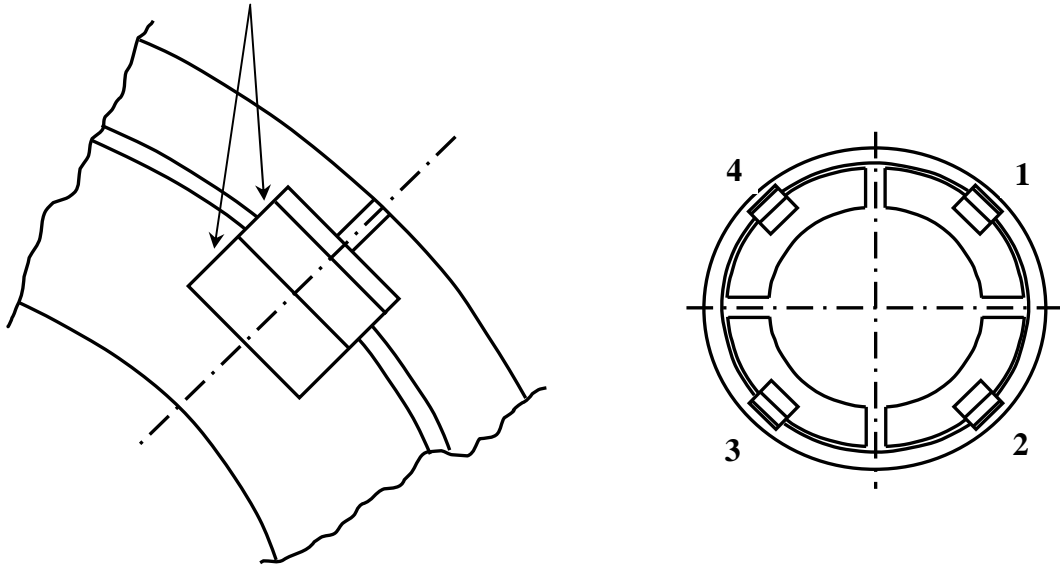
LEVELLING BLOCKS

BLOCK POSITION	1	2	3	4
COMPRESSOR SIDE	Good	Good	Good	Good
TURBINE SIDE	Good	Good	Good	Good

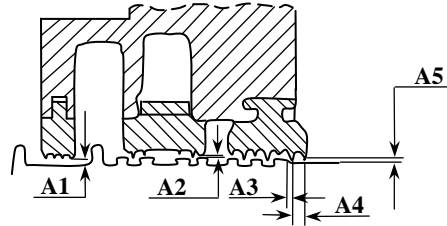
INLET CASING LABYRINTH SEALS - DETAIL "A"

CLEARANCES						Admitted clearances	SHAFT VISUAL INSPECTION
Detail "A"	Pos.	Before overhaul		After overhaul			
		Left	Right	Left	Right		
	A1	0,5	0,6	0,25	0,9	1,25 - 1,38	
	A2	0,8	0,8	0,4	1,0	1,55 - 1,78	
	A3					2,10 - 5,85	
	A4					2,55 - 6,05	
	A5	0,8	0,8	0,5	1,2	1,55 - 2,05

All air and oil seals assembled on Inlet Casing and Diffuser Body have been removed, cleaned and inspected. The seals on Inlet Casing have been found damaged and replaced with the new ones. No other problems have been found on remain seals on Diffuser Body. For assembling data see pages 19-20-21-30.

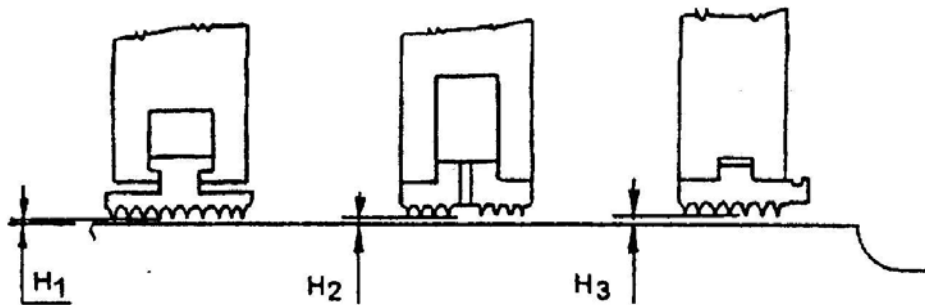
DIFFUSER BODY LABYRINTH SEALS - DETAIL "H"

DETAIL "H"	CLEARANCES					Permitted clearances	SHAFT VISUAL INSPECTION
	Pos.	Before overhaul		After overhaul			
		left	Right	Left	right		
H1	1,3	0,65	0,95	0,9	1,80 – 2,02		
H2	0,8	0,6	0,9	0,7	1,35 – 1,51		
H3	0,8	0,5	0,5	0,6	1,40 – 1,63

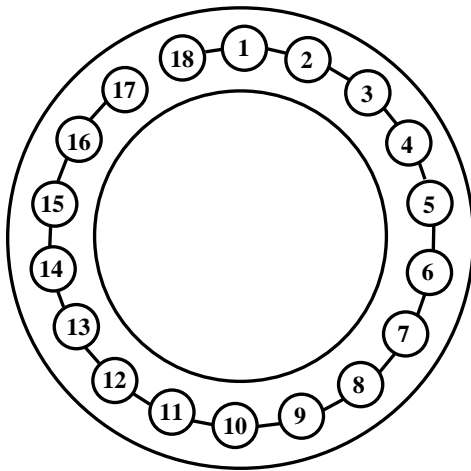
CROSS FLAME TUBE - INSPECTION

Position	Damage description	Position	Damage description
1	CRICCA 5mm	10	
2	CRICCA 5mm	11	
3	CRICCA 4mm	12	
4	CRICCA 80mm	13	
5		14	
6		15	
7		16	
8			
9

Position	Damage description	Position	Damage description
1	CRICCA 28mm	10	
2		11	
3		12	
4		13	
5		14	
6		15	
7		16	
8			
9

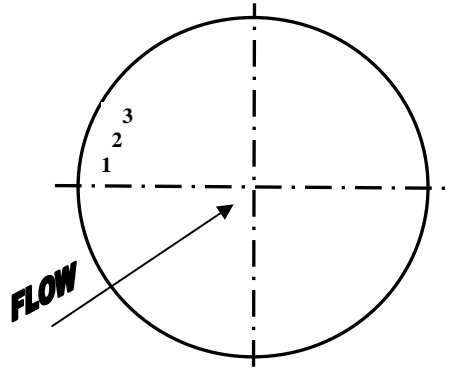
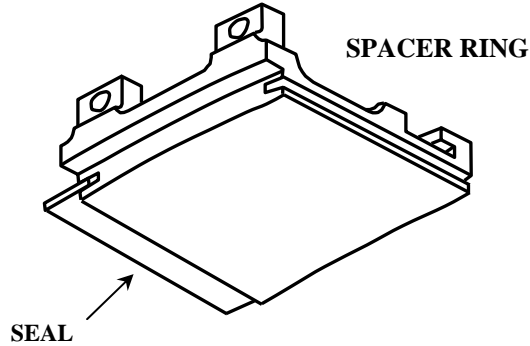
TURBINE 1ST STAGE VANE HOLDER – SPACERS AND SEALS

The Blade Rings 1st, 2nd, 3rd and 4th stage upper and lower part have been removed, fully dismantled, cleaned and the relevant components visually inspected. The spacer ring segments, 1st and 2nd row have been found with a light corrosion, which was eliminated through sandblasting. No other particular problems were reported, thus all the components were put back in the same positions. See pages from 66 to 69

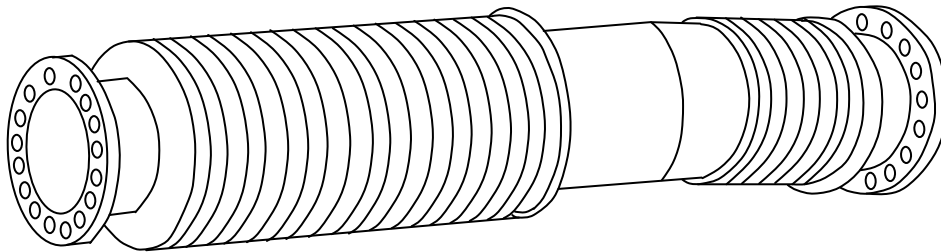
ROTOR COOLING FLEXIBLE PIPES – INSPECTION

TUBE N°	VISUAL CHECK	DAMAGE DESCRIPTION	REPAIRED	REPLACED
1	Good			
2	Good			
3	Good			
4	Good

NOTES: Contrast dye check were performed on the welding, no indications found

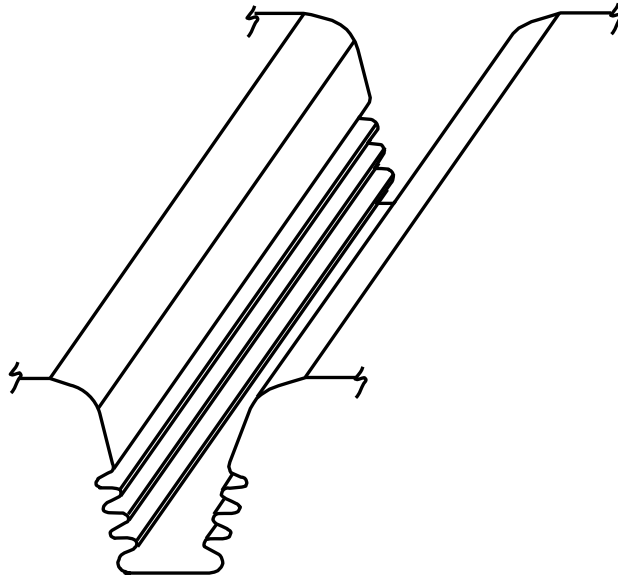
TURBINE DISKS – INSPECTION

TEST CARRIED OUT	DYE TEST	VISUAL CHECK	MAGNETIC CHECK
1ST STAGE	Good	Good	
2ND STAGE	Good	Good	
3RD STAGE	Good	Good	
4TH STAGE	Good	Good
