1 x GE LM2500+ SAC PK Model GenSet 30.3MW (60Hz. 13,8kV) for ISO Conditions

Model: LM2500+ SAC 7LM2500-PK-MD GE Gas Turbine Generator (GTG) Set

BORESCOPE REPORT

(Performed March 2024)

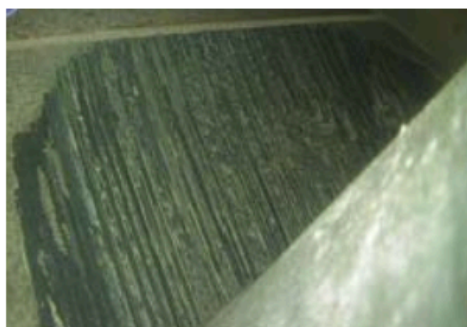
7. HPT STG1&2 Shrouds

Found in serviceable conditions

STG1S..... *Rubbing and Corrosion*

STG2S..... *No Remarks*
